INDIGENOUS MONITOR OVERVIEW REPORT

Month: August 2021

**Project Region: BC Interior
Spread 5A**

**Kilometre Posts (KPs) monitored:
KP 806–885**

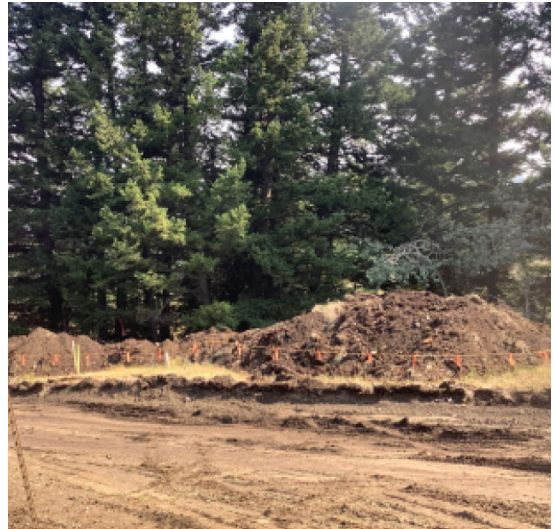
At KP 859, Indigenous Monitors were involved in inspecting the salvage and placement of topsoil and subsoil and were available if any potential heritage resources or items of traditional land use interest are unearthed during soil stripping operations. During the inspection, the Indigenous Monitor confirmed the soil piles were within the surveyed limits and no potential chance finds were identified.

Subsoil within log deck limits at KP 859.

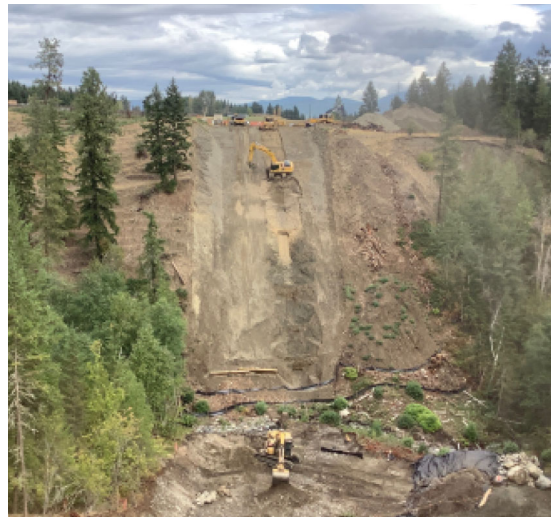
The Indigenous Monitors were involved in monitoring and inspecting such topsoil stripping mitigations. The Indigenous Monitors also investigated the construction areas before and after topsoil was stripped to identify any potential archaeological chance finds. No deficiencies or chance finds were identified during the inspection.

Soil stripping activities monitored near KP 821.

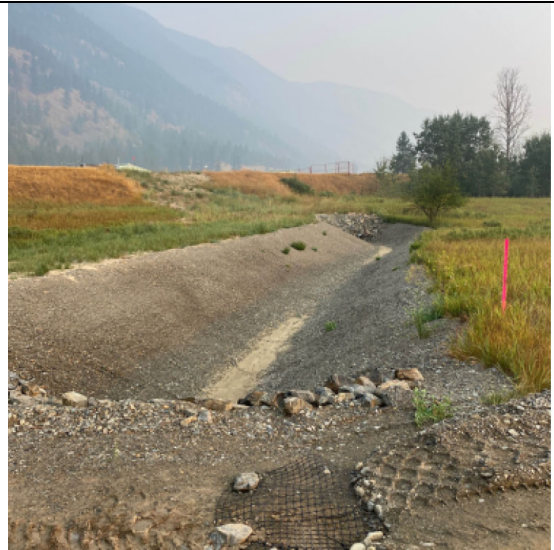
Inspections conducted by an Environmental Inspector and an Indigenous Monitor included observing housekeeping items, including waste management, equipment using drip trays, on-site stormwater management, soil buffers and placement locations and TLU signage. No environmental concerns were recorded at the time of the inspection.

On-site stormwater is tested for contamination before being released into the constructed ditch.

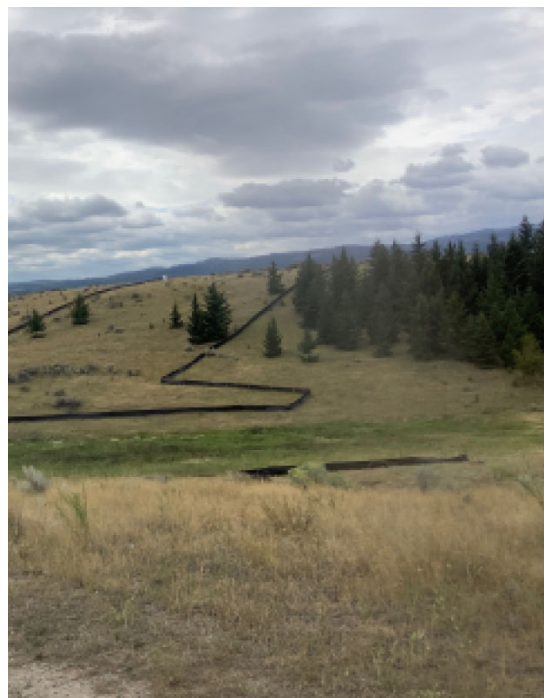
Near KP 849, the Indigenous Monitor participated in the implementation of the TLU Site Discovery Contingency Plan in areas where trees were identified as potentially culturally modified trees (CMT). Indigenous Monitors continue conducting CMT sweeps ahead of construction activity. Trees found during a CMT sweep were examined by the Indigenous Monitors and Environmental Inspectors on-site to collect initial information. The area was flagged off for additional evaluation. Resource specialists were contacted for evaluation of the tree and potential mitigation. The engagement process with applicable Indigenous groups was initiated to share information about the resource and seek feedback. The assessment of this resource is in progress.

General area where CMT sweeps were conducted.

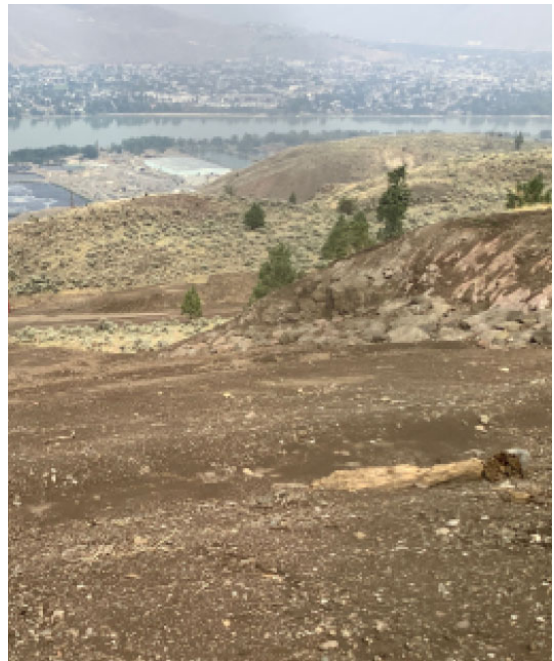
The Indigenous Monitors inspected topsoil replacement activities at Kenna Cartwright Park near KP 844 and noted good housekeeping efforts and soil handling measures. No deficiencies were identified.

Topsoil replacement at Kenna Cartwright Park near KP 844.
