INDIGENOUS MONITOR OVERVIEW REPORT

Month: July 2021

**Project Region: BC Interior
Spread 5A**

**Kilometre Posts (KPs) monitored:
KP 806–885**

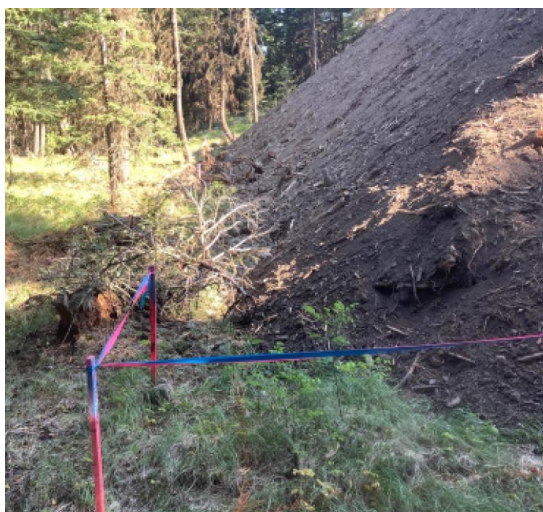
At KP 863, Indigenous Monitors were involved in inspecting the salvage and placement of topsoil and subsoil and were available if any potential heritage resources or items of traditional land use interest are unearthed during soil stripping operations. During the inspection the Indigenous Monitor confirmed the soil piles were within the surveyed limits. No concerns were identified.

Subsoil within log deck limits at KP 863.

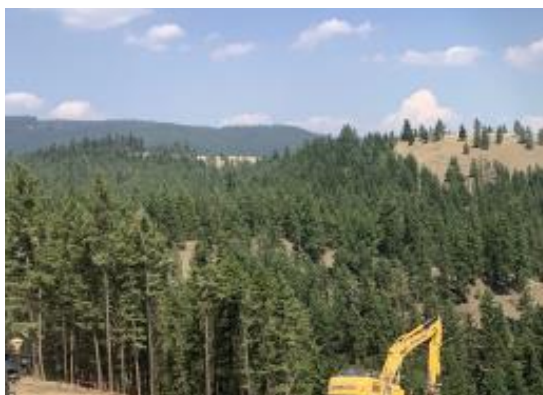
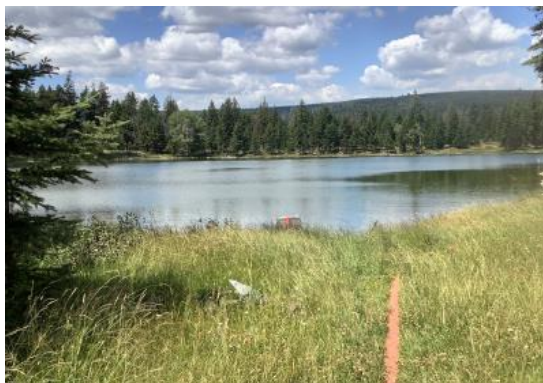
Near KP 915 the Indigenous Monitor participated in the implementation of the TLU Site Discovery Contingency Plan in areas where trees were identified that were thought to be potentially culturally modified. Indigenous Monitors continue conducting CMT sweeps ahead of construction activity. Trees found during a CMT sweep were examined by the Indigenous Monitors and Environmental Inspectors on-site to collect initial information. The area was flagged off for additional evaluation. Resource specialists were contacted for evaluation of the tree and potential mitigation. The engagement process with applicable Indigenous groups was initiated to share information about the resource and seek feedback. The assessment of this resource is in progress.

General area where CMT sweeps were conducted.

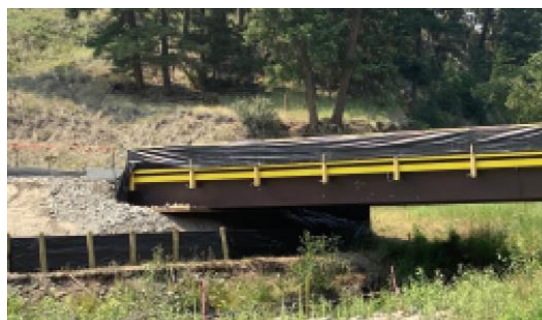
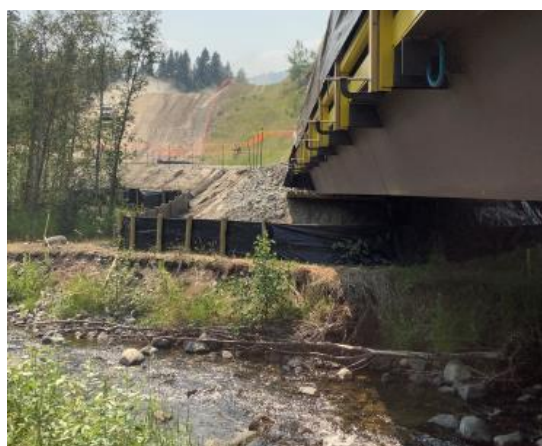
The Indigenous Monitors reviewed TMEP's bridge cleaning process, bridge installation drawings and foot traffic protocols and observed the use of filter cloth and rig mats for bridge protection. It was noted that spill barrels were placed adjacent to the creek and all appropriate signage was in place per the Environmental Protection Plan.

The IM will conduct followup monitoring under the bridge during heavy rainfall. No deficiencies were identified in the area.

Moore Creek bridge crossing at KP 889.

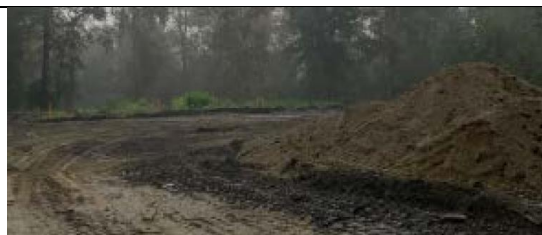
An inspection was conducted by an Environmental Inspector and an Indigenous Monitor at the Black Pines Transmission Line. The inspection included observing housekeeping items, equipment using drip trays, on-site stormwater management, soil buffers and placement locations and TLU signage. No environmental concerns were recorded at the time of the inspection.

Topsoil stripping activities.

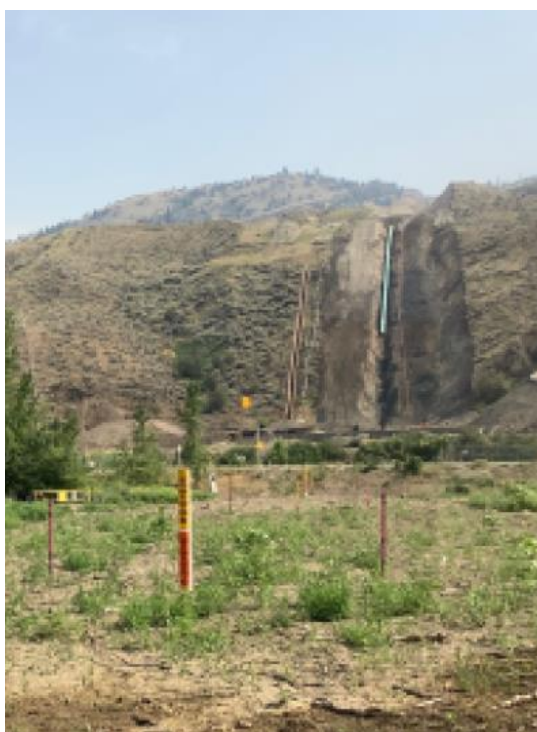
The Indigenous Monitor inspections focused on appropriate signage and flagging and inspecting vegetation ground cover. It was noted that the site was on the right trajectory for re-vegetation. Native species were observed including Common Milkweed and Aspen saplings. Weed species were also identified. The Indigenous Monitor and Environmental Inspector reported the deficiency and notified the team in charge of the herbicide application. The Environmental Inspector worked collaboratively with the contractor to remove the weeds by applying herbicide. The Indigenous Monitor continues to participate in follow-up inspections for this area.

Observing vegetation regrowth at an HDD entry site near Mission Flats.

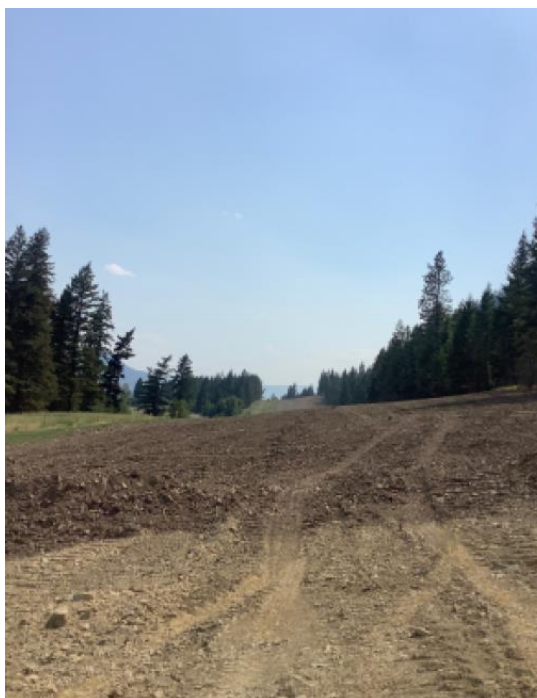
The Indigenous Monitors inspected pastureland around Black Pines near KP 806 and noted good housekeeping efforts and soil handling measures. No deficiencies were identified.

Topsoil replacement at KP 806.
