INDIGENOUS MONITOR OVERVIEW REPORT

Month: November 2021

**Project Region: BC Interior
Spread 5A**

**Kilometre Posts (KPs) monitored:
KP 806–927**

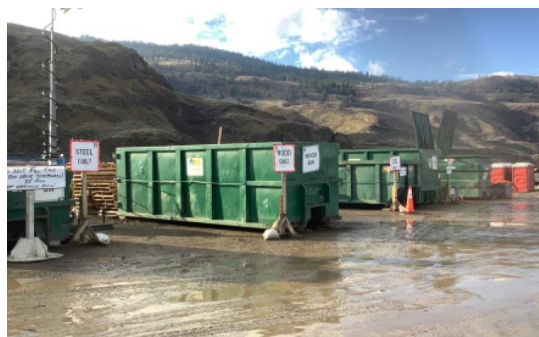
A joint inspection was conducted by the Environmental Inspector (EI) and Indigenous Monitor (IM) at the Mission Flats laydown yard. At the yard, garbage was identified and removed near the above-ground storage tank. Ponding was noted at the yard due to a post-rain event, however, no water was observed leaving the yard. The IM documented and reported insufficient segregation of waste materials. The yard attendant was notified and addressed the deficiency during the inspection. No further follow up action was required for the inspection.

Inspecting waste management at Mission Flats.

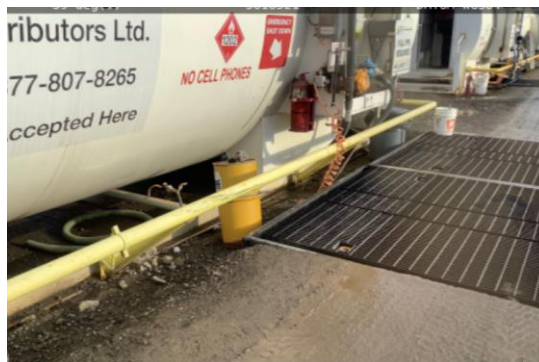
Garbage identified near the above-ground storage tank.

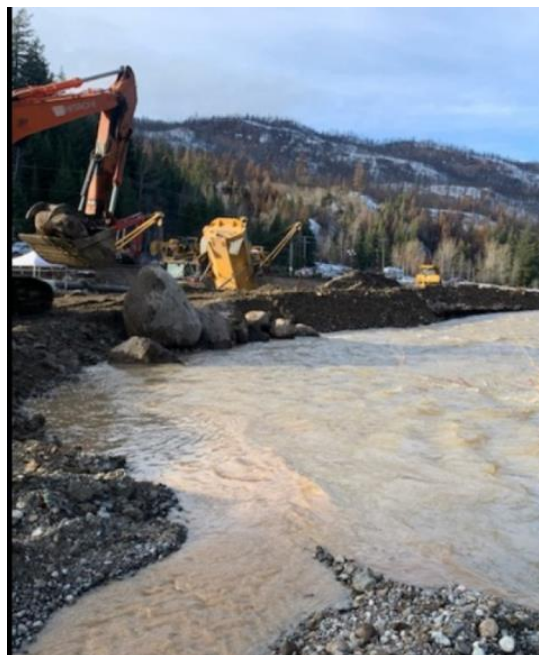
Strengthening berm for diversion --- Coldwater.

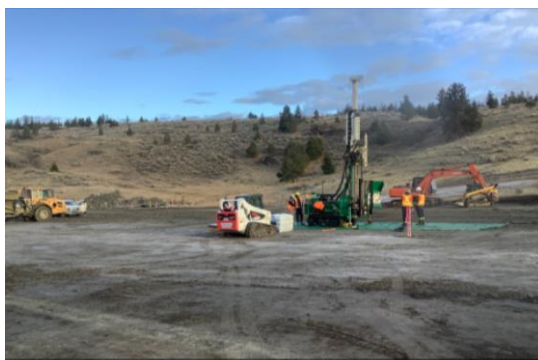
At KP 852, the topsoil was stripped and segregated and grading activities commenced. The IM identified a light tower missing a drip tray. The deficiency was documented and corrective action was applied by the foreman on-site. No surface staining was observed.

Bore pad construction at KP 852 near Jacko Lake.

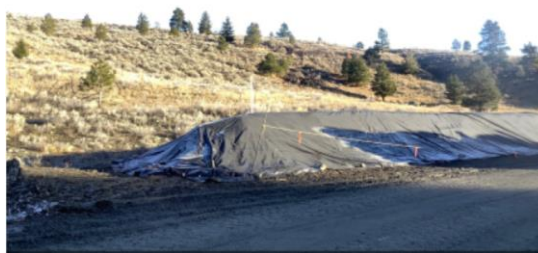
Topsoil storage piles at KP 852 near Jacko Lake.

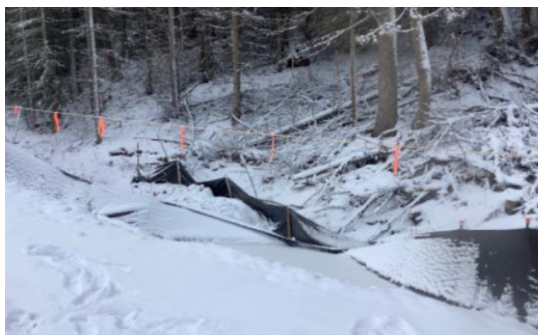
After the heavy rainfall and extreme weather conditions in mid-November, the Indigenous Monitors alongside the Environmental Inspector checked ESC measures in construction areas that were safely accessible. At KP 862, ESC measures were monitored and deficiencies were documented to the EI on-site. Corrective action was addressed by the EI and contractor. Near Moore Creek at KP 889, the Indigenous Monitors observed erosion and sediment control mitigations in good standing condition. Silt fencing, hoses and pumps were also identified to be in good condition.

KP 862, near Goose Lake Road, silt fencing deficiency identified and corrective action applied.

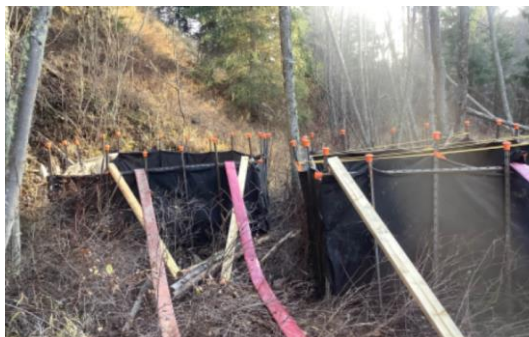
At KP 888 near Moore Creek. Elevated pump in bore bellhole and hoses.

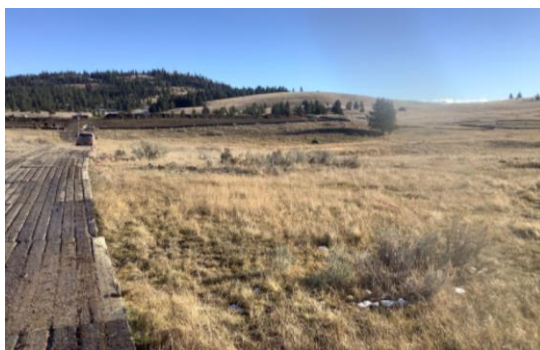
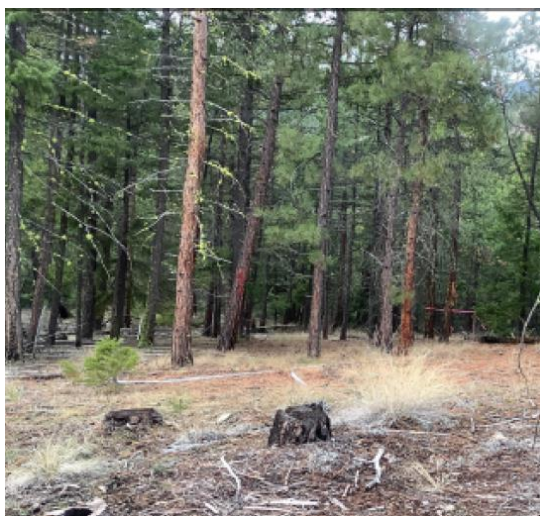
Near the Coldwater West Alternative Route, the Indigenous Monitor participated in the implementation of the TLU Site Discovery Contingency Plan in areas where trees were identified that were thought to be potentially culturally modified. Indigenous Monitors continued to conduct CMT sweeps ahead of construction activity. Trees found during a CMT sweep were examined by the Indigenous Monitors and Environmental Inspectors on-site to collect initial information. The area was flagged off for additional evaluation. Resource Specialists and Knowledge Holders of Indigenous Monitor's communities were contacted for evaluation of the tree and potential mitigation. The engagement process with Indigenous groups was initiated to share information about the resource and seek feedback. The tree was determined to be culturally modified. A buffer was placed around the tree and continued avoidance was recommended.

General area near the Coldwater Reroute where CMT sweeps were conducted.

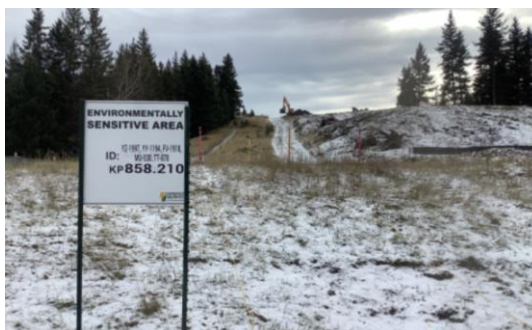
Around KP 858, Environmental Inspectors and Indigenous Monitors inspected TLU sites to verify the staking and signage were properly installed. No

Inspecting installed signage at environmentally sensitive sites.

deficiencies were identified during the inspection. Ongoing monitoring by the Indigenous Monitors continues to ensure protection and avoidance measures remain accurate at such sites.
