INDIGENOUS MONITOR OVERVIEW REPORT

Month: April 2022 Indigenous Monitor days on-site: 25

Spread 5A KP 806–974

Indigenous Monitors on the Trans Mountain Expansion Project - Overview

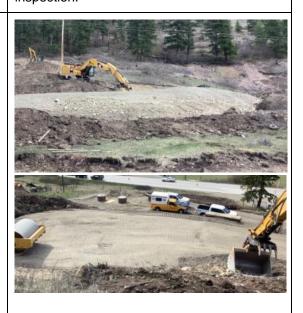
Darfield pump station soil handling inspection.
