INDIGENOUS MONITOR OVERVIEW REPORT

Month: February 2023

**Project Region: BC Interior
Spread 5A**

**Kilometre Posts (KPs) monitored:
KP 806–974**

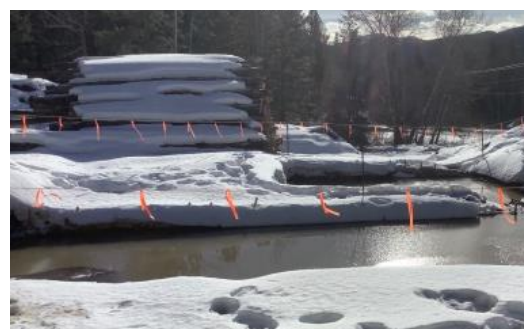
The Indigenous Monitors conducted inspections in areas of known environmental features to ensure flagging and staking of buffer zones are the correct distances. During the inspection, Indigenous Monitors identified a section of fencing that required maintenance and a damaged sign. Both corrective actions were brought to the attention of the environmental inspection team, which led to the items being repaired immediately. No further concerns were identified at this location.

Buffers and signage maintained at an environmental feature near KP 953.

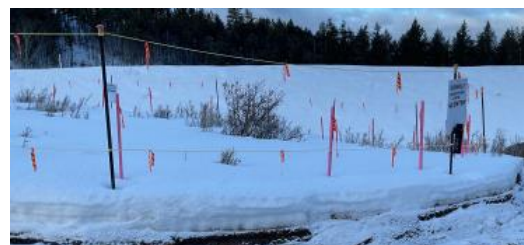
Buffers and signage maintained at an environmental feature near AK 17 at the Coldwater re-route.

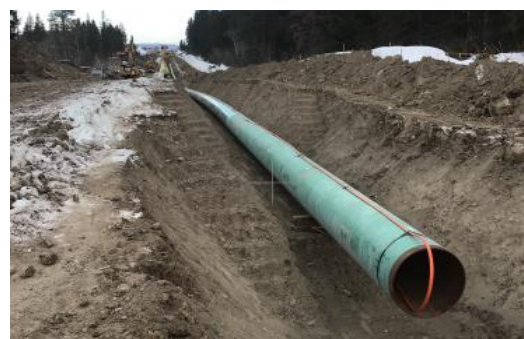
Pipe installation and trench backfill activities at KP 947.

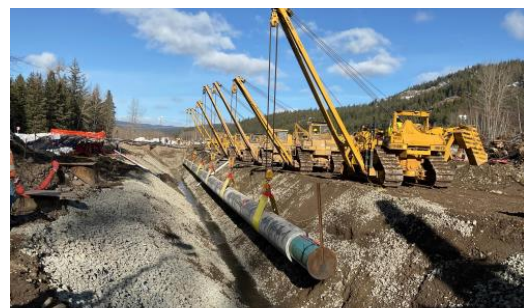
Pipe installation and trench backfill at KP 954.

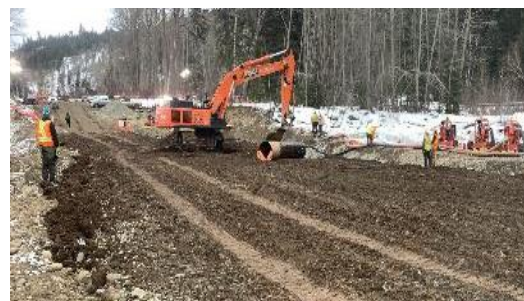
Backfilled trench following pipe placement at KP 953.

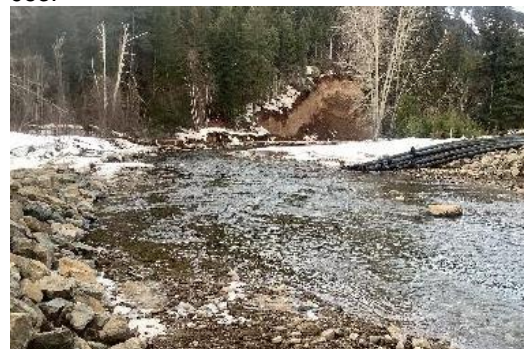
Looking downstream after crossing completed at KP 953.

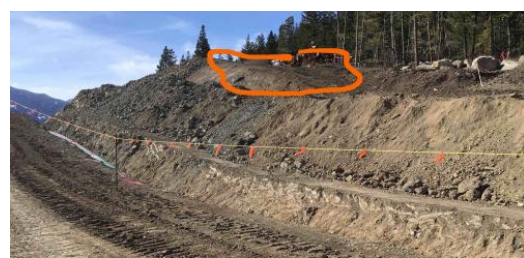
Reptile den reconstruction site near AK 16.

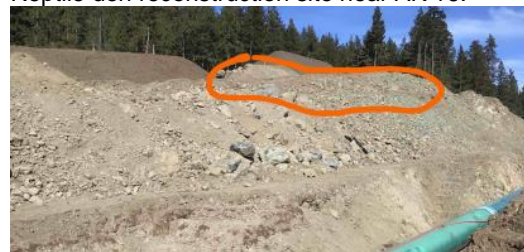
Reptile den reconstruction site near AK 16.
