## INDIGENOUS MONITOR OVERVIEW REPORT

**Month: January 2023**

**Project Region: BC Interior  
Spread 5A**

**Kilometre Posts (KPs) monitored:  
KP 806–974**

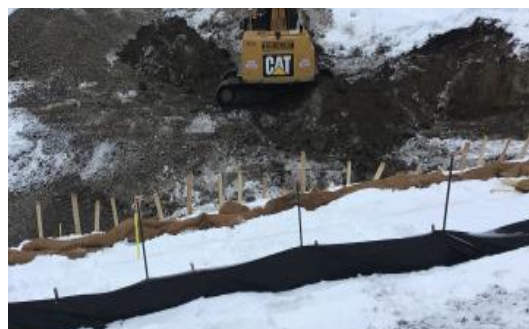
The Indigenous Monitors alongside the Environmental Inspector checked ESC measures along the right-of-way. Near Klup Creek at KP 899, the Indigenous Monitors observed maintenance activities on erosion and sediment control mitigations, including previously installed straw wattles to prevent slope erosion and sediment traps to reduce runoff water and allow sediment to settle before it's discharged. No concerns were identified.

ESC maintenance; excavator maintaining swales KP 899.

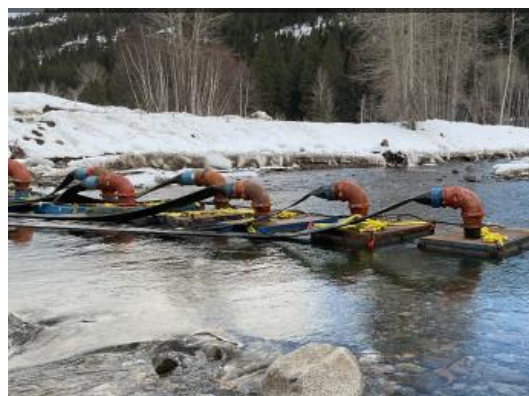
At Coldwater River near KP 954, Indigenous Monitors observed watercourse crossing construction activities, including grading and workspace preparation along the banks, installation of bypass pumps and ESC measures.

Bypass pumps to support isolation.

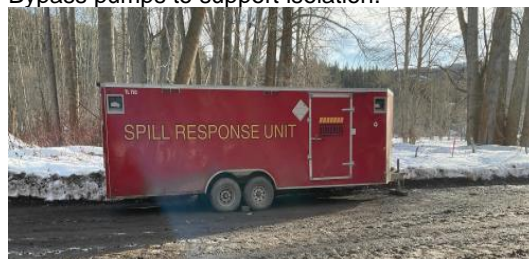
Mitigations noted during monitoring included spill kits available on-site, spill trays used for fuel storage on-site and on-going water quality monitoring by qualified professionals. No concerns were identified.

Spill response unit staged near construction activity.

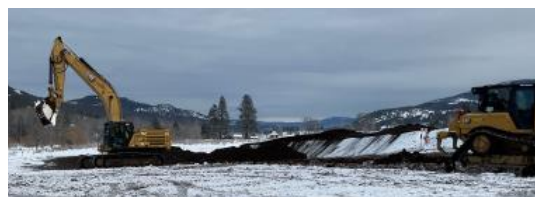
Snow removal, topsoil stripping and soil segregation at AK 17.

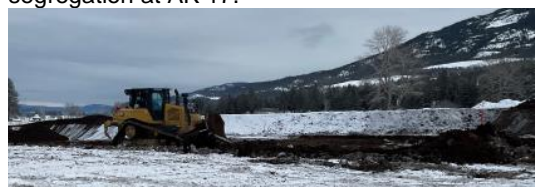
Grading activities at AK 17.

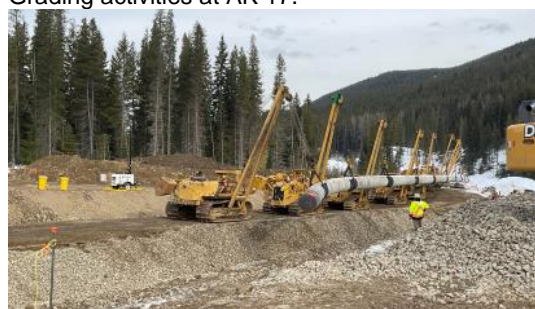
Pipe installation at KP 976.

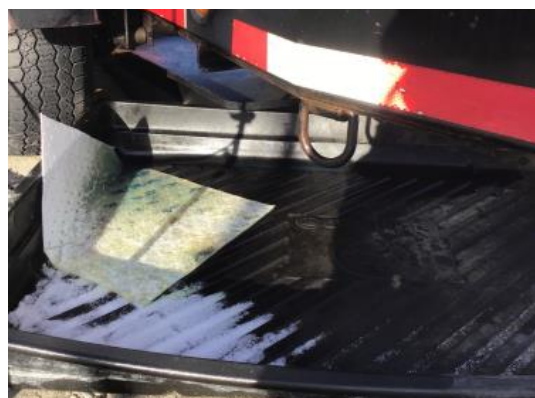
Drip trays used for equipment.

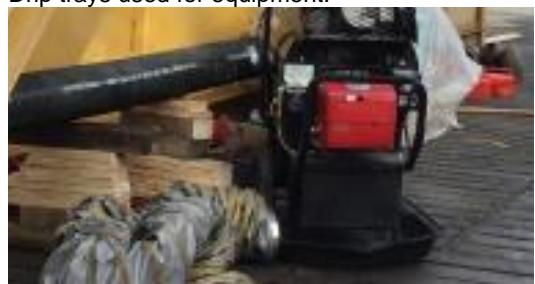
Drip trays used for equipment at KP 852

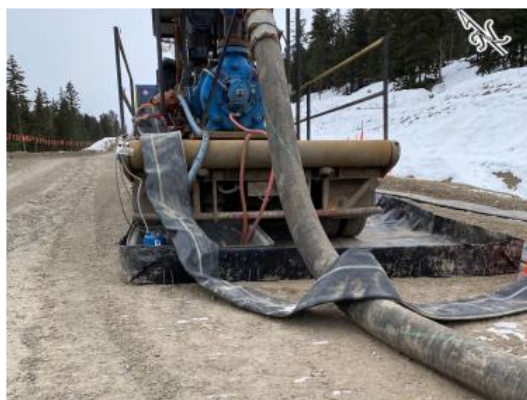
Near Stump Lake, the Indigenous Monitors observed hydrostatic testing near KP 858. Safe work practices, including signage and fencing were noted. The ground near parked machinery was inspected for surface staining. No concerns were identified. Good housekeeping and proper waste management procedures were identified during the inspection. Environmental features at KP 858 near the active construction area were monitored for continued avoidance, appropriate signage and buffers. No concerns were identified.

Hydrostatic test system.

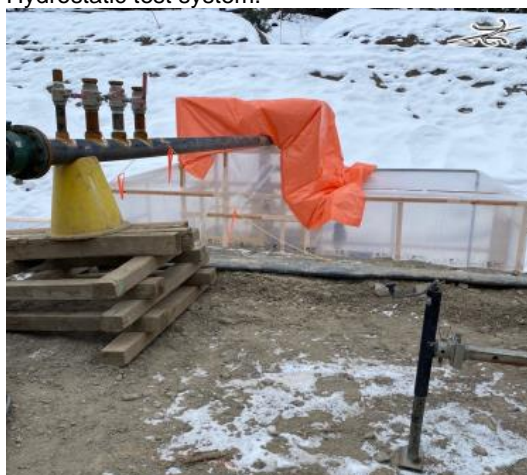
Hydrostatic test system.
