INDIGENOUS MONITOR OVERVIEW REPORT

Month: July 2023

**Project Region: BC Interior
Spread 5A**

Indigenous Monitors on the Trans Mountain Expansion Project – Overview

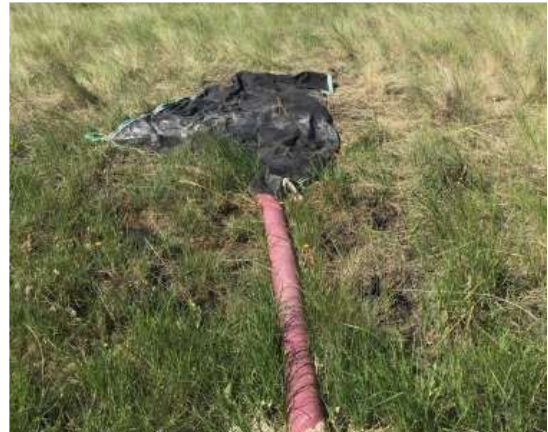
The Indigenous Monitors inspected the pump-off of water at KP 855 near Borepad 5. Water management mitigation measures were verified and in effect.

Sediment filtration device placed in well-vegetated area near KP 855.

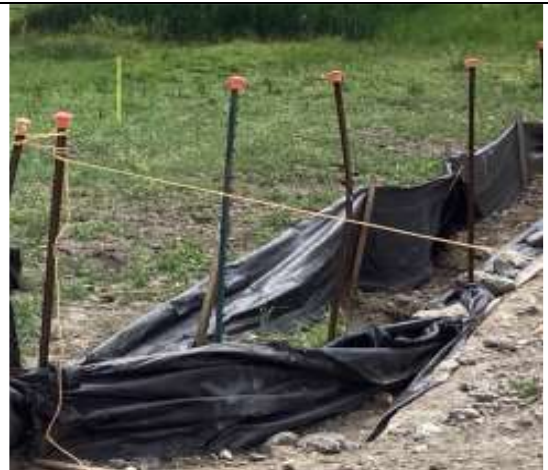
Amphibian fencing near KP 886.

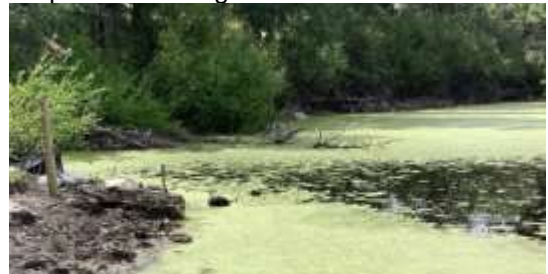
Western Toad site at KP 885.

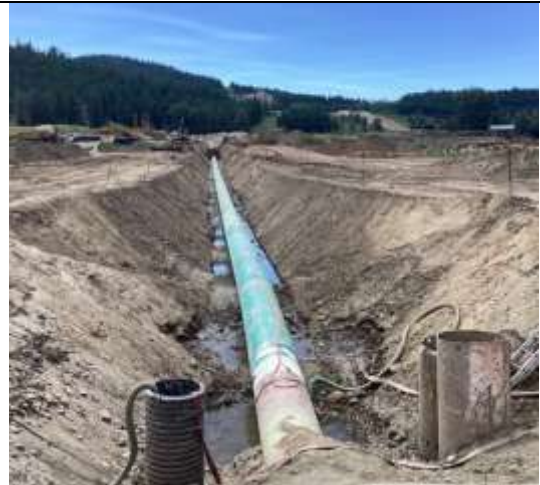
The Indigenous Monitors observed sand and subsoil being backfilled over the pipe prior to topsoil being replaced and ensured backfill activities were confined to the construction right-of-way. Construction activities were noted as confined to the construction right-of-way. No issues or potential chance finds were identified.

Backfill activities at AK 16.7.

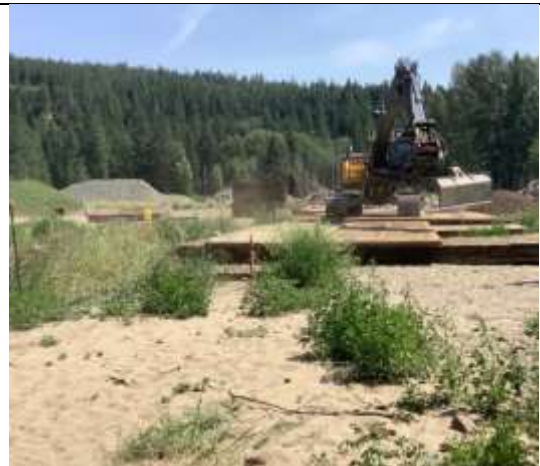
Indigenous Monitors observed mitigation measures during the air bridge installation, which included installation and maintenance of erosion and sediment control measures to avoid or minimize erosion and the potential discharge of sediment or other substances into any nearby watercourses and connecting drainage systems. All appropriate signage was in place and noted per the Environmental Protection Plan.

The Indigenous Monitors conducted walk-throughs of the area to check for any potential culturally significant items; no potential culturally significant items were identified. No concerns were identified during the inspection.

Airbridge installation at KP 954.

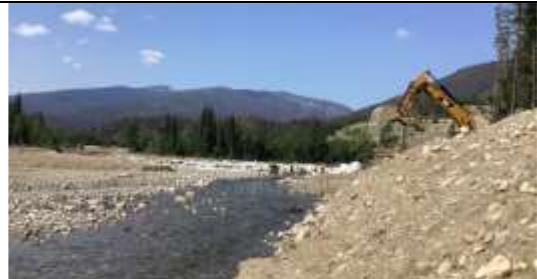
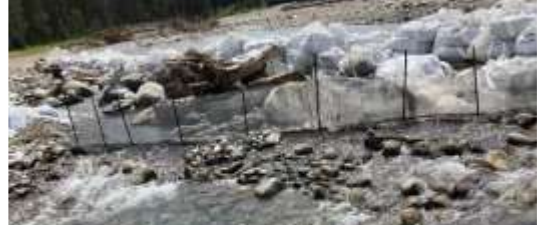
Mitigations noted during monitoring included spill kits available on-site, spill trays used for fuel storage on-site, excavated material placed above the highwater mark and top of bank of nearby water bodies to ensure sediment re-entry to the watercourse is prevented and ongoing water quality monitoring by qualified professionals. No concerns were identified.

Installation of isolation fencing near KP 976.
