INDIGENOUS MONITOR OVERVIEW REPORT

Month: June 2022

**Project Region: BC Interior
Spread 5A**

**Kilometre Posts (KPs) monitored:
KP 806–974**

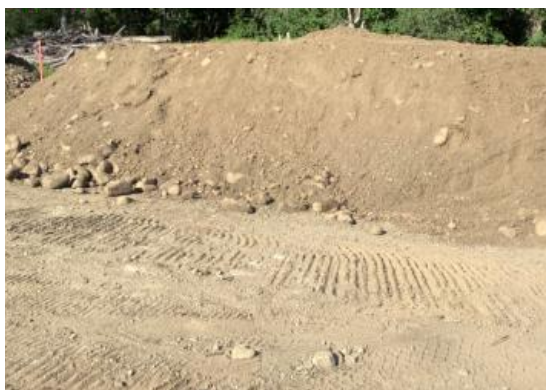
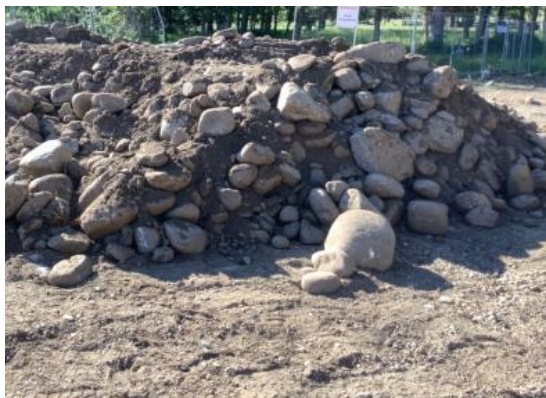
During the inspection, spill kits were inspected for containment volume and spill response material and to ensure the appropriate placement in relation to work fronts. Soil stripping and grading activities were inspected by an Indigenous Monitor for cultural and heritage chance finds. Other soil handling mitigations documented include segregation of topsoil from root zone material, proper storage to reduce potential erosion, effective labelling and signage, and inspection of soil piles to ensure they are within the survey limits of the right-of-way. The Indigenous Monitors observed that compliance measures were followed and no potential chance finds were identified.

Darfield pump station soil handling inspection.

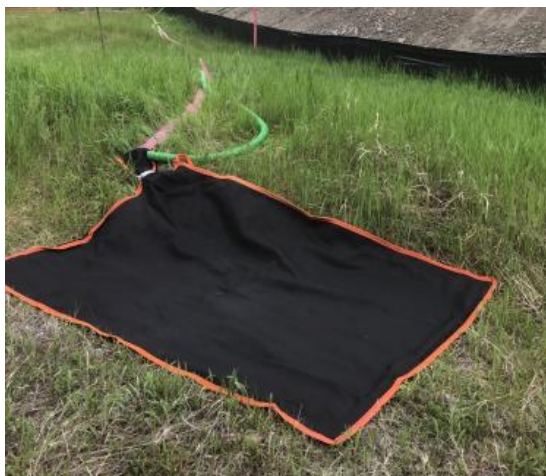
The Indigenous Monitors inspected the pump-off of water near KP 853. They observed water coming out of the silt bag free of sediment. The release site was noted as well vegetated and the silt bag was clean. The water management mitigation measures were followed and verified. No concerns were identified.

Dewatering activities at Borepad 3 near Jacko Lake.

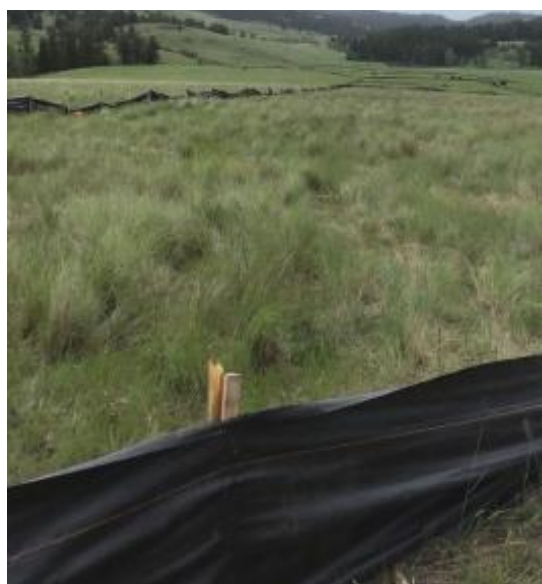
Amphibian fencing near KP 856.

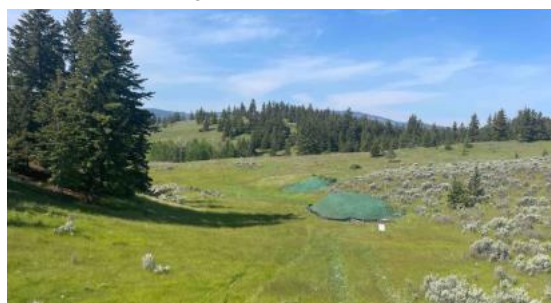
Hydroseeding topsoil piles at KP 851.

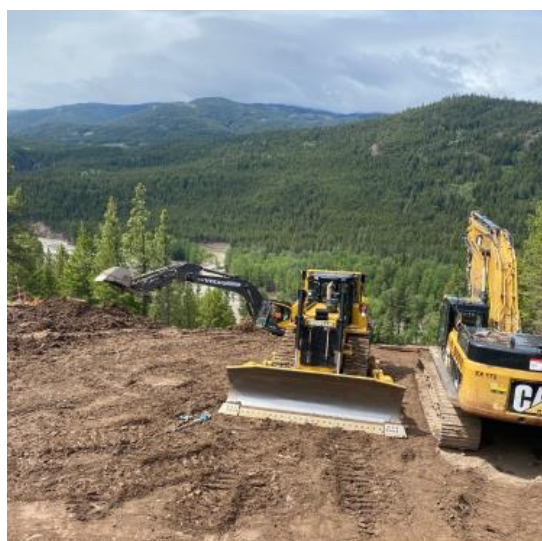
The Indigenous Monitors noted mitigations for the topsoil piles to reduce erosion potential including grading, applying tackifiers and reducing ponding. Inspections were conducted for the excavated soil placed in the trench over the installed pipe. The Indigenous Monitors observed sand and subsoil being backfilled over the pipe prior to topsoil being replaced and ensure backfill activities are confined to the construction right-of-way. No issues or potential chance finds were identified.

Topsoil stripping and soil segregation at KP 953.

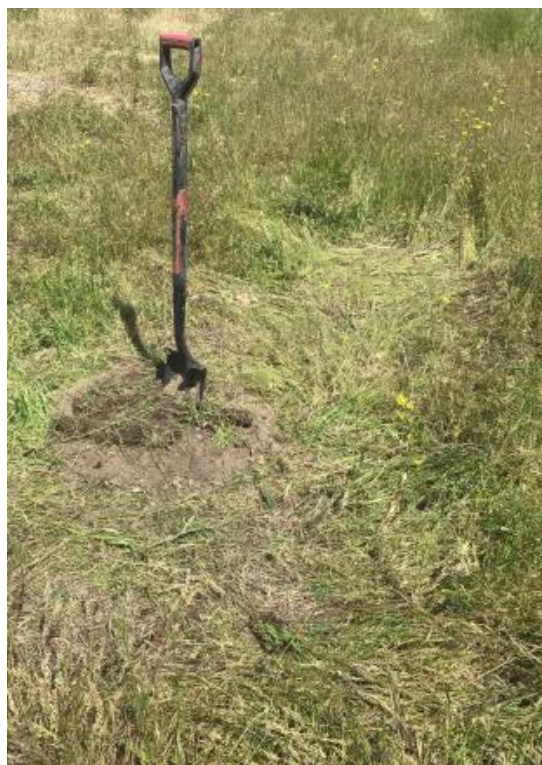
The Indigenous Monitor observed the implementation of an Archaeological Impact Assessment (AIA) conducted on Zoht 4 Reserve near KP 914. The assessment, completed by a qualified archaeologist and Indigenous participants, may include visual inspection to identify features with predictable archaeological potential, surface inspection of areas with exposed sediments for cultural materials and subsurface testing of terrain features exhibiting archaeological potential. If an archaeological site is found, Trans Mountain completes the applicable reporting and applies for the required permits in alignment with the *Heritage Conservation Act*. Ongoing AIA activities continue in the area.

Shovel test during the AIA on Zoht 4 Reserve.

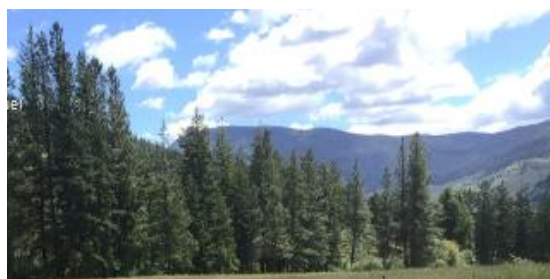
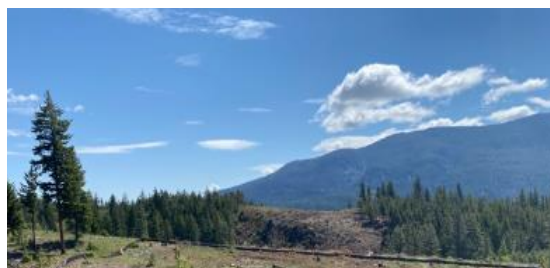
General area near the Coldwater West Alternative Route where CMTs are monitored.

<p>Inspectors on-site to collect initial information. The area was flagged off for additional evaluation. Resource Specialists and Knowledge Holders of Indigenous Monitors' communities were contacted for evaluation of the tree and potential mitigation. The engagement process with Indigenous groups was initiated to share information about the resource and seek feedback. The tree was determined to be culturally modified. The feature was flagged, a buffer was placed around the tree and continued avoidance was recommended.</p>	
--	--
