INDIGENOUS MONITOR OVERVIEW REPORT

Month: June 2023
Project Region: BC Interior
Spread 5A

Indigenous Monitors on the Trans Mountain Expansion Project – Overview

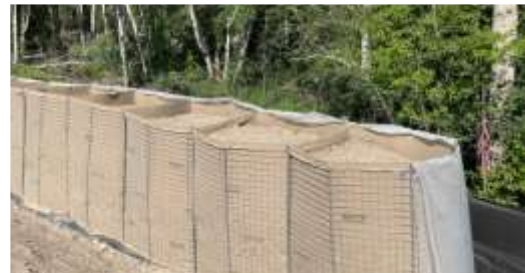
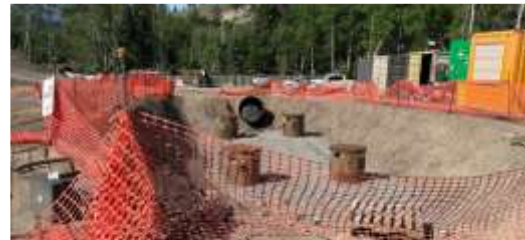
At Coldwater River near AK 1.3, Indigenous Monitors observed cleanup activities after the completion of pipe installation under the Coldwater River. Cleanup activities included preparing the removal of meter bags and storage cans and de-mobbing equipment. No concerns were identified.

Cleanup activities observed at Coldwater River near AK 1.3.

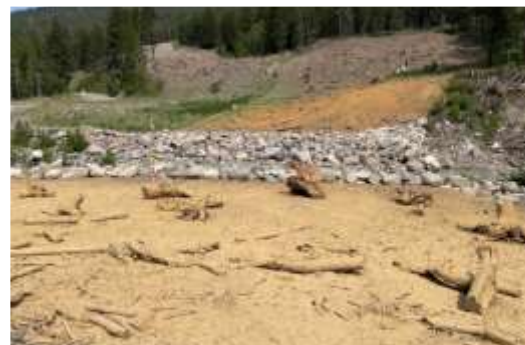
The Indigenous Monitors inspected and participated in monitoring activities at KP 912 near Mill Creek, inspecting vegetation establishment and weed management in previously excavated and backfilled areas, and ensuring correct signage is in place. At KP 914, a survey was conducted to identify locations of future shrub planting. The Indigenous Monitors also monitored general site housekeeping efforts. No concerns were identified.

Reclaimed site near Mill Creek.

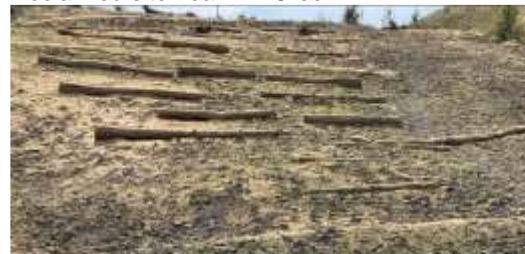
Reclamation near Mill Creek. Construction completed in the area.

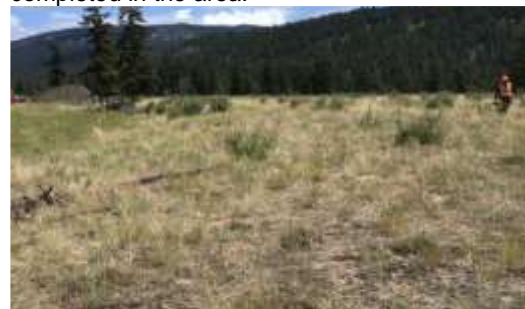
Survey activities to identify location of planned shrub planting near KP 914.

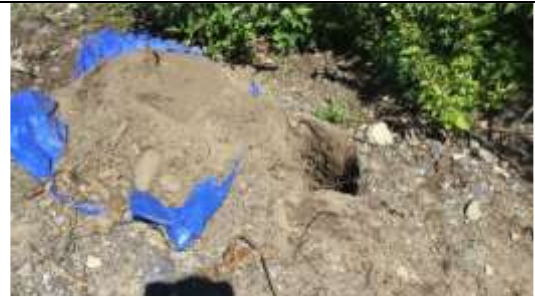
The Indigenous Monitors observed the implementation of an AIA conducted near KP 954 near Gillis Creek. The assessment, completed by a qualified archaeologist and Indigenous participants, may include visual inspection to identify features with predictable archaeological potential, surface inspection of areas with exposed sediments for cultural materials and shovel testing of terrain features exhibiting archaeological potential. No concerns were identified.

Shovel testing near KP 954.

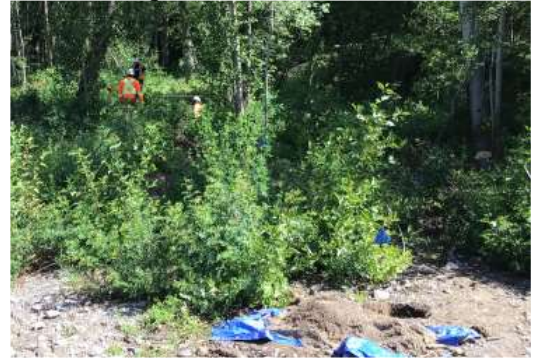
Shovel testing near KP 954.

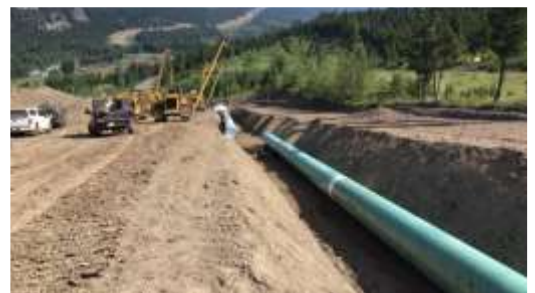
The Indigenous Monitors noted mitigations for the topsoil piles to reduce erosion potential, including grading and identifying drainage pathways to reduce ponding. The Indigenous Monitors observed sand and subsoil being backfilled over the pipe prior to topsoil being replaced and ensured backfill activities were confined to the construction right-of-way. Construction activities were noted as confined to the construction right-of-way. No issues or potential chance finds were identified.

Pipe installation at AK 18.

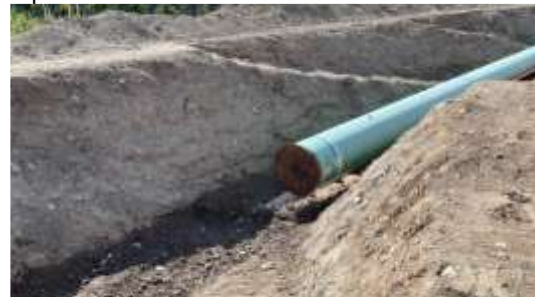
Tying-in at AK 18.

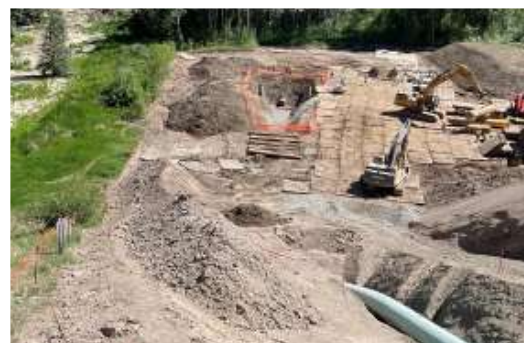
Near AK 16 at Coldwater Creek, Indigenous Monitors observed DPI activities, including rig mat removal and cleanup. Reclamation activities will follow once pad deconstruction and cleanup is complete.

Mitigations noted during monitoring included spill kits available on-site, spill trays used for fuel storage on-site, excavated material placed above the high-water mark to ensure sediment re-entry to the watercourse is prevented and ongoing water quality monitoring by qualified professionals. No concerns were identified.

DPI workspace cleanup near AK 16.

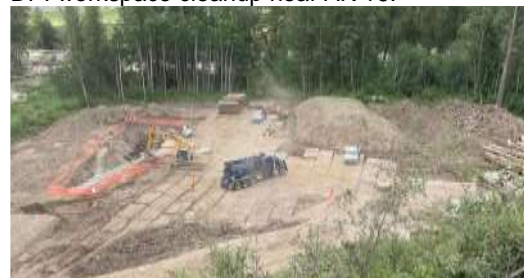
Coldwater Creek DPI, drilling complete and rig mats removed near AK 16.
