INDIGENOUS MONITOR OVERVIEW REPORT

Month: March 2022

**Project Region: BC Interior
Spread 5A**

**Kilometre Posts (KPs) monitored:
KP 806–974**

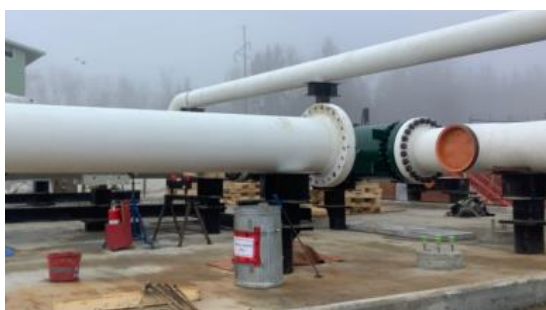
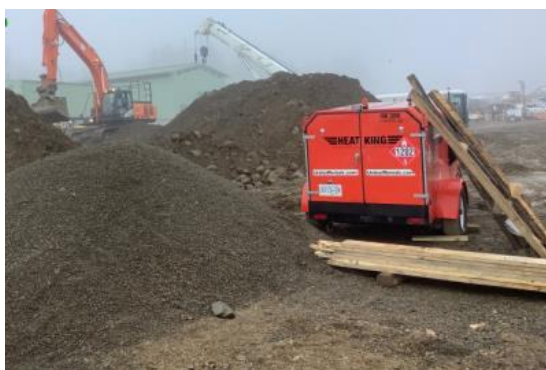
During the inspection, Indigenous Monitors identified misplaced debris, garbage and recycling, which was brought forward as a deficiency and addressed. Spill kits were inspected for volume and types of spill response material and to ensure the appropriate placement in relation to work fronts. Drip trays were inspected under stationary equipment to make sure they were present when parked. A drip tray that had accumulated water from snow melt was identified. The deficiency was addressed and the snow melt was properly drained. No cultural concerns were identified during the inspection.

Darfield pump station housekeeping inspection.

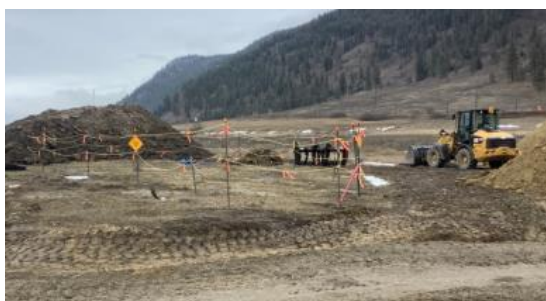
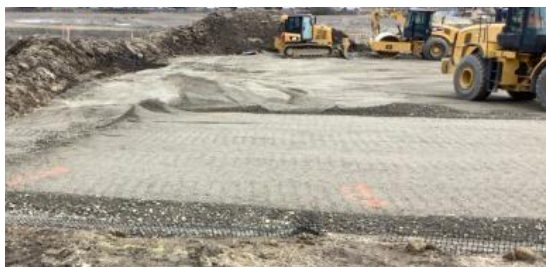
Indigenous Monitors continue to monitor the construction activity at the Black Pines Transmission Line. The inspection included observing archaeological impact assessment crews, equipment using drip trays, on-site stormwater management, soil buffers and placement locations and TLU signage. No concerns were recorded during the inspection.

Stripping and grading activities at Black Pines Structure 3.

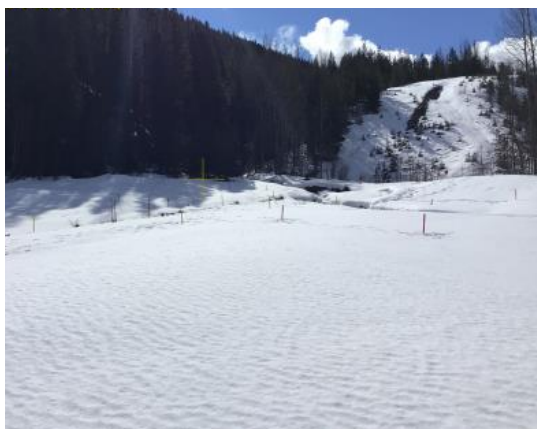
Access road of bridge installation at BCVA-246a near KP 968–969.

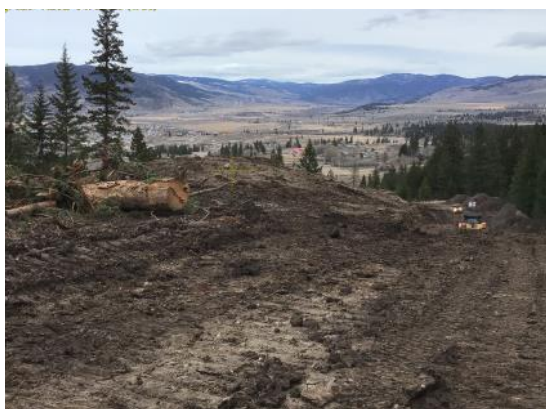
At KP 930 near Merritt, the Indigenous Monitors were involved in monitoring and inspecting such soil salvage mitigations. The Indigenous Monitors also inspected the construction areas before and after soil stripping to identify any potential archaeological chance finds. No potential archaeological chance finds were identified.

Soil stripping at KP 930.

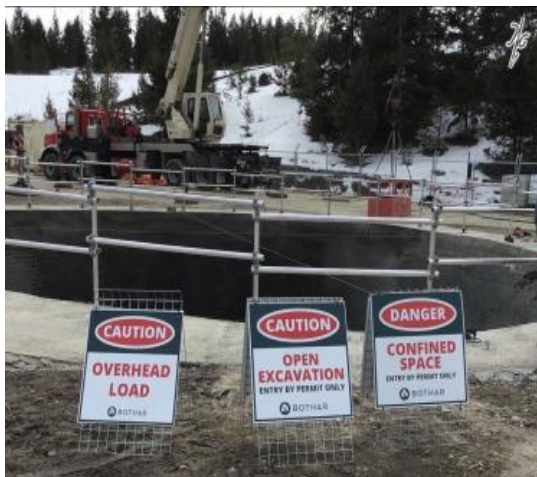
At KP 855 and KP 852, safe work practices, including signage, fencing and proper ladder use were noted. The ground near parked machinery was inspected for surface staining. No concerns were identified. Good housekeeping and proper waste management procedures were identified during the inspection. Environmental features at KP

Bore Pad construction at KP 852 near Jacko Lake.

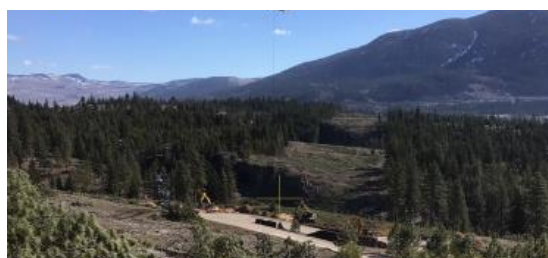
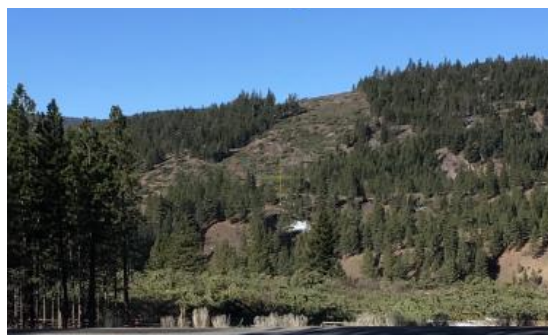
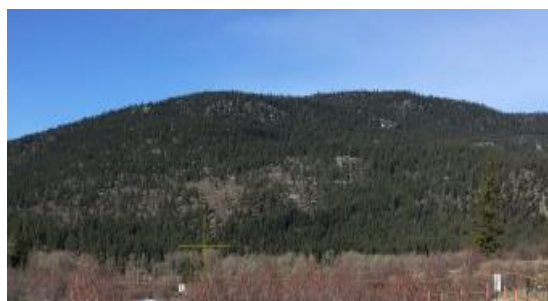
Near the Coldwater West Alternative Route (the portion of the right-of-way that goes around the Coldwater 1 Reserve), the Indigenous Monitor participated in the implementation of the TLU Site Discovery Contingency Plan in areas where trees were identified as potentially culturally modified. Trees found during a CMT sweep were examined by the Indigenous Monitors and Environmental Inspectors on-site to collect initial information. The area was flagged off for additional evaluation. Resource Specialists and Knowledge Holders of Indigenous Monitors' communities were contacted for evaluation of the tree and potential mitigation. The engagement process with Indigenous groups was initiated to share information about the resource and seek feedback. The tree was determined to be culturally modified. The feature was flagged, a buffer was placed around the tree and continued avoidance was recommended.

General area near the Coldwater West Alternative Route where CMT sweeps were conducted ahead of clearing activities.

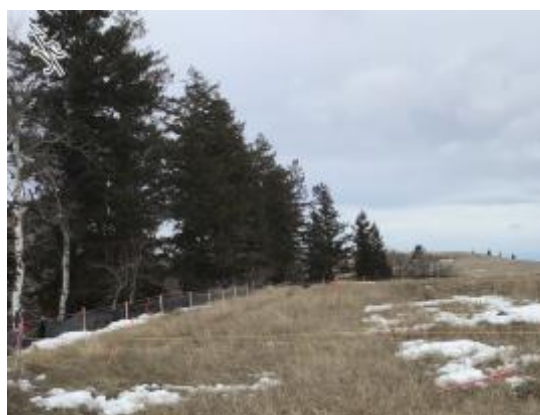
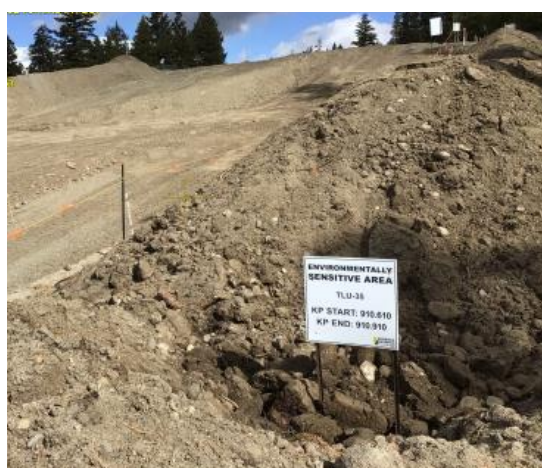
Indigenous Monitors inspected TLU areas and archaeological sites to verify the staking and boundaries and continued equipment avoidance. Sites inspected include but are not limited to TLU-34, TLU-35, TLU-36, TLU-37 and TLU-38. Ongoing monitoring by the Indigenous Monitors continues at such sites.

Appropriate signage and buffers confirmed at TLU-35.
