INDIGENOUS MONITOR OVERVIEW REPORT

Month: March 2023

**Project Region: BC Interior
Spread 5A**

**Kilometre Posts (KPs) monitored:
KP 806–974**

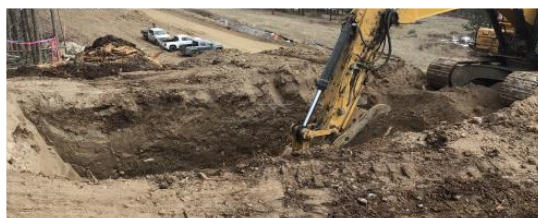
Topsoil and materials such as rocks and woody debris were salvaged from disturbed snake den sites and used to reconstruct the snake habitat. Indigenous Monitors observed large rocks placed on the bottom of the excavated den, with smaller rocks placed on top. Geo fabric and subsoil were then placed overtop the rock bed. No concerns were identified.

Reptile den reconstruction at AK 16.

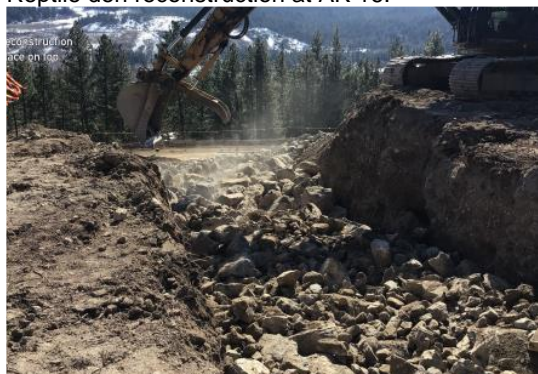
Smaller rocks placed over large rocks for den reconstruction at AK 16.

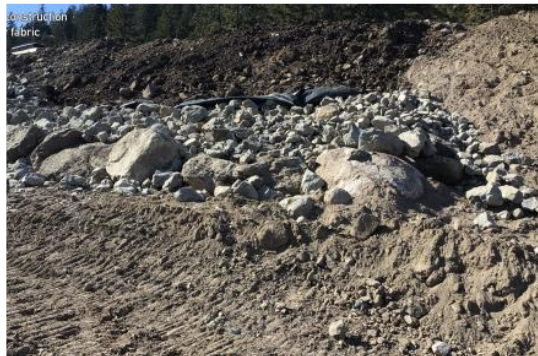
Geo textile and soil placed above rocks for den reconstruction at AK 16.

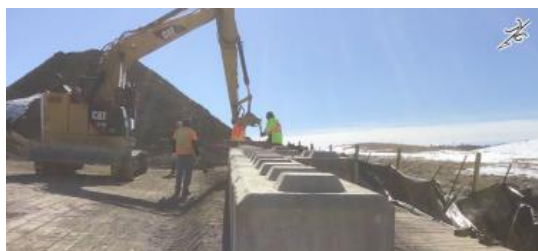
At KP 855, crews worked on a material storage site at Pad 5. The Indigenous Monitor inspected safe work practices, including signage and fencing. The ground near parked machinery was inspected for surface staining. Deficiencies were documented and corrective actions were applied by the contractor. Good housekeeping and proper waste management procedures were identified during the inspection.

Placement of blocks at the material storage site at Borepad 5.

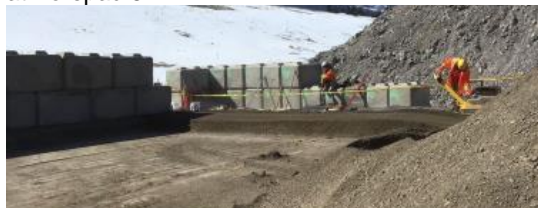
Placement of blocks at the material storage site at Borepad 5.

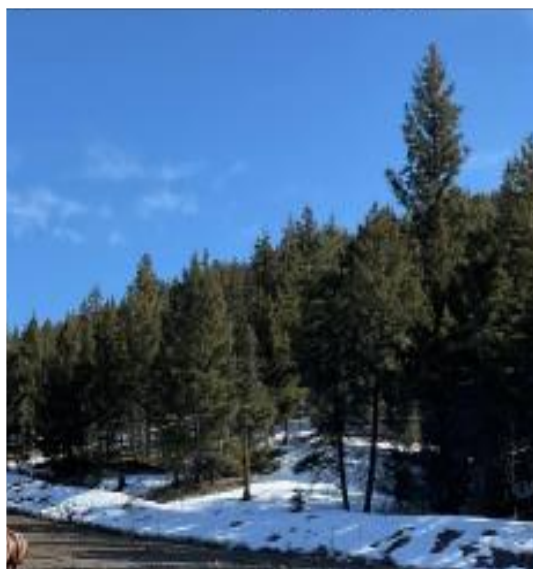
Along the Coldwater Alternative Route, a previously identified and culturally modified tree was noted. Trees found during a CMT sweep are examined by Indigenous Monitors and Environmental Inspectors on-site to collect initial information. The areas are flagged off for additional evaluation. Resource Specialists and Knowledge Holders of Indigenous Monitors' communities are contacted for tree evaluation and potential mitigation. The Indigenous Monitor confirmed continued avoidance and appropriate buffers and signage. No concerns were identified.

General area of CMT sweeps.

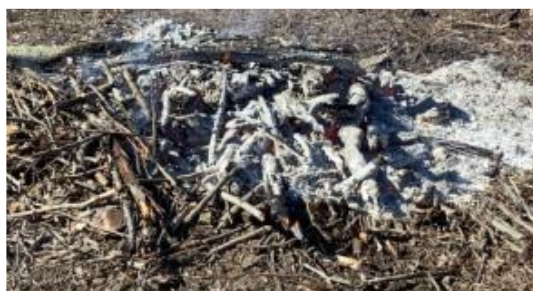
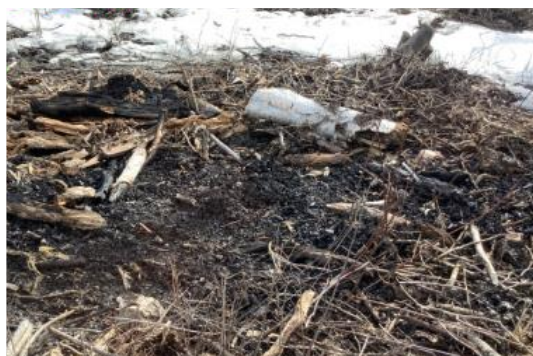
At KP 806, the Indigenous Monitors were on-site monitoring during the debris removal. The Indigenous Monitors confirmed the fires were extinguished and noted good general housekeeping at the burn site.

Images of controlled burn near Black Pines Pump Station.

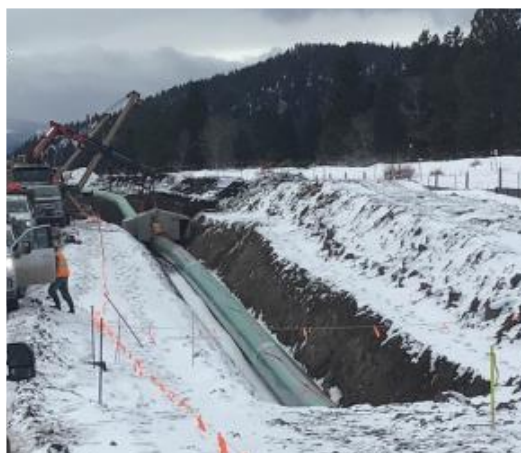
Pipe installation at AK 9.

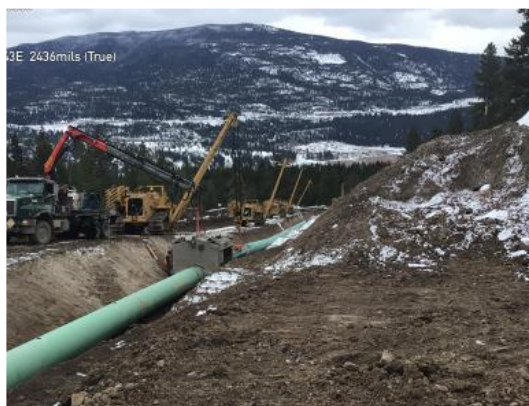
Pipe installation at AK 12.

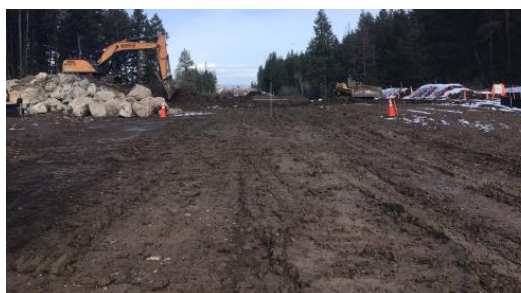
Topsoil replacement at KP 947.

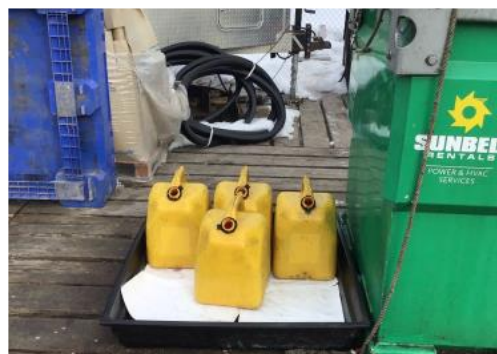
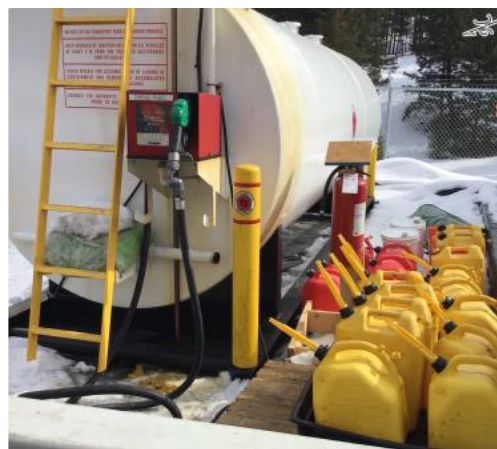
Spill kits were inspected for volume and types of spill response material and to ensure the appropriate placement in relation to work fronts. Secondary containment was inspected under heaters, machines, containers and fuelling stations. No concerns were identified.

Images of secondary containment used at fuelling stations.
