# INDIGENOUS MONITOR OVERVIEW REPORT

**Month: May 2023**

**Project Region: BC Interior  
Spread 5A**

**Kilometre Posts (KPs) monitored:  
KP 806–974**

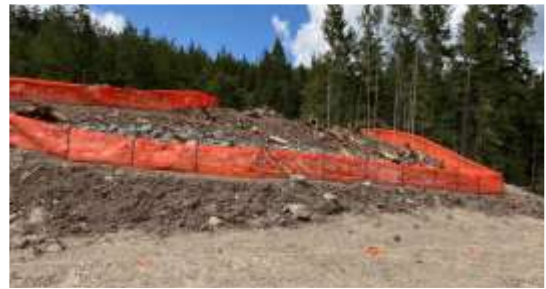
Topsoil and materials such as rocks and woody debris were salvaged from disturbed snake den sites and used to reconstruct the snake habitat. Indigenous Monitors noted erosion and sediment control (ESC) measures in place, along with appropriate signage and fencing. No concerns were identified.

ESC monitoring at reptile den reconstruction site near AK 16.

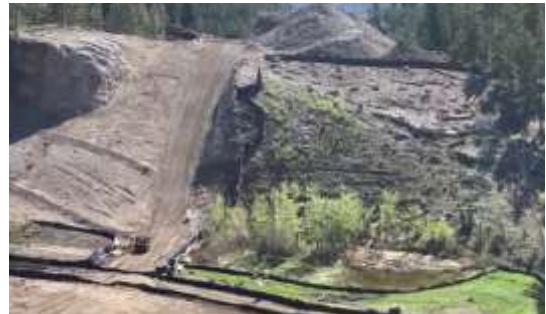
ESC monitoring at reptile den reconstruction site, near AK 3.

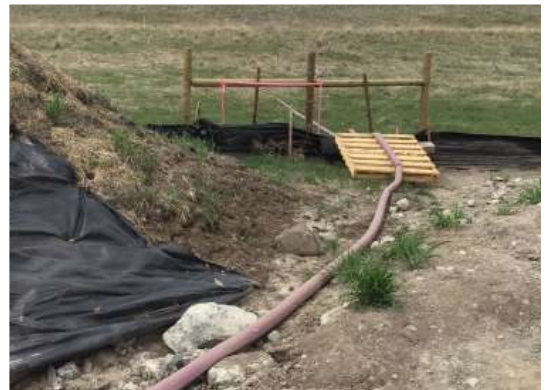
The Indigenous Monitors inspected the pump-off of water at KP 856 near Borepad 5. Water management mitigation measures were verified and in effect.

Water pump-off hose.

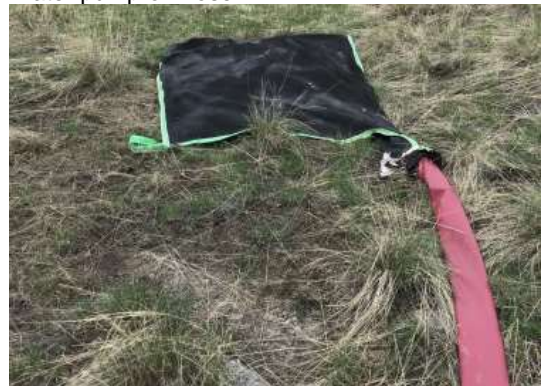
Sediment filtration device placed in well vegetated area, near KP 856.

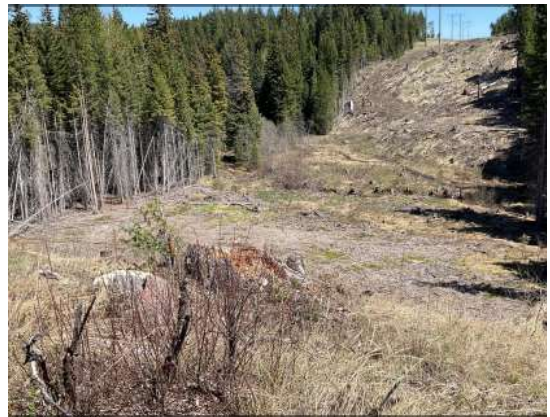
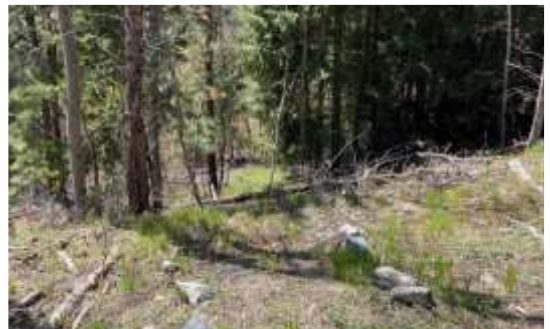
The Indigenous Monitors inspected and participated in post-construction monitoring activities on Kingsvale Transmission Line, inspecting vegetation establishment and weed management in previously excavated and backfilled areas and ensuring correct signage is in place. The Indigenous Monitors also monitored general site housekeeping efforts. No concerns were identified.

Inspecting vegetation establishment and weed management at Kingsvale Transmission Line.

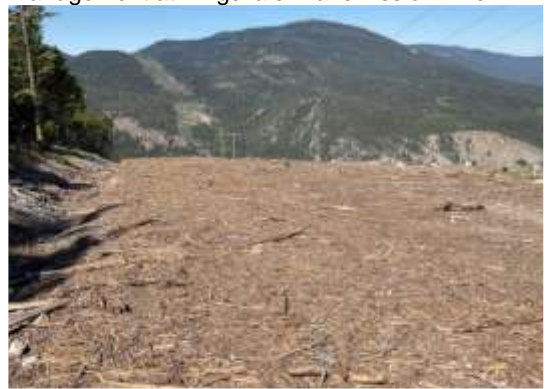
Vegetation established and mulch applied on access road.

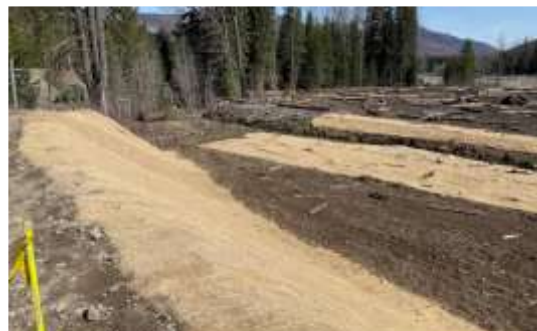
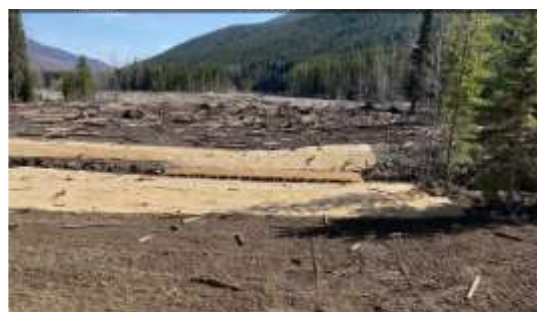
At Coldwater River near KP 976, Indigenous Monitors observed reclamation activities from previous watercourse crossing construction, including applying coconut matting, reseeding in previously backfilled areas, rock armouring and stream bed material replacement. These mitigations were installed and observed to be working as planned. No concerns were identified.

Reclamation activities observed at BC-570 Coldwater River Crossing #3.

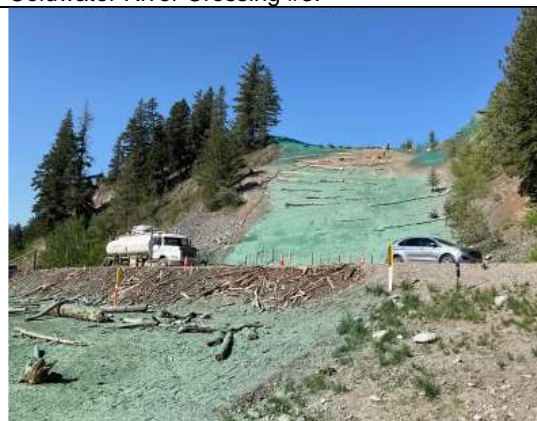
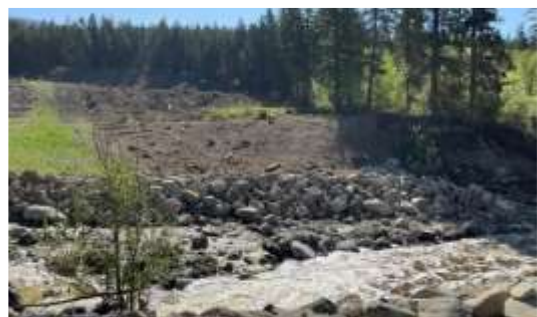
Near Claperton Creek, Indigenous Monitors inspected tackifier applications on topsoil piles and exposed slopes. No issues were identified for the completed construction and ESC in the area.

Hydroseeding steep slopes at KP 912.

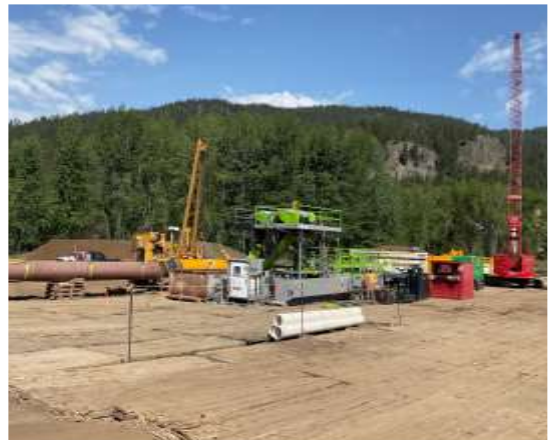
Mitigations noted during monitoring included spill kits available on-site, spill trays used for fuel storage on-site, excavated material placed above the high-water mark to ensure sediment re-entry to the watercourse is prevented and ongoing water quality monitoring by qualified professionals. No concerns were identified.

DPI workspace near AK 16.

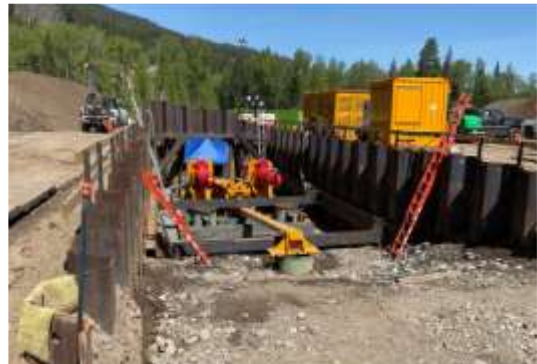
DPI entry near AK 16.
