INDIGENOUS MONITOR OVERVIEW REPORT

Month: October 2023

**Project Region: BC Interior
Spread 5A**

**Kilometre Posts (KPs) monitored:
KP 806–974**

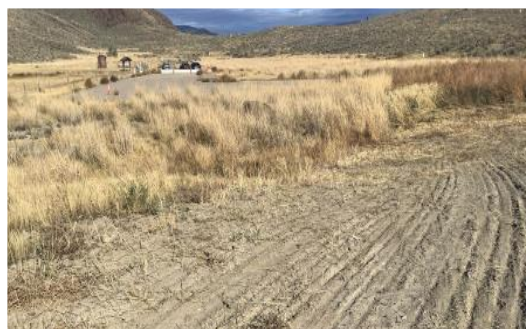
Reclaimed archaeological site at Lac Du Bois.

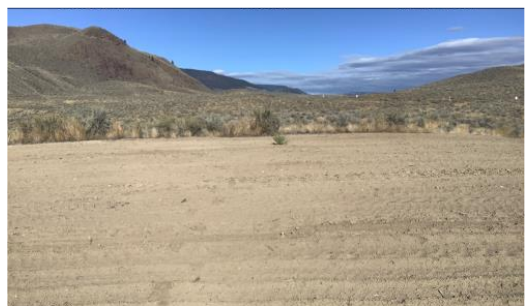
Reclaimed archaeological site near McQueen Lake.

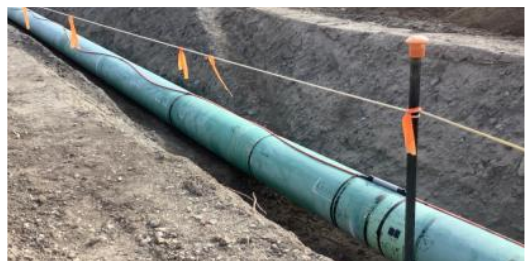
Near AK 1 of the Coldwater Alternate Route, the Indigenous Monitors noted mitigations for storing topsoil to reduce erosion potential, including grading, applying tackifiers and grading to reduce ponding. Inspections were focused on the excavated soil placed in the trench over the installed pipe. The Indigenous Monitors observed sand and subsoil being backfilled over the pipe prior to topsoil being replaced and ensure backfill activities are confined to the construction right-of-way. No issues or potential chance finds were identified.

Pipe installation near AK 1 on the Coldwater Alternative Route.

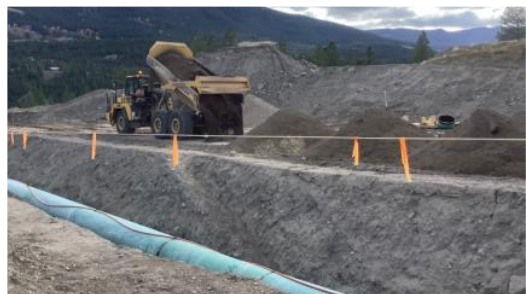
Backfill activities near AK 1 on the Coldwater Alternative Route.

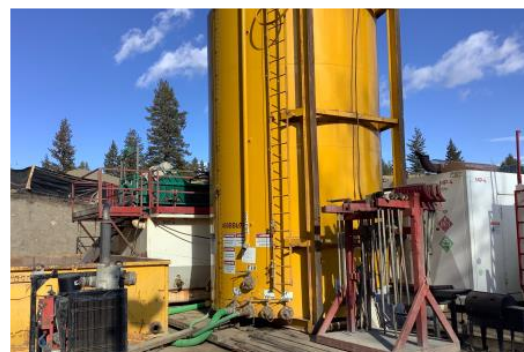
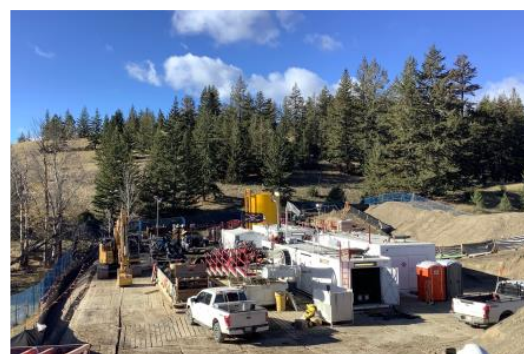
Near KP 858, Indigenous Monitors inspected matting and soil piles for Borepad 6. The ground near parked machinery was inspected for surface staining. Good housekeeping and proper waste management procedures were identified during the inspection. Soil stripping activities were monitored to ensure activities stayed within the construction boundaries. Environmental features were monitored for continued avoidance, appropriate signage and buffers. No concerns were identified.

Inspection of horizontal directional drilling area at Borepad 6.

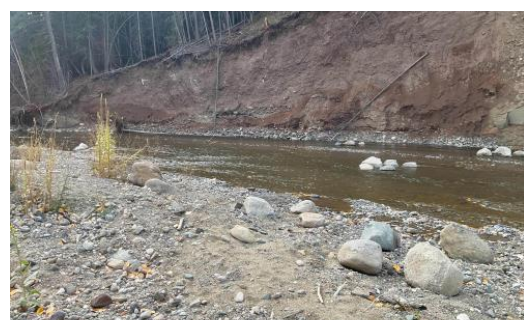
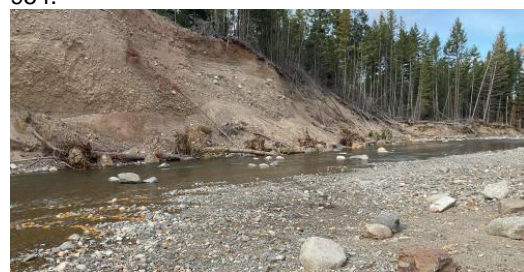
During the walk-through, IMs identified good housekeeping and vegetation regrowth on the right trajectory. No concerns were identified.

Coldwater River watercourse crossing near KP 954.

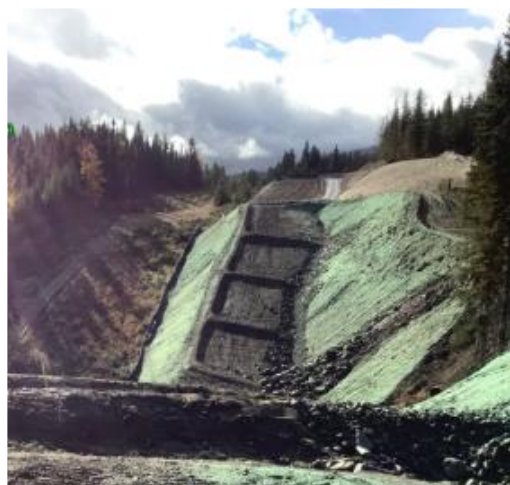
Indigenous Monitors continue to monitor the reclamation activity. At KP 982, the inspections included reseeding activity in previously excavated and backfilled areas and ensuring correct signage was in place. The Indigenous Monitors documented topsoil reclamation and general site housekeeping efforts at KP 846 and 912. No concerns or potential chance finds were documented during the inspection.

Soil placement and hydroseeding at KP 982.

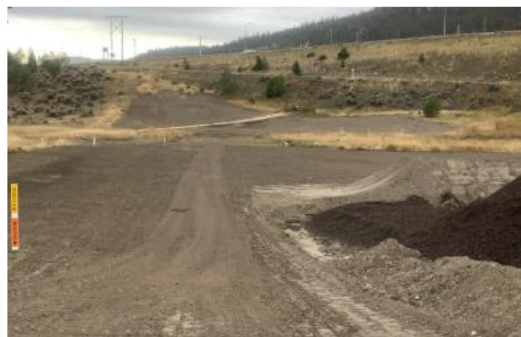
Subsoil placement at KP 846.

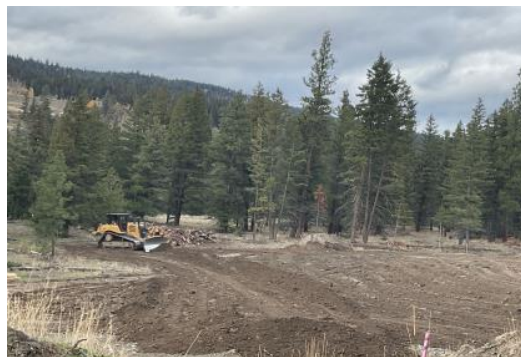
Topsoil placement at KP 912.
