# INDIGENOUS MONITOR OVERVIEW REPORT

**Month: September 2023**

**Project Region: BC Interior  
Spread 5A**

**Kilometre Posts (KPs) monitored:  
KP 806–974**

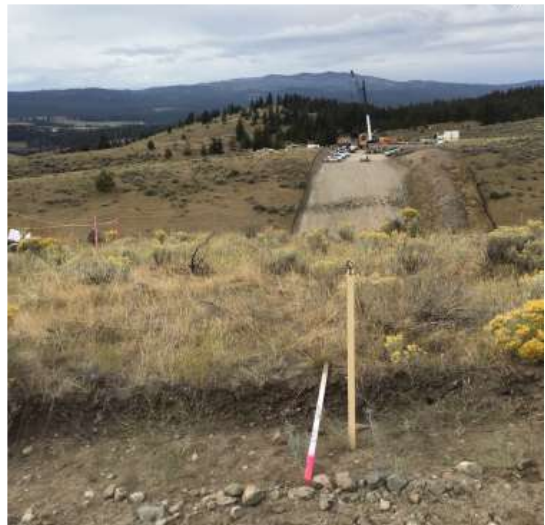
Indigenous Monitors also monitored excavation activities to confirm activities stayed within the construction boundaries. Further, Indigenous Monitors monitored environmental features for continued avoidance, appropriate signage and buffers. No concerns were identified.

Maintaining staking near environmental features for continued avoidance near KP 851.

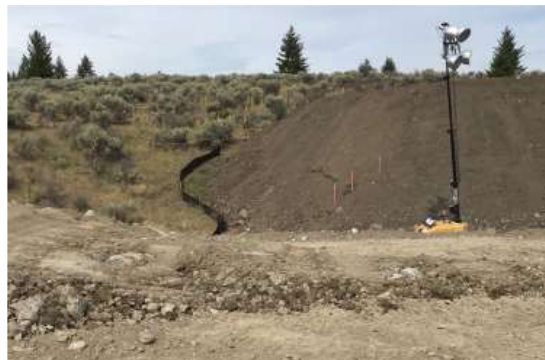
Sediment fencing, culverts and drainage were inspected at access road 1 at KP 851. Regular maintenance of sediment fencing was recommended by an Indigenous Monitor and implemented immediately by the contractor.

Sediment fencing near KP 851.

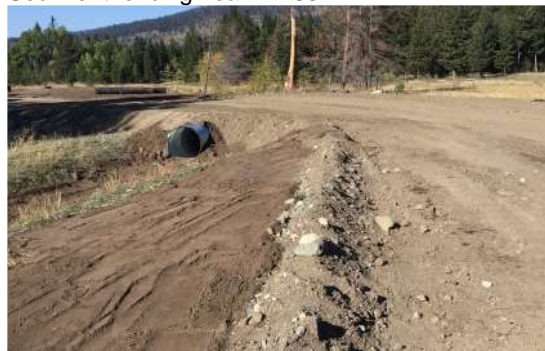
Installed culvert near access Road 1.

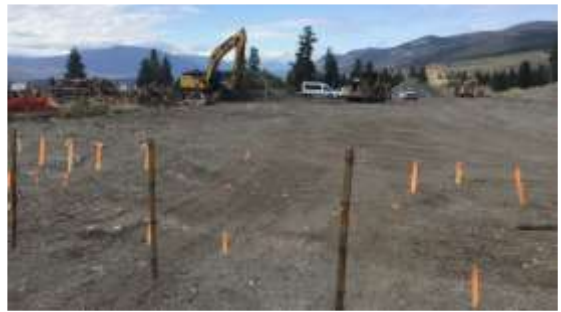
Cleaning up debris and materials at KP 914.

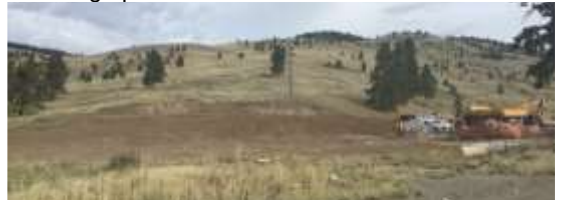
Topsoil placement and grading at KP 915.

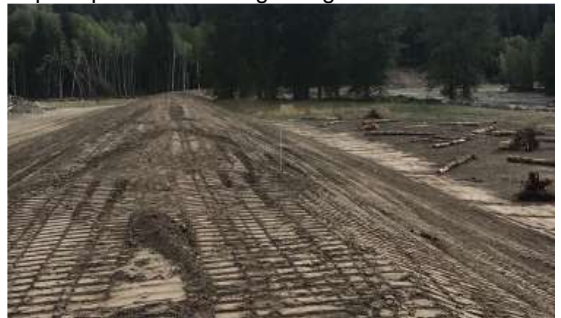
Topsoil placement and grading at KP 954.

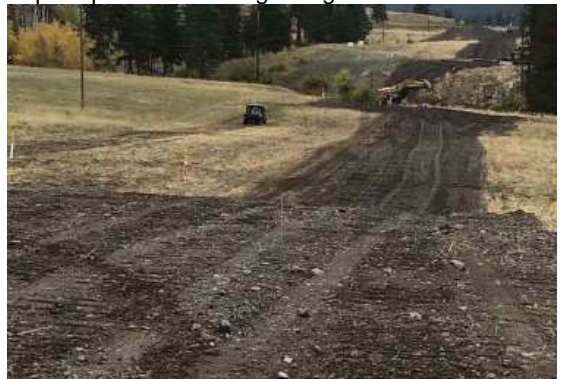
Harrowing soil for seeding at KP 914.

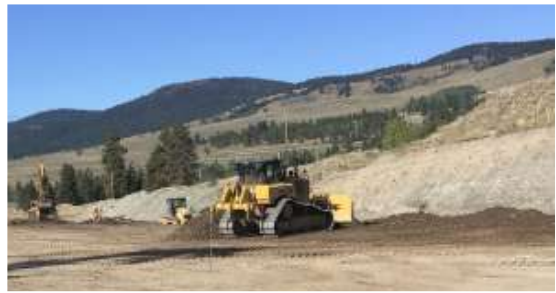
Backfilling pipe at KP 914.

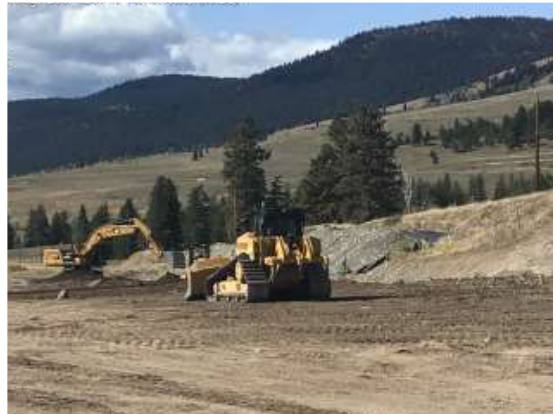
Backfilling pipe at KP 914.

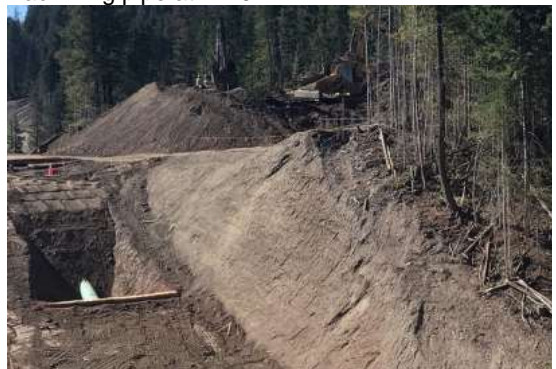
Screening soil material for backfill at KP 958.

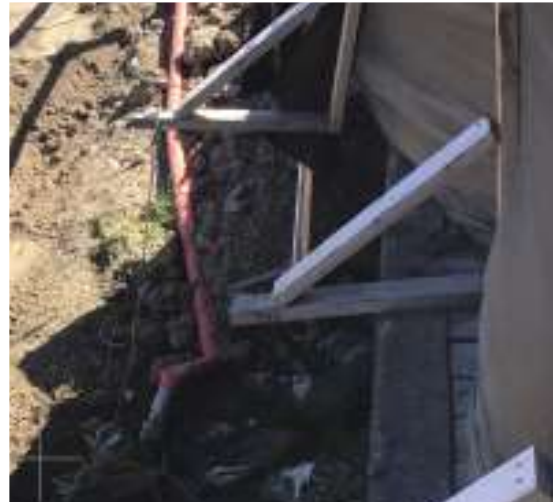
In various areas on Spread 5A, the Indigenous Monitor observed that water accumulating on-site was pumped off to a settling containment system and filter bags. Water flowing out of the filtration system was discharged upland to a well-vegetated area. The settling containment systems were inspected and functioning as intended and no sediment loading was identified at the discharge points.

Dewatering near KP 961.

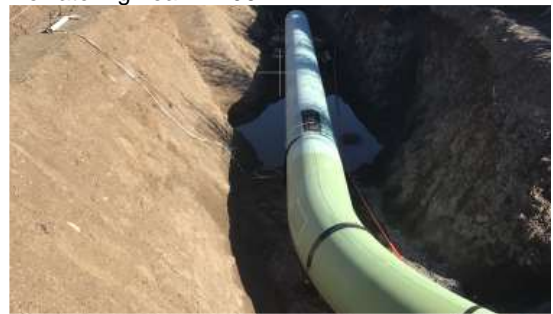
Dewatering near KP 952.
