## INDIGENOUS MONITOR OVERVIEW REPORT

**Month: February 2023**

**Project Region: Coquihalla Hope  
Spread 5B**

**Kilometre Posts (KPs) monitored:  
KP 990–1075**

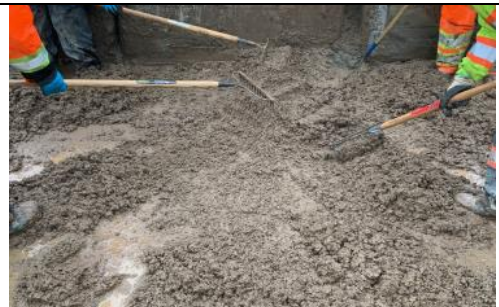
Soils screened and processed after stripping near KP 1039 RD 40.

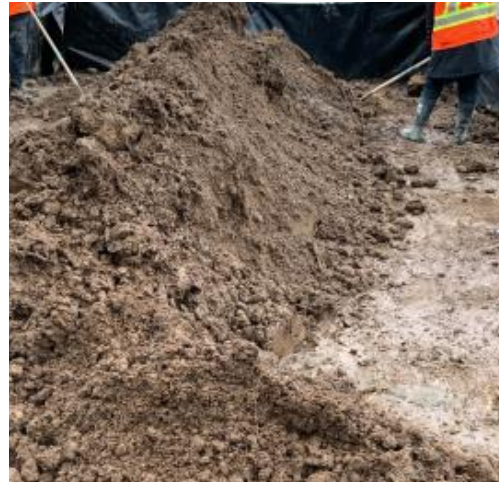
Soils screened and processed after stripping near KP 1043 RD 50.

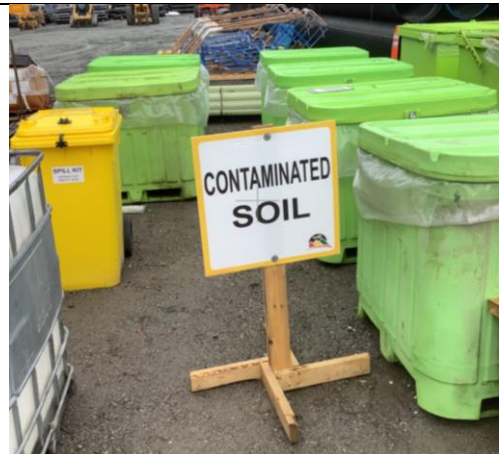
Key aspects of the inspection included housekeeping and waste management with corrective actions noted, such as proper waste disposal and using drip trays. In addition, spill kits and spill response procedures were reviewed and implemented at the site. Loose miscellaneous debris was identified and disposed of,

Waste management signage at Skagit yard.

and corrective actions were taken during the inspection.

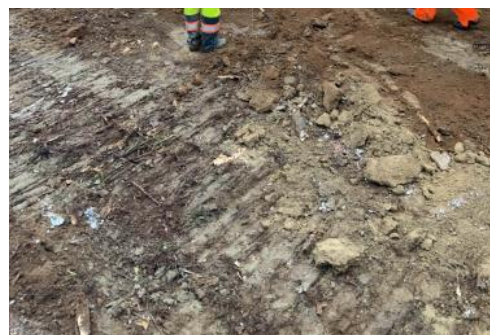
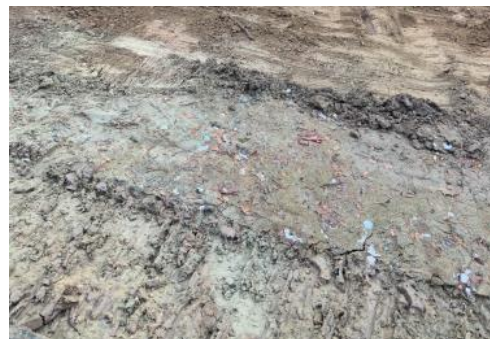
The Indigenous Monitors noted mitigations for the topsoil piles to reduce erosion potential, including grading and identifying drainage pathways to reduce ponding. The Indigenous Monitors observed the right-of-way boundaries, environmental features and TLU sites staked prior to construction commencing. Construction activities were noted as confined to the construction right-of-way. No issues or potential chance finds were identified.

Topsoil stripping and grading near Road 40 at KP 1039.

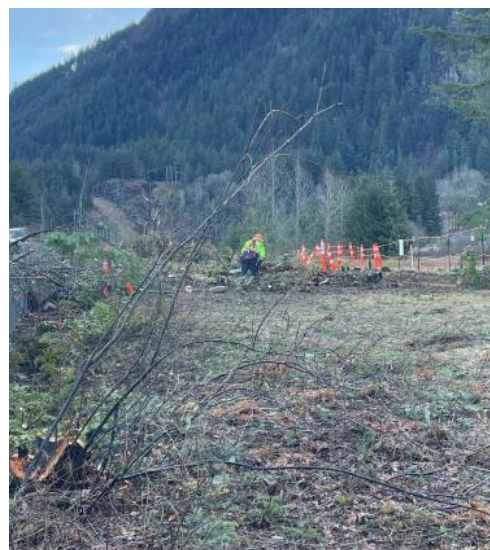
Near Hope off Road 53, the Indigenous Monitors participated in the implementation of the TLU Site Discovery Contingency Plan in areas where trees were identified as potentially culturally modified. Trees found during a CMT sweep were examined by Indigenous Monitors and Environmental Inspectors on-site to collect initial information. The area was flagged off for additional evaluation. Resource Specialists and Knowledge Holders of Indigenous Monitors' communities were contacted for evaluation of the tree and potential mitigation. The tree was not determined

General area of CMT sweeps.

to be culturally modified. Indigenous Monitors continue conducting CMT sweeps ahead of construction activity.

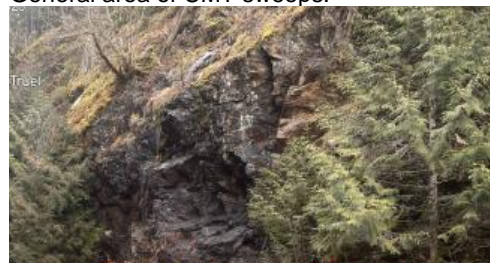
General area of CMT sweeps.
