INDIGENOUS MONITOR OVERVIEW REPORT

Month: January 2022

**Project Region: Edmonton and
Yellowhead**

Indigenous Monitors on the Trans Mountain Expansion Project – Overview

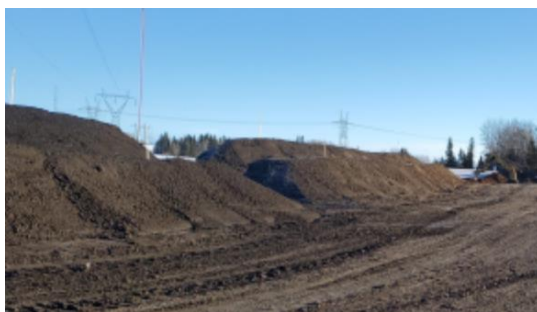
Topsoil and seconds with appropriate wildlife break KP 377.

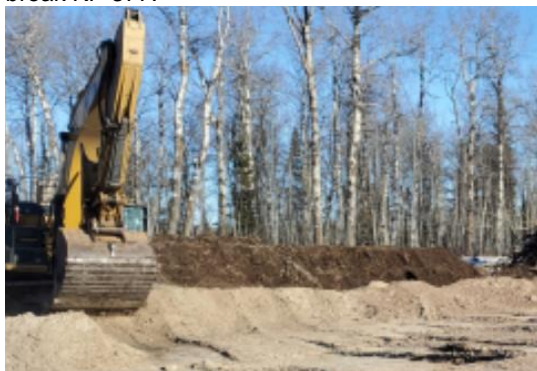
Proper soil segregation near KP 377.

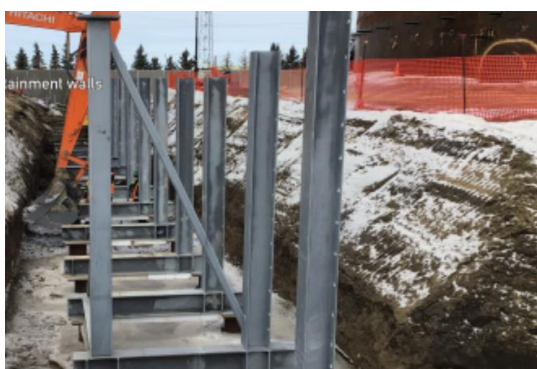
Piles for containment walls on west end of Edmonton Terminal.

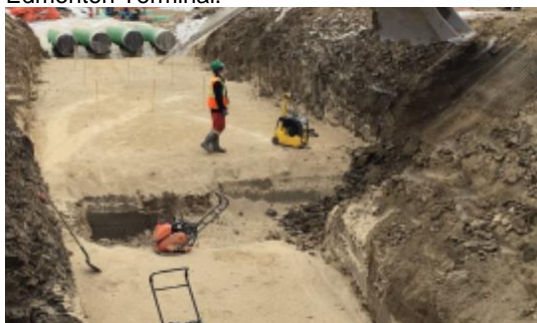
Tie-in to manifold East Edmonton Terminal.

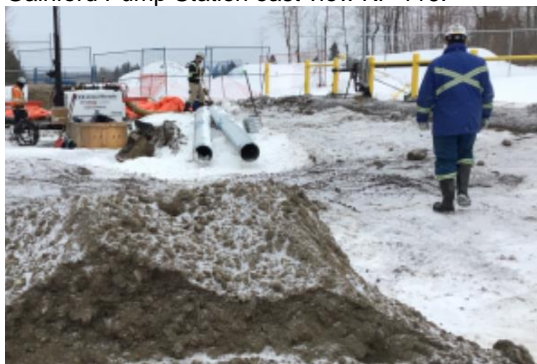
Culverts to be installed at Gainford Pump Station KP 116.

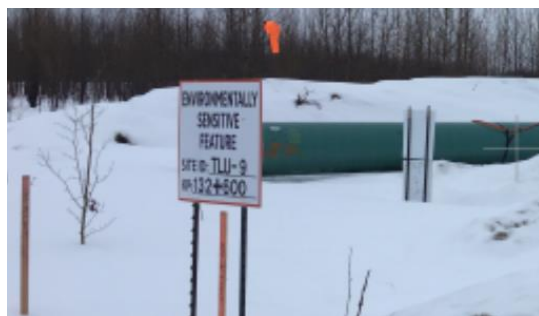
Signage and mitigations in place at TLU-9 KP 132.

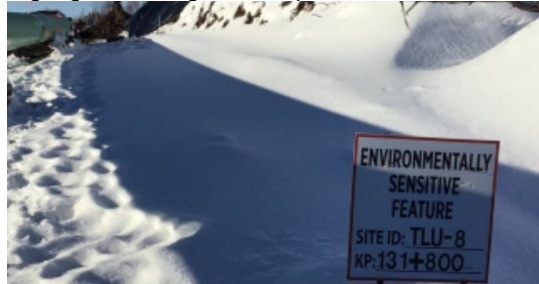
Proper signage in place at TLU-8 KP 131.

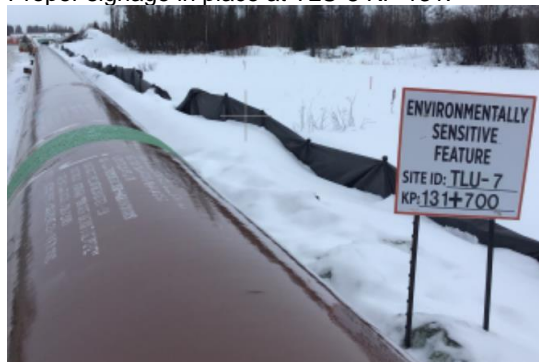
Signage and mitigations in place at TLU-7 KP 131.

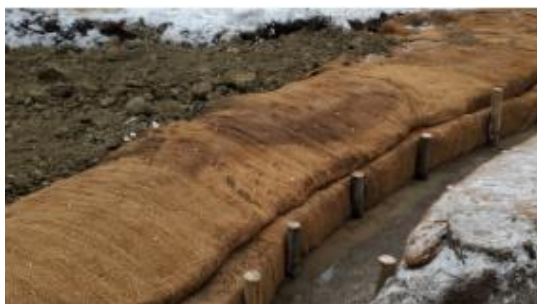
Hard wrap used for stream bank restoration at Happy Creek AB-185 KP 321+720

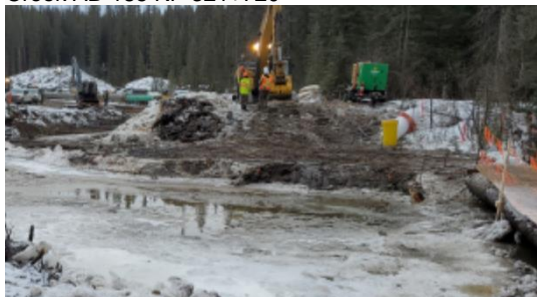
Prep for crossing at Maskuta Creek AB-188 KP 326.

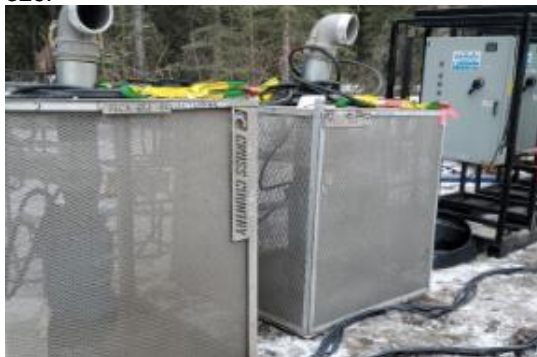
Pumps ready for crossing at Maskuta Creek AB-188 KP 326.

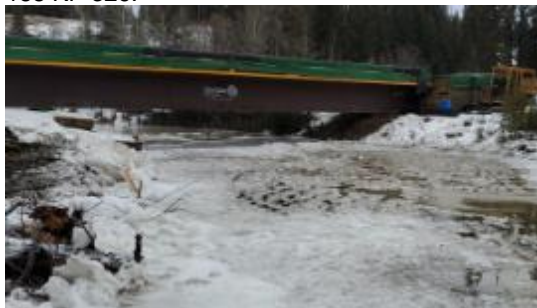
Temporary Bridge installed at Maskuta Creek AB-188 KP 326.
