INDIGENOUS MONITOR OVERVIEW REPORT

Month: December 2022

**Project Region: Edmonton and
Yellowhead**

**Kilometre Posts (KPs) monitored:
KP 1–377**

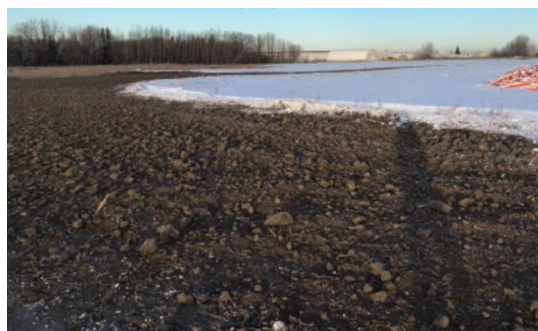
Topsoil replacement and cleanup at KP 59.

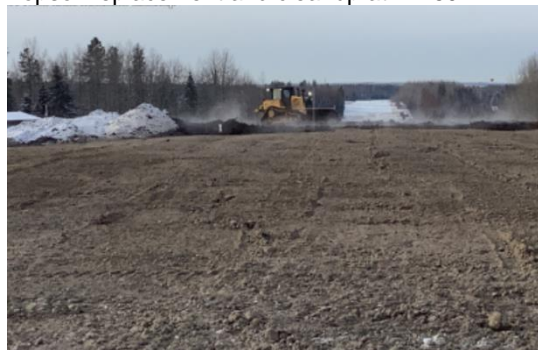
Topsoil replacement at KP 197.

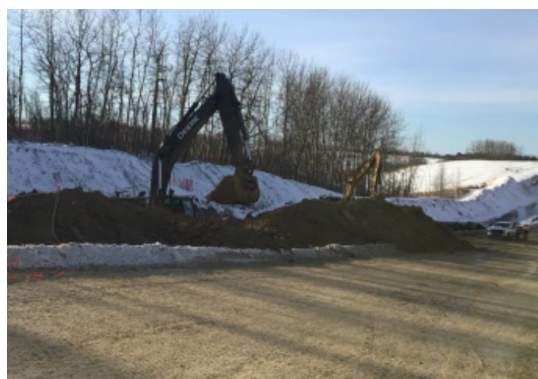
Backfill in progress KP 78.

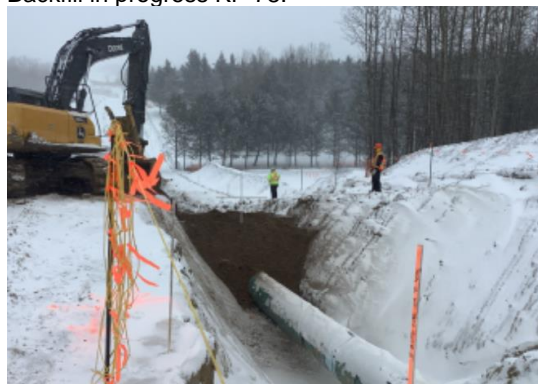
Backfill in progress KP 76.

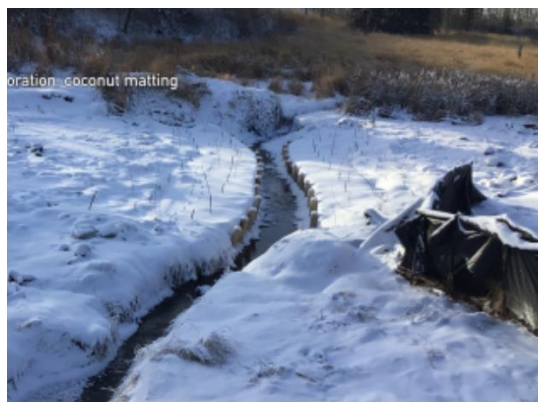
Monitoring of AB-21 at KP 65.

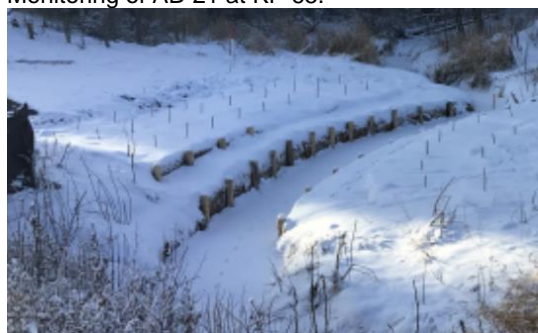
Monitoring of AB-19 at KP 63.

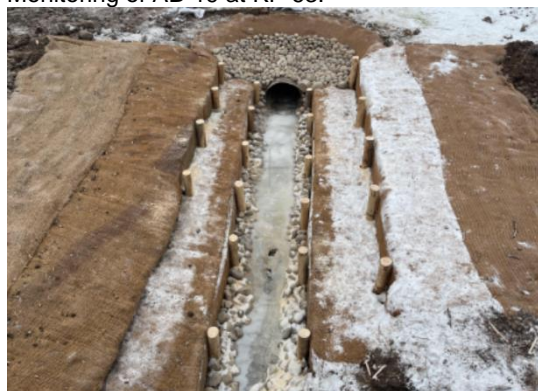
Restoration of AB-37A complete at KP 95.

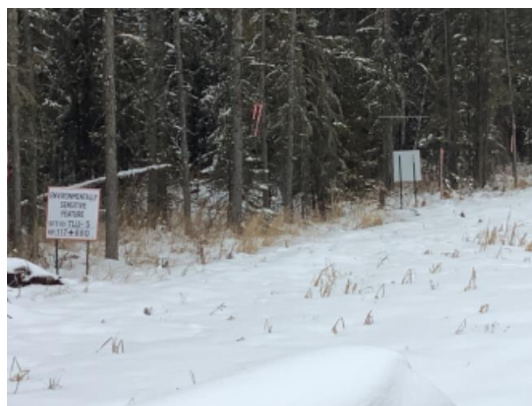
Signage and mitigations in place at TLU-5.

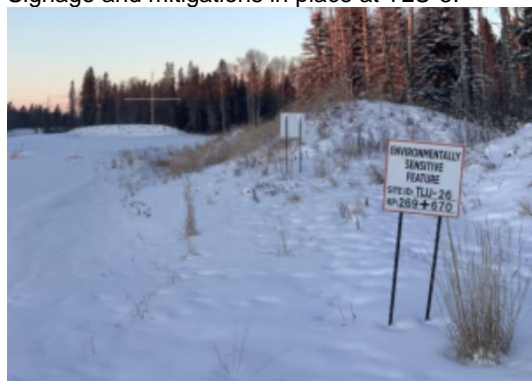
Signage and mitigations in place at TLU-26.

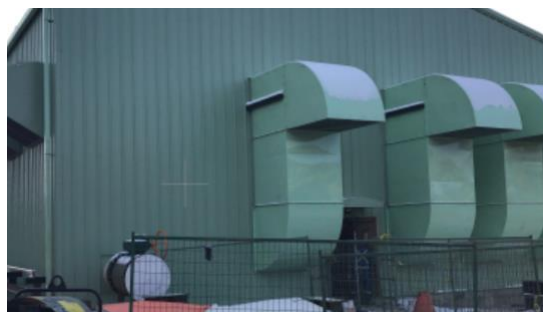
New pump building enclosed at Edmonton Terminal.

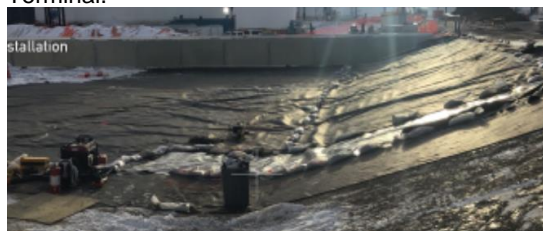
Good housekeeping on-site at Edmonton Terminal.

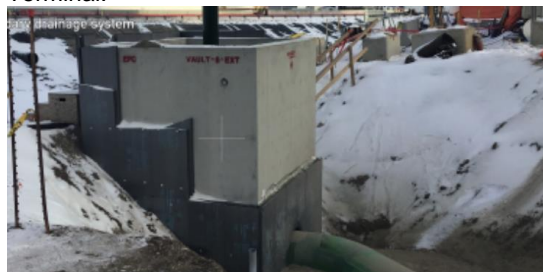
Fire and stormwater collection system under construction.

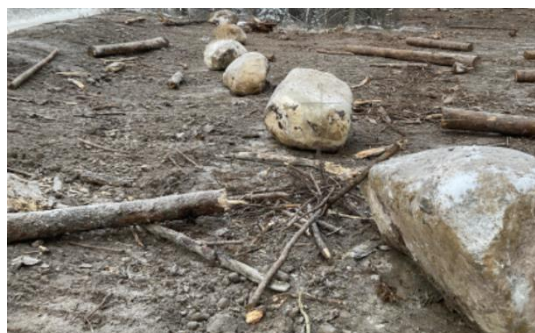
Final cleanup complete with CWD and access management in place at KP 321.

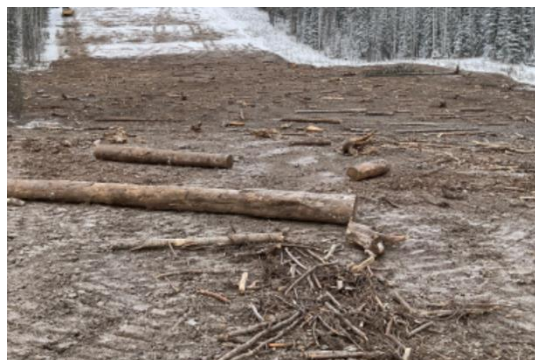
CWD installed below berm at KP 320.
