INDIGENOUS MONITOR OVERVIEW REPORT

Month: February 2023

**Project Region: Edmonton and
Yellowhead**

Indigenous Monitors on the Trans Mountain Expansion Project – Overview

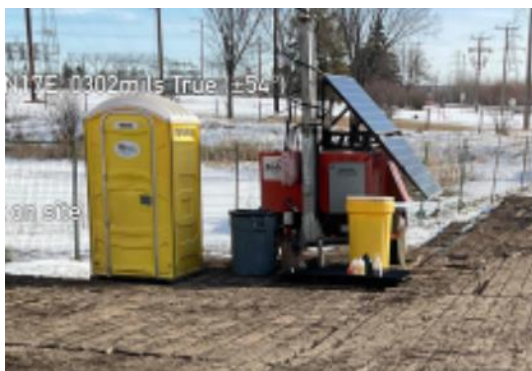
The Indigenous Monitors conducted housekeeping inspections near KP 99 on Spread 2. Indigenous Monitors also check that secondary containment is placed underneath machinery and stored petrochemicals. No environmental concerns were identified.

Housekeeping and spill preparedness KP 99.

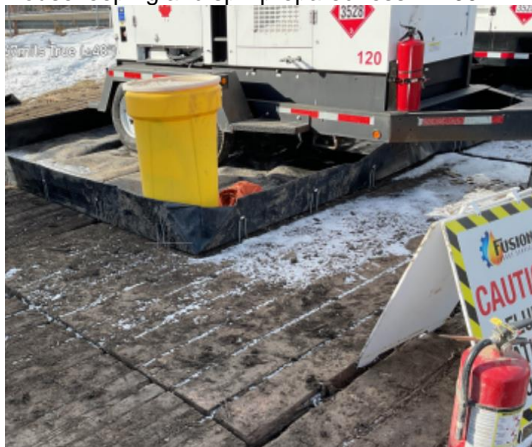
Housekeeping and spill preparedness KP 99.

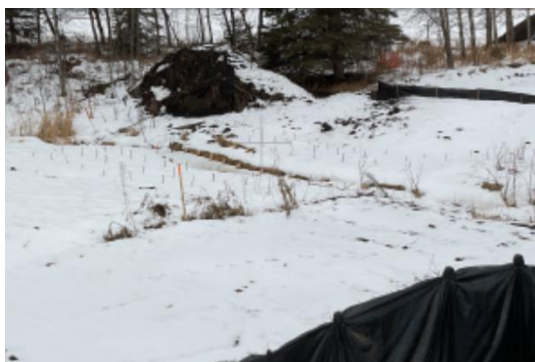
Indigenous Monitors inspected the effectiveness of restorations completed for several watercourses in Spread 2, including AB-19 at KP 63 and AB-176 at KP 314. Indigenous Monitors observed site housekeeping efforts, recontour of the bank and transplant areas including erosion control blanket, willow stakes in riparian zones, re-seeding in previously excavated and backfilled areas, and rock armouring and stream bed material replacement. These mitigations were installed and working as planned. No deficiencies were identified.

Inspection of AB-19 at KP 63

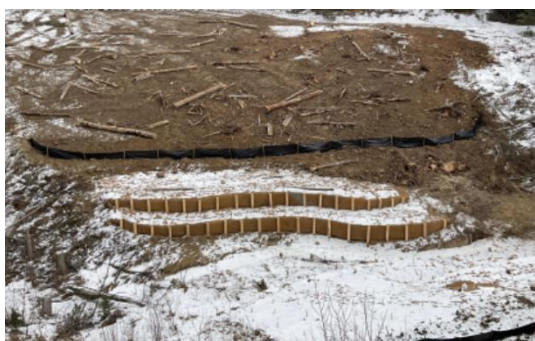
Inspection of AB-176 at KP 314.

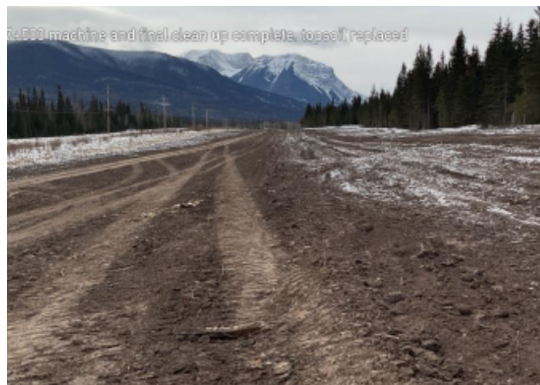
Topsoil replacement KP 337.

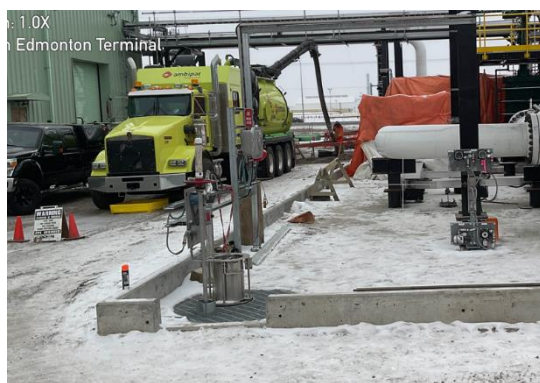
Waste management was inspected as well as secondary containment for equipment and fuel storage tanks. Open excavations were marked and properly delineated. Walking paths were kept clear. Spill kits and spill response procedures were also reviewed in the field. Key compliance measures on the construction permit were reviewed and mitigations were in place. No deficiencies were noted.

Good housekeeping on-site at Edmonton Terminal.

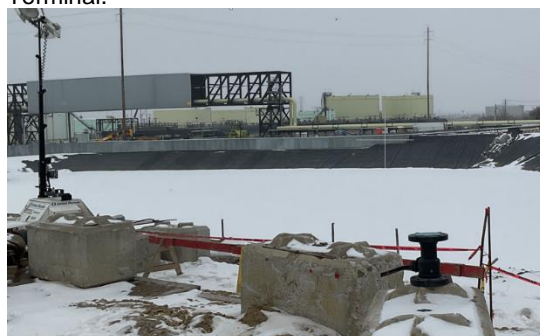
Fire and stormwater collection system under construction.

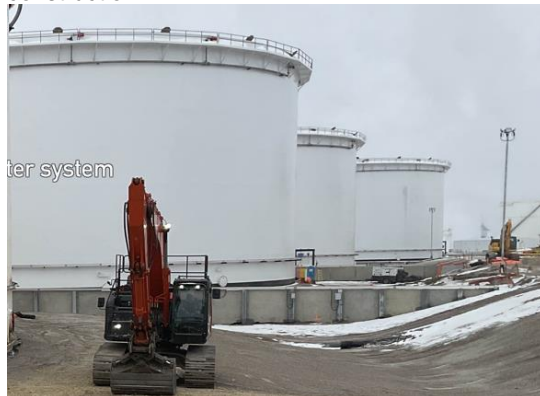
New tanks Edmonton Terminal.

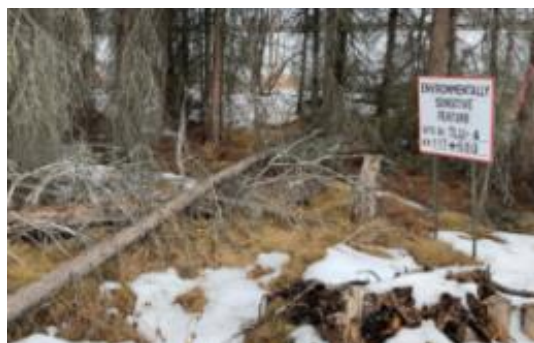
Signage and mitigations in place at TLU-4.

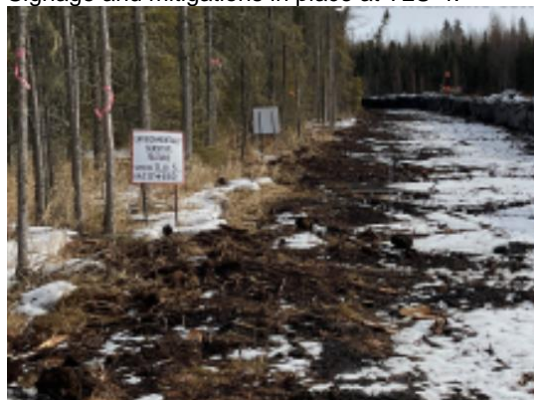
Signage and mitigations in place at TLU-5.

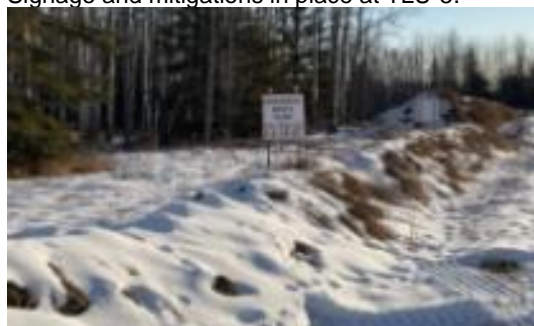
Signage and mitigations in place at TLU-25.

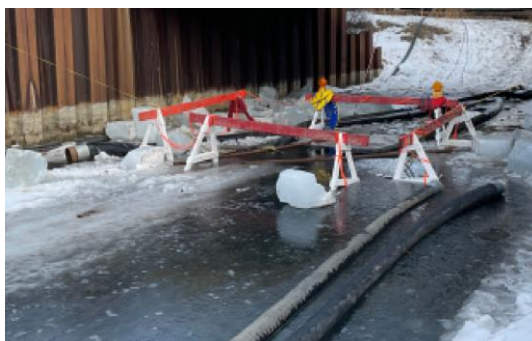
Hydrotest withdrawal point Wabamun Park KP 97

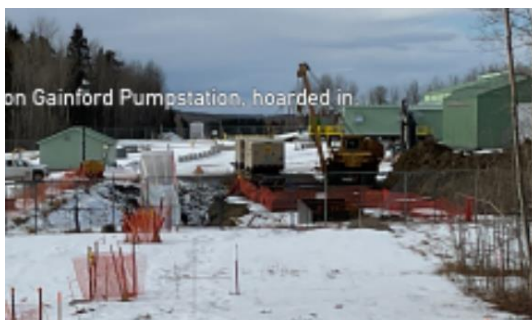
Hydrotest Gainford Pump Station KP 99.

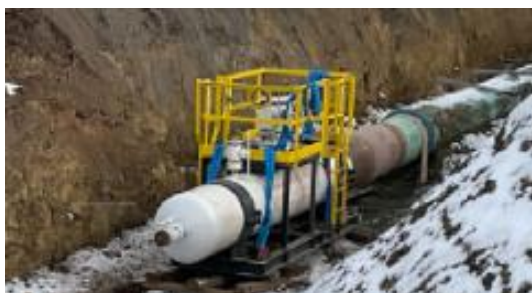
Temporary test head installed at KP 135.
