INDIGENOUS MONITOR OVERVIEW REPORT

Month: January 2023

**Project Region: Edmonton and
Yellowhead**

**Kilometer Posts (KPs) monitored:
KP 1–337**

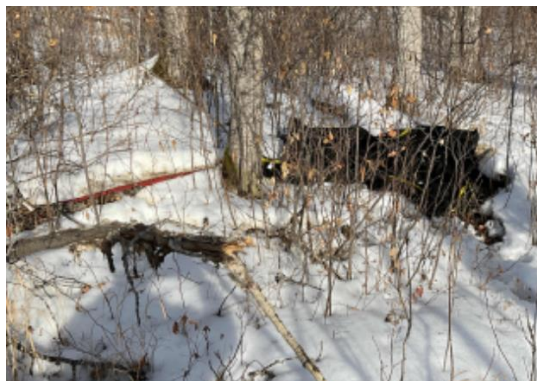
The Indigenous Monitors inspected to ensure the filtration system was functioning as intended and that no sediment loading was identified at the discharge point. Observation showed pump-off water was released a minimum of 50 m from the nearest watercourse, replacement materials were readily available including sediment control devices, pumps, spills kits and secondary containment, and housekeeping of off-construction footprint locations took place. No deficiencies were found.

Pump-off location near KP 115.

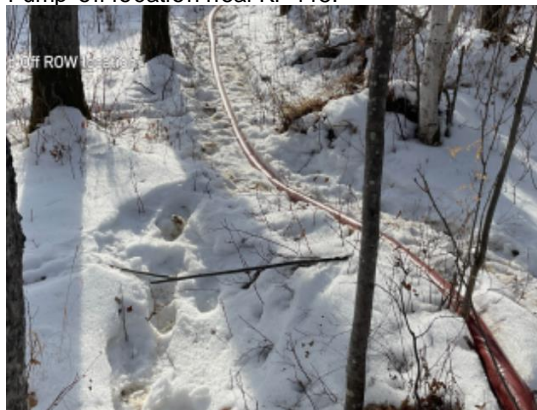
Pump-off in progress near KP 115.

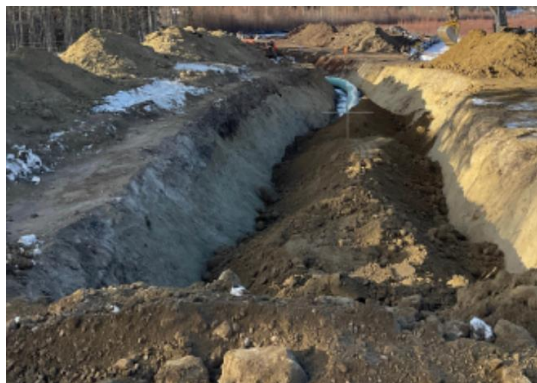
Inspections were conducted for the excavated soil placed in the trench over the installed pipe. The Indigenous Monitors observed sand and subsoil being backfilled over the pipe prior to topsoil being replaced and ensured backfill activities were confined to the construction right-of-way. No issues or potential chance finds were identified.

Backfill in progress KP 117.

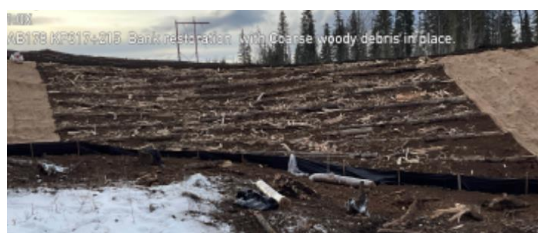
Indigenous Monitors inspected the effectiveness of restorations completed at various watercourses in Spread 2 and observed site housekeeping efforts, recontour of the bank and transplant areas including erosion control blanket, willow stakes in riparian zones, re-seeding in previously excavated and backfilled areas, and rock armouring and stream bed material replacement. These mitigations were installed and working as planned. No deficiencies were identified.

Inspection of AB-178 at KP 317.

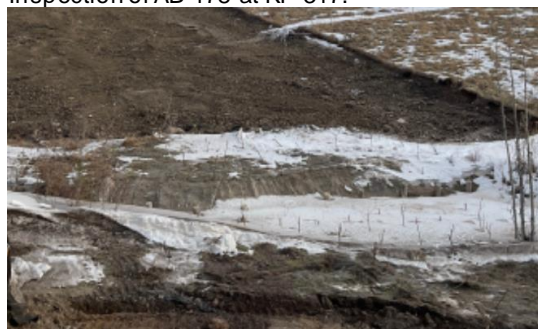
Monitoring of AB-202 at KP 337.

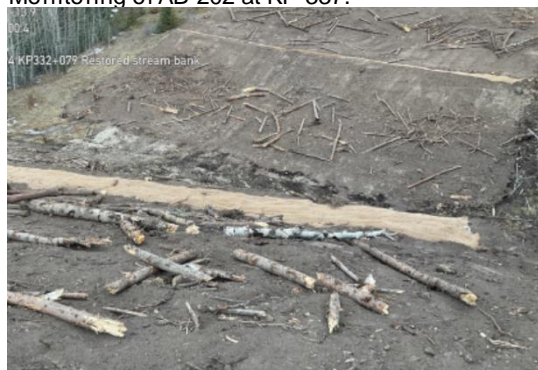
Restoration of AB-194 complete at KP 332.

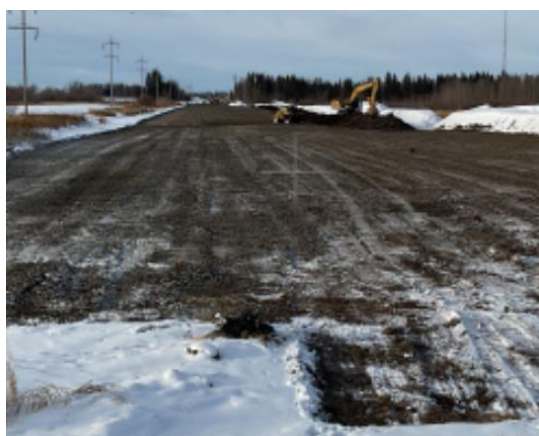
Indigenous Monitors were on-site inspecting various reclamation activities, including discing for soil decompaction, topsoil replacement, confirming topsoil depth and confirmation that proper seed mixes are applied. Indigenous Monitors were engaged in conversations with crews and EIs in all stages of reclamation. No deficiencies were found.

Topsoil replacement and cleanup at KP 64.

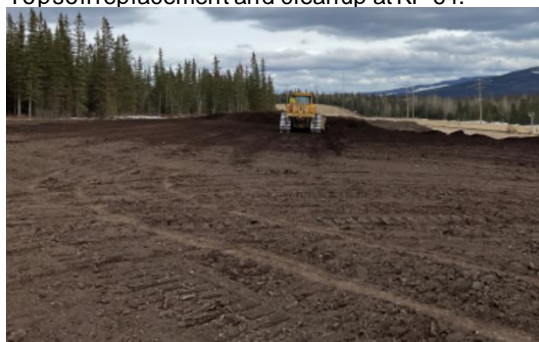
Topsoil replacement at KP 337.

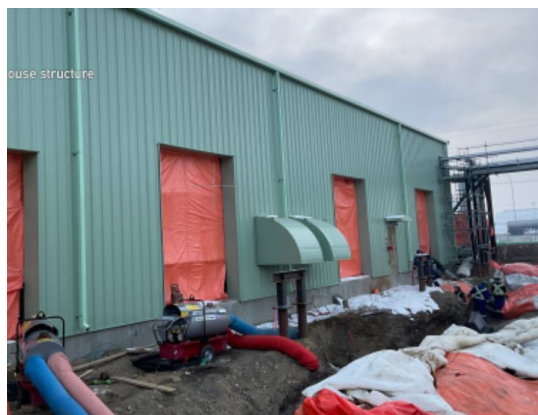
New pump building enclosed at Edmonton Terminal.

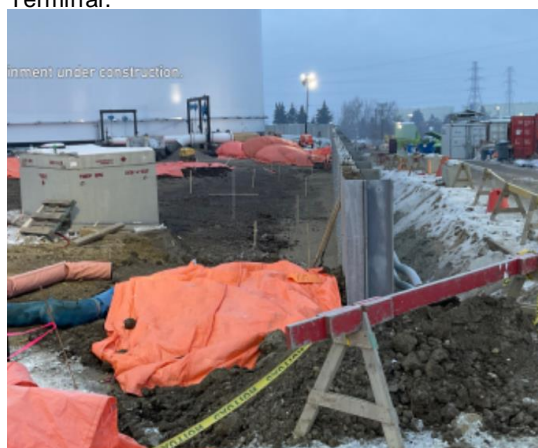
Waste management was inspected as well as secondary containment for equipment and fuel storage tanks. Open excavations were marked and properly delineated. Walking paths were kept clear. Spill kits and spill response procedures were also reviewed in the field. Key compliance measures on the construction permit were reviewed and mitigations were in place. No deficiencies were noted.

Good housekeeping on-site at Edmonton Terminal.

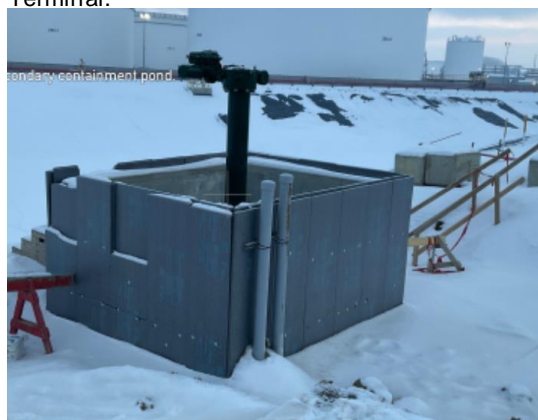
Fire and stormwater collection system under construction.

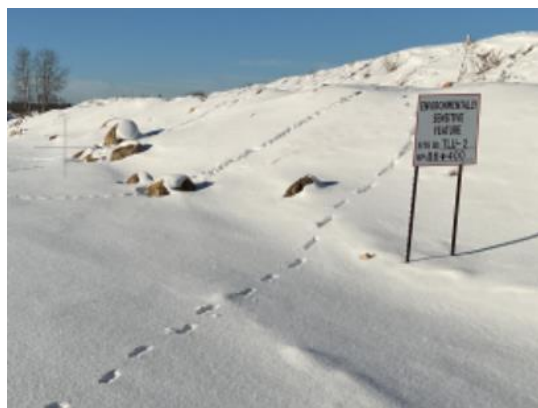
Indigenous Monitors inspected previously identified TLU sites along the right-of-way on Spread 2 to confirm mitigation measures remain in place including signage, staking and flagging.

Signage and mitigations TLU-2.

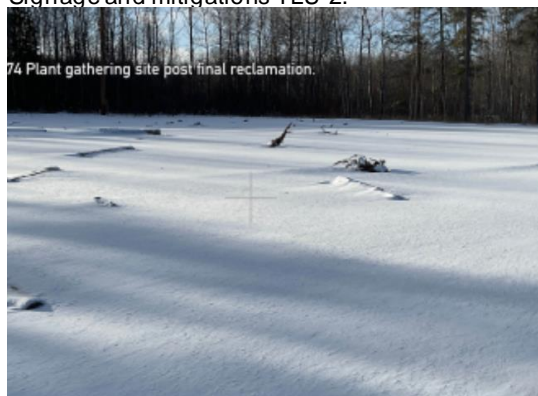
Reclamation complete TLU-17.

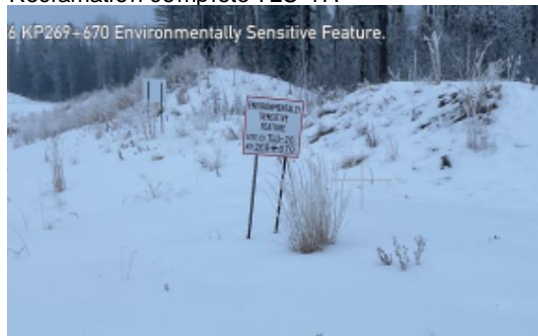
Mitigations TLU-26.

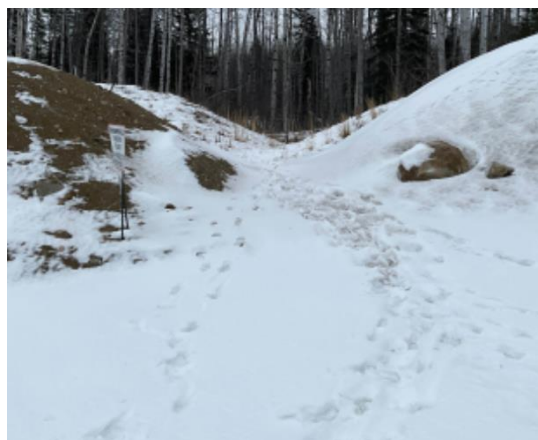
Indigenous Monitors regularly inspect for signs of wildlife and confirmed that soil breaks are working effectively to maintain movement of wildlife through construction areas. No environmental concerns were identified.

Wildlife break in soil working as intended KP 312.
