INDIGENOUS MONITOR OVERVIEW REPORT

Month: July 2022

**Project Region: Edmonton and
Yellowhead**

Indigenous Monitors on the Trans Mountain Expansion Project – Overview

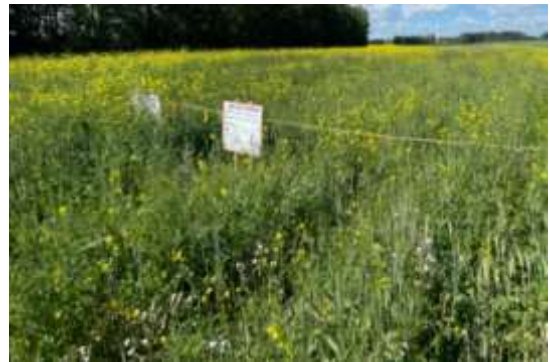
Bird nest buffer in place at KP 66.

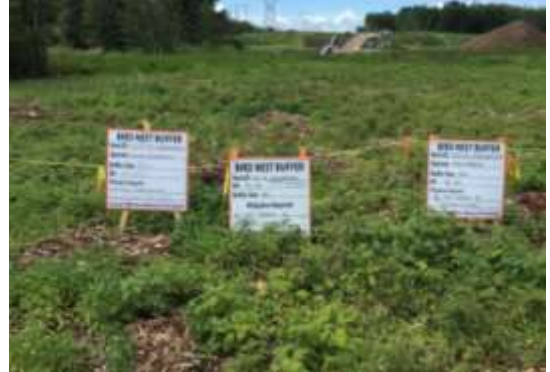
Bird nest buffer KP 90.

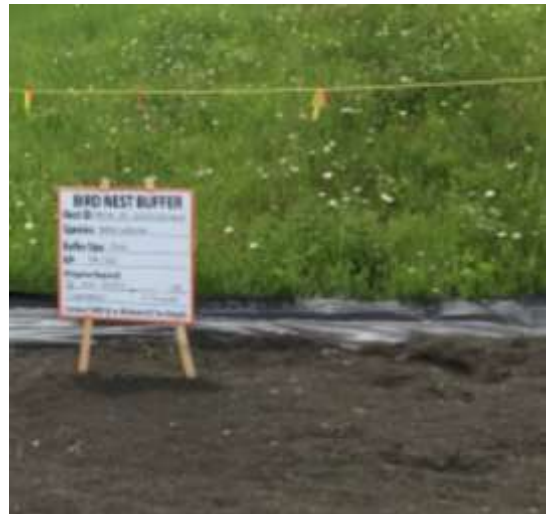
Bird nest buffer at KP 126.

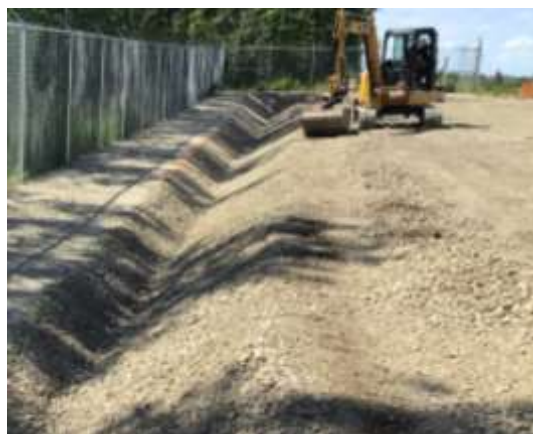
The inspection included observing the sites' waste management procedures, use of secondary containment and the completion of final grade for the Gainford Pump Station buildings. Two drainage culverts were being installed as well as a drainage ditch to manage surface run-off. No environmental concerns were identified.

Drainage ditch construction at Gainford Pump Station KP 116.

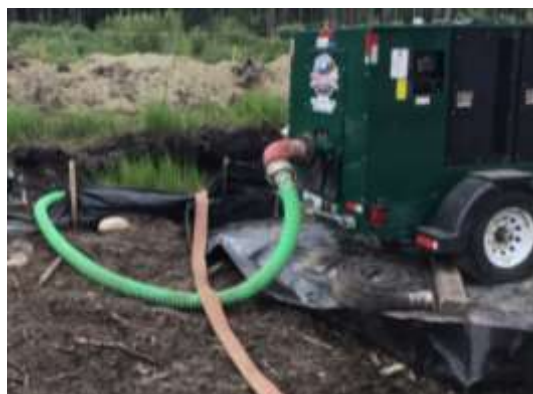
The Indigenous Monitors inspected to ensure the filtration system was functioning as intended and that no sediment loading was identified at the discharge point. It was observed that pump-off water was released a minimum of 50 m from the nearest watercourse, replacement materials were readily available, including sediment control devices, pumps, spills kits and secondary containment, and housekeeping of off-construction footprint locations. No deficiencies were identified during the inspection.

Pump-off location at KP 265.

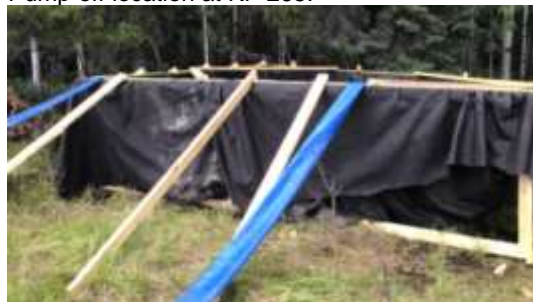
Pump-off release location KP 265.

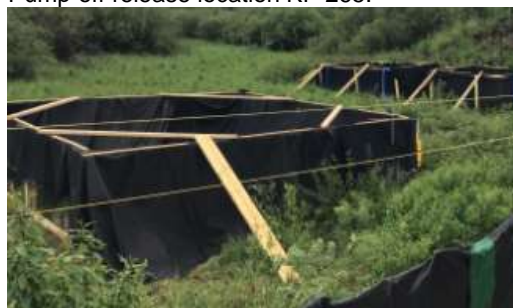
Pump-off location at KP 246.

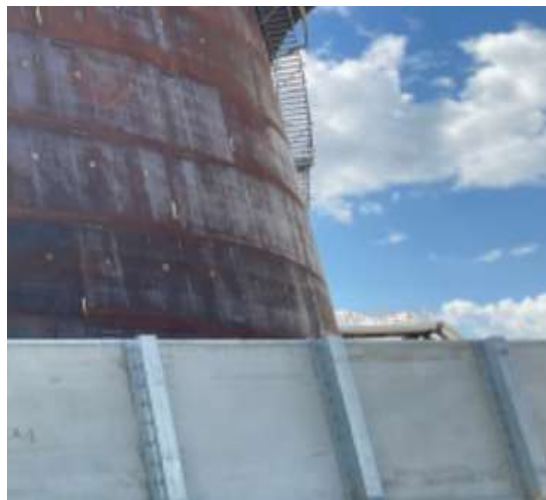
Containment wall complete beside new tank, coating to be completed, Edmonton Terminal.

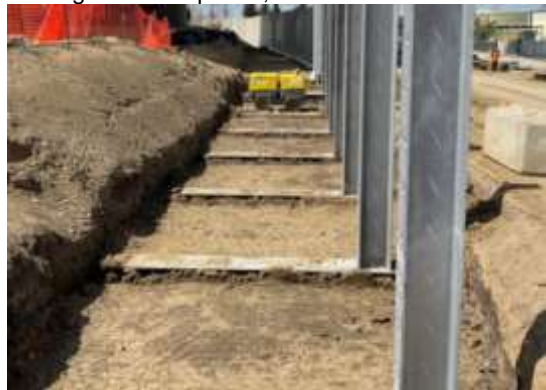
Piling construction for containment walls at Edmonton Terminal.

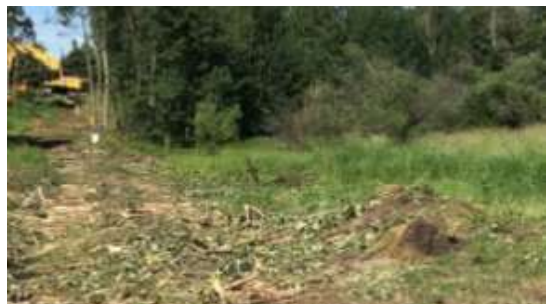
At KP 76, the Indigenous Monitors inspected clearing activities, wildlife mitigations, including general housekeeping, erosion and sediment control measures, buffers and signage for environmentally sensitive areas. No rare or medicinal plants were identified by the Indigenous Monitors in the workspace. No concerns were noted.

Clearing activities at KP 76.

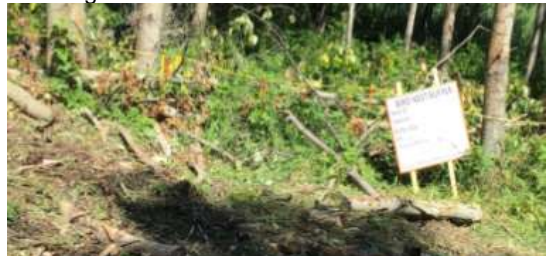
Bird buffers confirmed in place before clearing at KP 76.

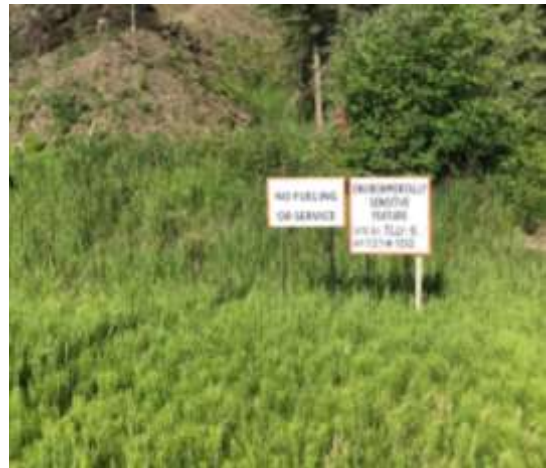
Signage in place at TLU-6 .

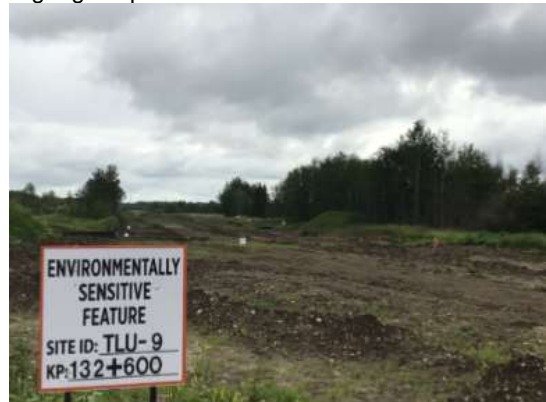
Signage in place at TLU-9.

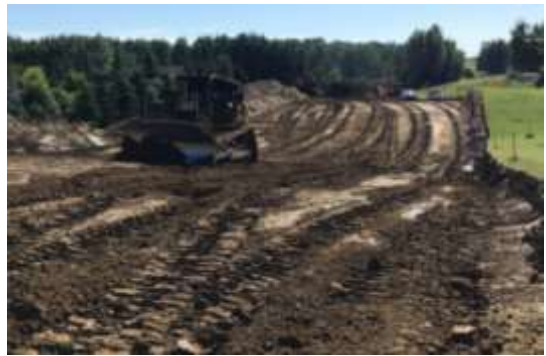
Topsoil strip and grading crew working at KP 74.

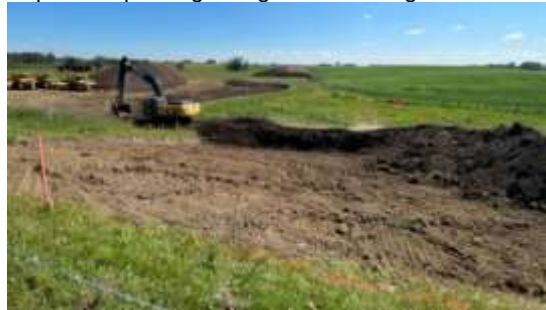
Strip and grade crew at KP 69.

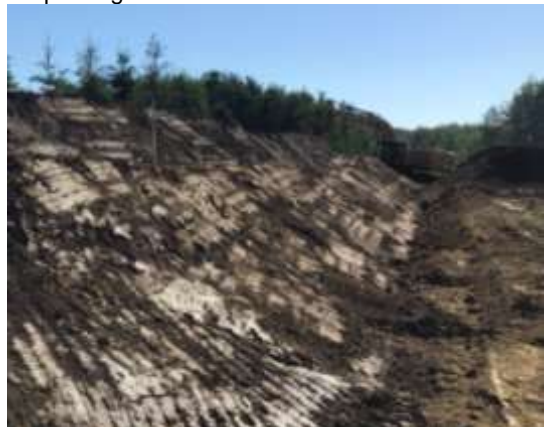
Topsoil pile staked and labeled KP 74.

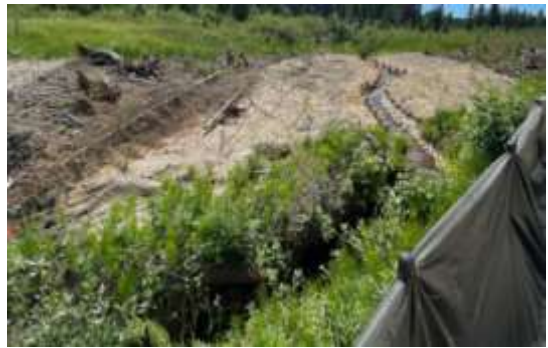
Stream bank restoration complete at AB-153 KP 290.

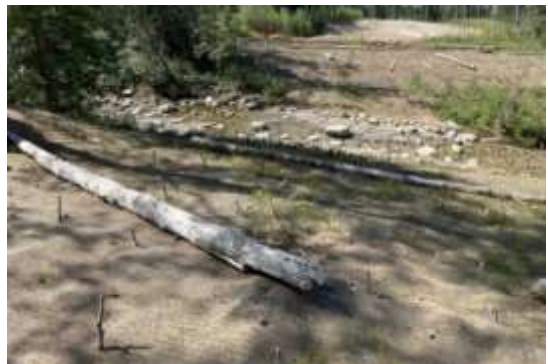
Stream bank restoration complete at AB-167 KP 307.

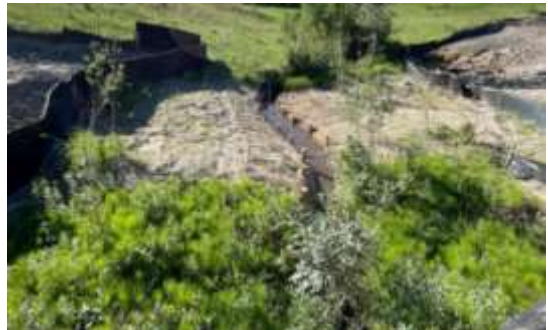
Stream bank restoration complete at AB-202 KP 337.
