INDIGENOUS MONITOR OVERVIEW REPORT

Month: November 2022

**Project Region: Edmonton and
Yellowhead**

Indigenous Monitors on the Trans Mountain Expansion Project – Overview

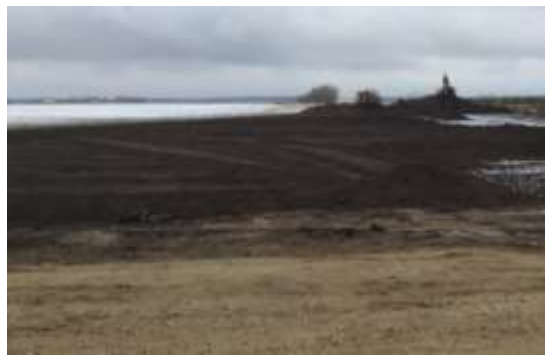
Topsoil replacement and cleanup at KP 54.

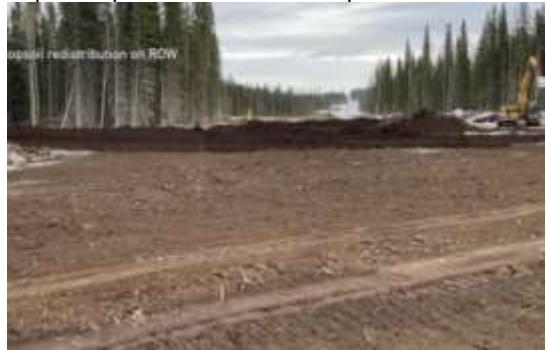
Topsoil replacement KP 325.

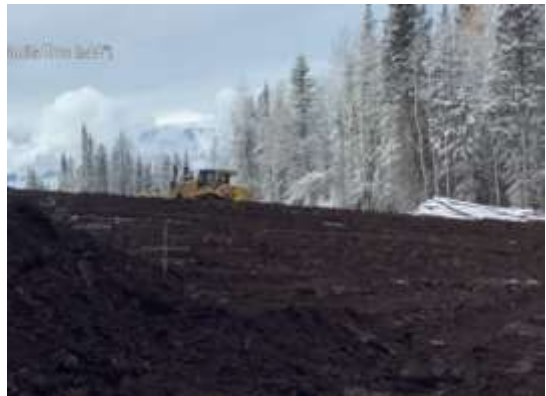
Topsoil replacement KP 322.

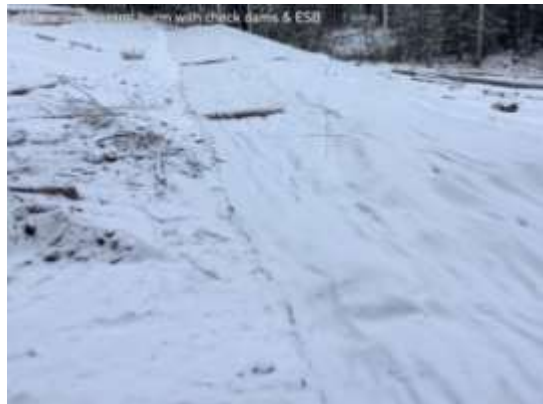
Berm constructed with erosion control blanket at KP 322.

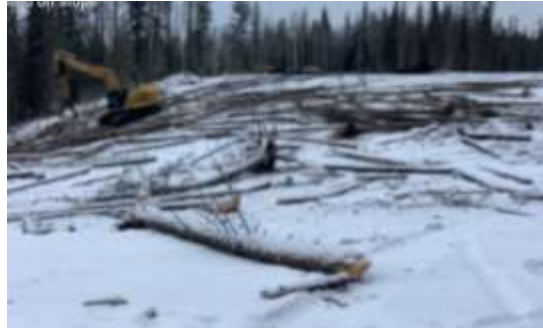
CWD installed below berm at KP 322.

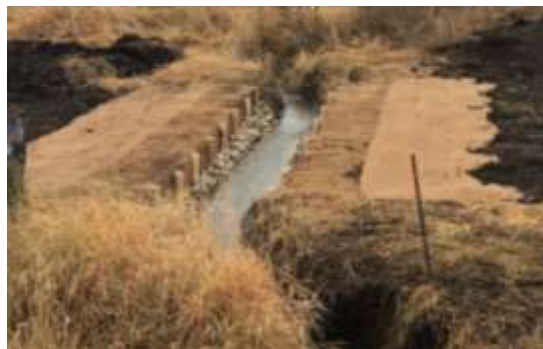
Restoration of AB-20 complete at KP 64.

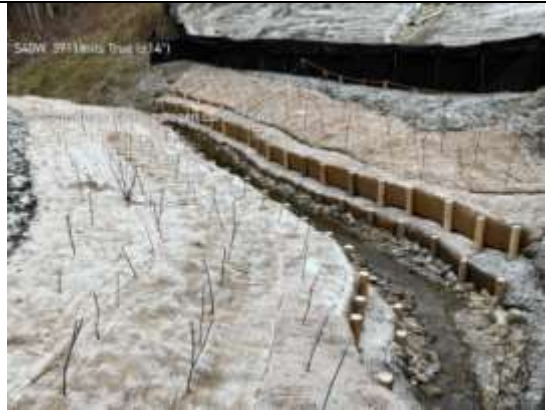
Restoration of AB-44 at KP 107.

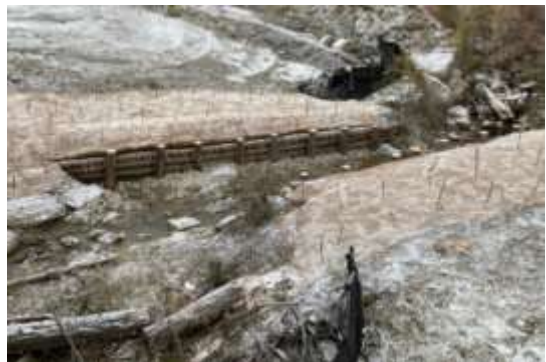
Restoration AB-48 at KP 112.

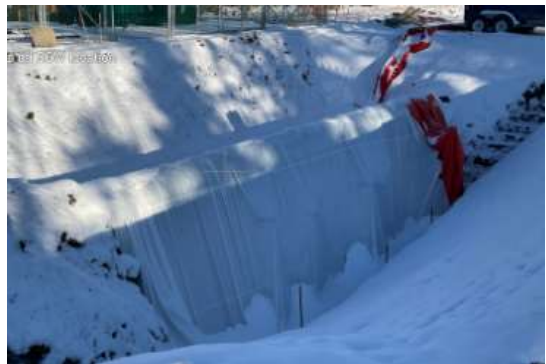
Open excavation required pump-off at KP 177.

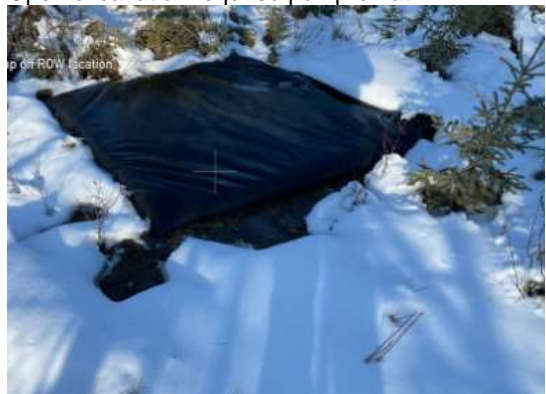
Pump-off location KP 177.

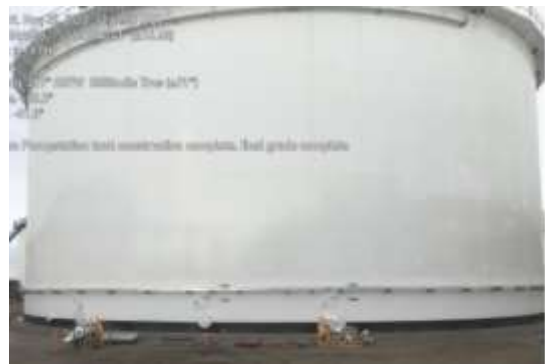
Tanks complete Edmonton Terminal.

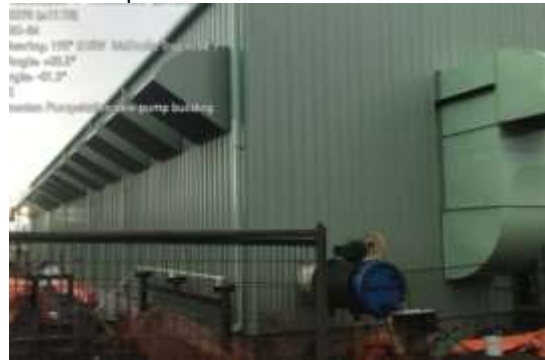
New pump building enclosed at Edmonton Terminal.

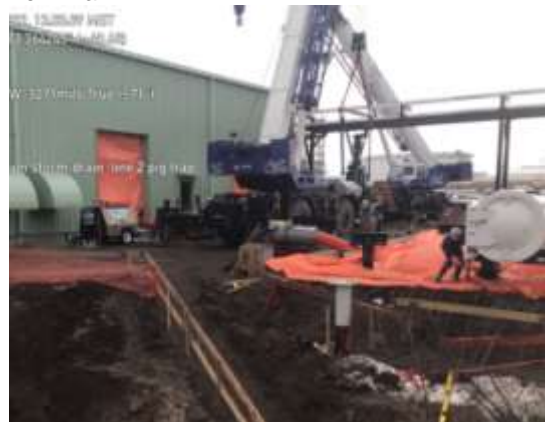
Good housekeeping on-site at Edmonton Terminal.

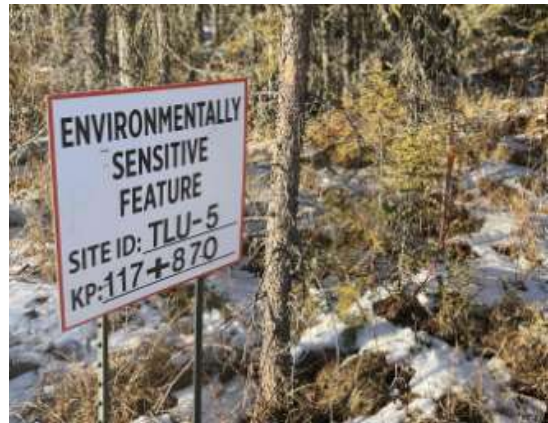
Mitigations in place at TLU-5.

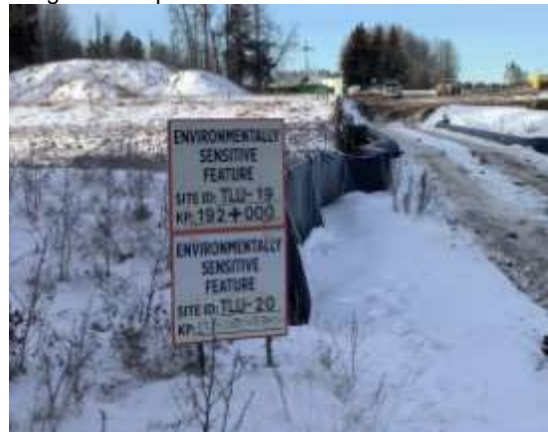
Signage and mitigations in place at TLU-19 and TLU-20.

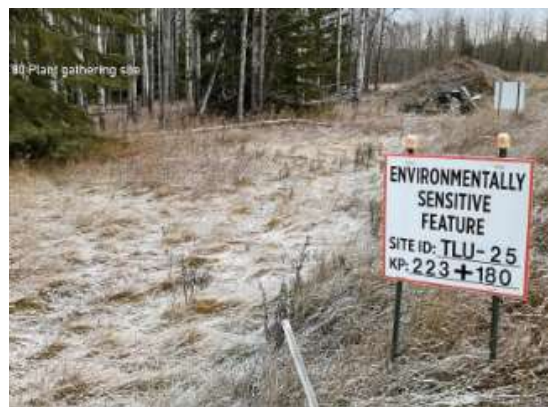
Signage and mitigations in place at TLU-25
