INDIGENOUS MONITOR OVERVIEW REPORT

Month: October 2023

**Project Region: Edmonton and
Yellowhead**

Indigenous Monitors on the Trans Mountain Expansion Project – Overview

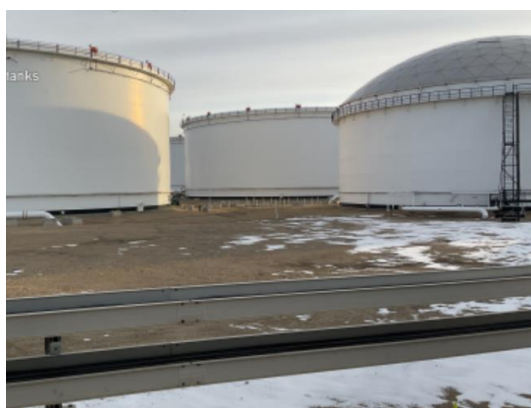
Edmonton Terminal tanks.

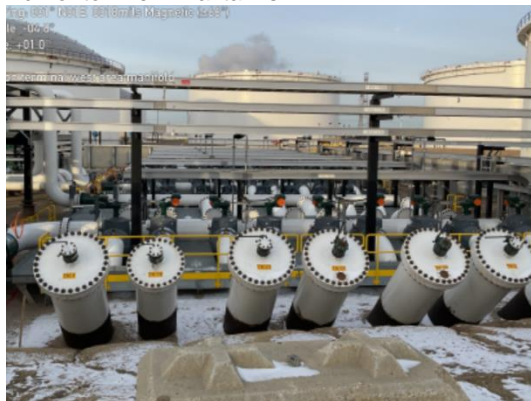
West manifold area Edmonton Terminal.

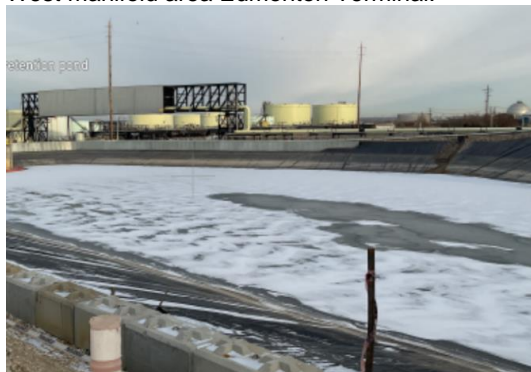
Containment basin complete Edmonton Terminal.

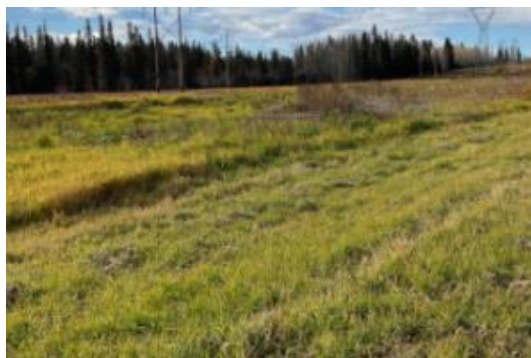
Regrowth at TLU-3.

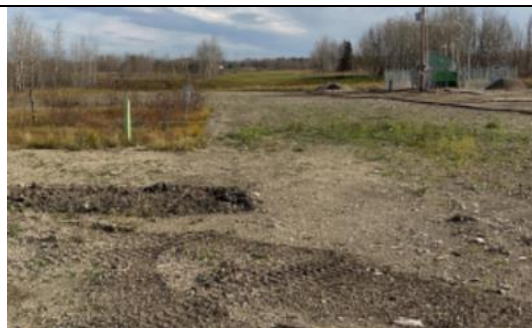
Reclamation complete and seeded at TLU 9.

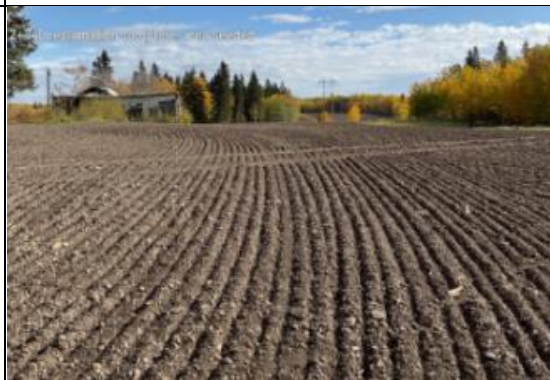
Reclamation and seeding complete KP 112.

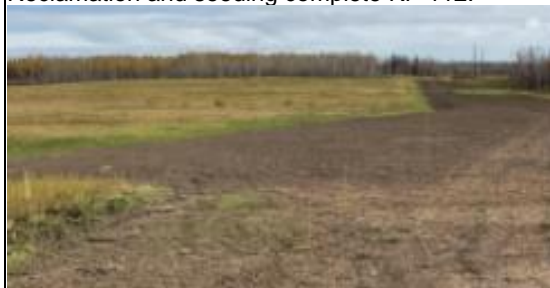
Reclamation and seeding complete KP 135.

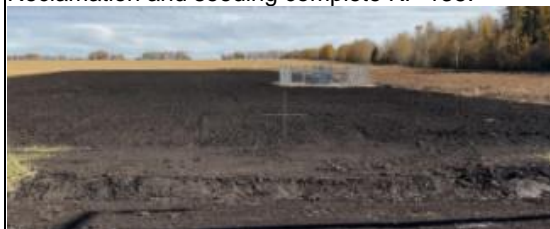
Reclamation complete and valve installed KP 144.

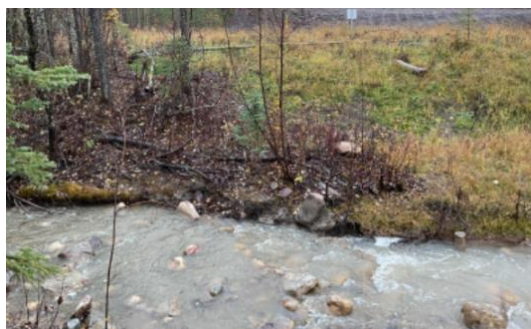
Indigenous Monitors inspected the effectiveness of restorations completed at AB-157 at KP 297, AB-167 at KP 307 and AB-202 at KP 337. This included observing site transplant areas, including erosion control blanket, willow stakes in riparian zones, reseeded in previously excavated and backfilled areas, rock armouring and stream bed material replacement. No deficiencies were identified.

ESC in place at AB-167 KP 307.

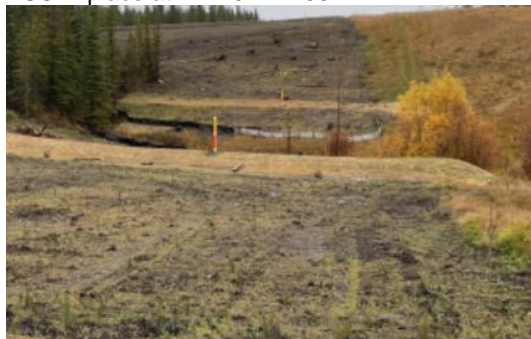
Regrowth and ESC in place AB-202 KP 337.

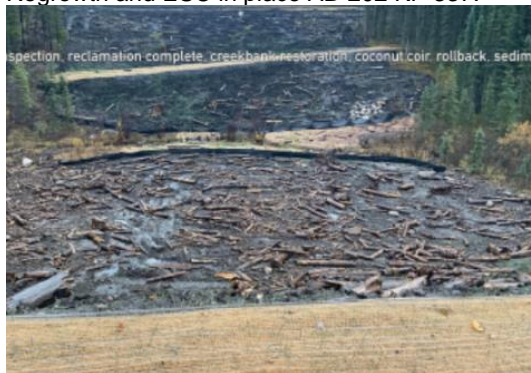
ESC functioning at AB-157 KP 297.
