# INDIGENOUS MONITOR OVERVIEW REPORT

**Month: April 2023**

**Project Region: Fraser Valley**

## **Indigenous Monitors on the Trans Mountain Expansion Project – Overview**

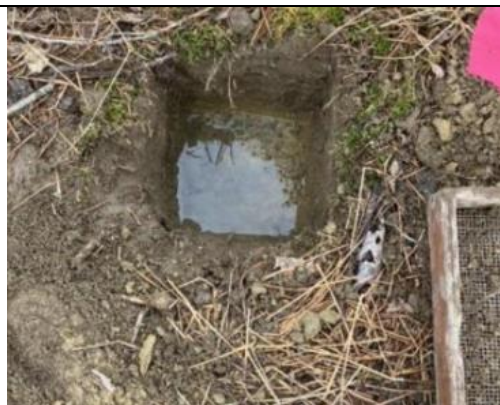
The Indigenous Monitors observed the implementation of an AIA conducted near KP 1145. The assessment, completed by a qualified archaeologist and Indigenous participants, may include visual inspection to identify features with predictable archaeological potential, surface inspection of areas with exposed sediments for cultural materials and shovel testing of terrain features exhibiting archaeological potential. No concerns were identified.

Test hole assessed by the resource specialist near KP 1145. Test holes conducted were negative.

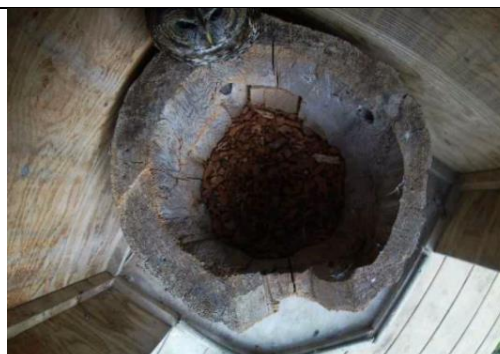
The Indigenous Monitor observed the Resource Specialist monitor activity near an owl sanctuary at KP 1145. Noise recordings measured in decibels are recorded and the owls are monitored via video camera in their aviary to observe if noise from construction causes behavioural changes. No issues or changes were identified.

Owl monitored via video camera in a sanctuary at KP 1145.

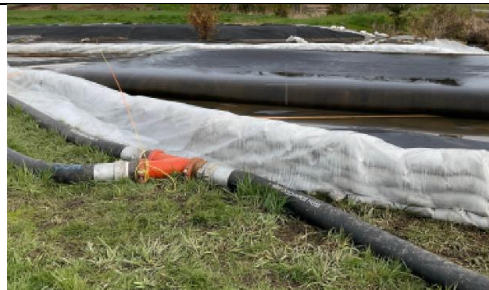
Near KPs 1081, 1098, 1103, 1105 and 1116, an Indigenous Monitor observed that water accumulating on-site was pumped off to a settling containment system and filter bags. Water flowing out of the filtration system was discharged upland to a well-vegetated area. The settling containment systems were inspected and functioning as intended and no sediment loading was identified at the discharge points.

Near KP 1081, the dewatering system was observed to be functioning as intended.

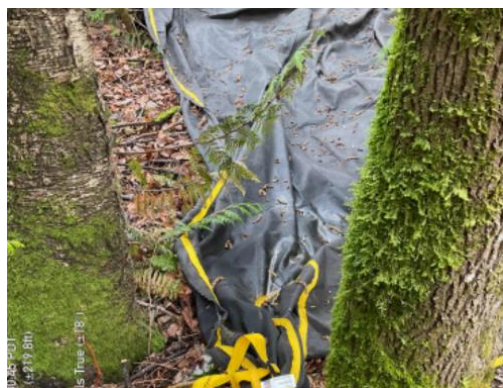
Pump-off location inspected Near KP 1116.

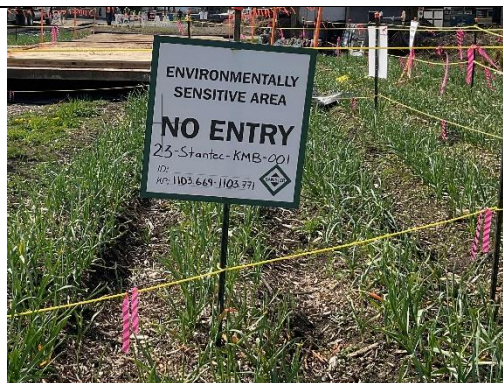
Near KP 1103, the Indigenous Monitor observed environmental feature signage and flagging was in place and archaeological areas of interest were secure.

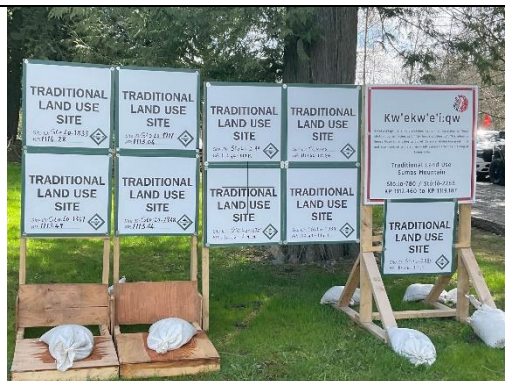
TLU signage inspected near KP 1112–1113.

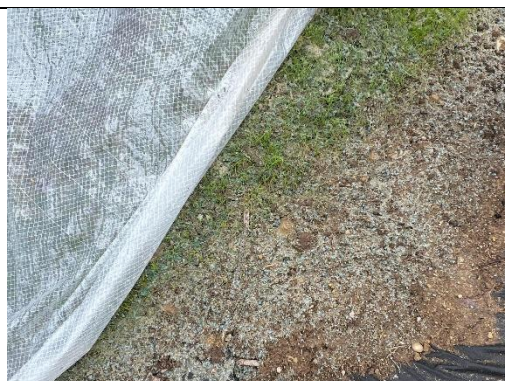
Growth in areas hydroseeded for erosion and sediment control inspected at Sumas Terminal.

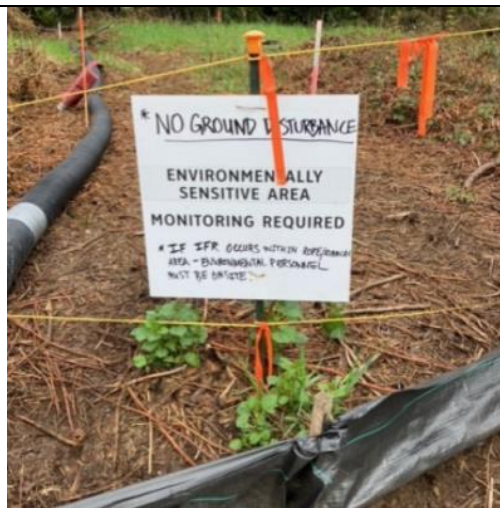
IFR pathway monitored near KP 1153.

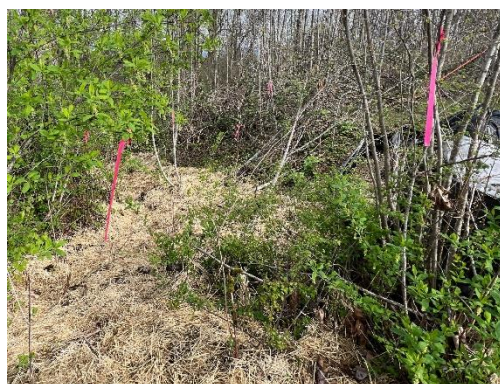
The Indigenous Monitors participated in monitoring and inspections of environmental mitigations at the crossing HDD sites. Inspections included observing that signage and buffers were in place for environmental features, including archaeological sensitive areas, and that these areas were undisturbed during construction activities. Other environmental mitigations observed included inspection of Inadvertent Fluid Release (IFR) cleanup materials, ESC measures, and participation in wildlife sweeps. The Indigenous Monitor worked alongside the environmental inspector near KP 1158 to ensure the IFR walking pathway was flagged for the contractor to clear brush.

IFR walking pathway flagged for future brush clearing by the contractor near KP 1158.
