INDIGENOUS MONITOR OVERVIEW REPORT

Month: August 2023 Indigenous Monitor days on-site: 25

Project Region: Fraser Valley Kilometre Posts (KPs) monitored:

Indigenous Monitors on the Trans Mountain Expansion Project - Overview

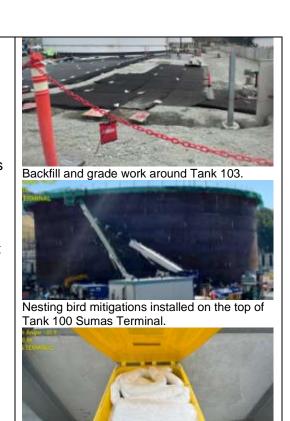
Spill kit stocked at Sumas Terminal.
