INDIGENOUS MONITOR OVERVIEW REPORT

Month: February 2022

Project Region: Fraser Valley

Indigenous Monitors on the Trans Mountain Expansion Project – Overview

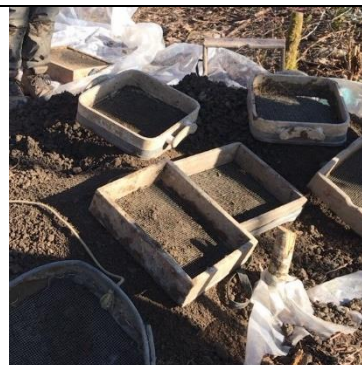
Archaeological site and excavation unit box assembly.

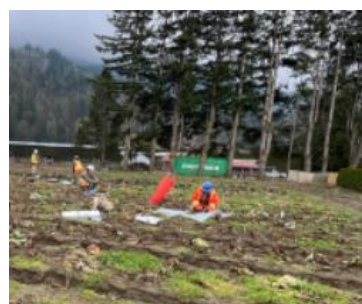
Resource specialists conducting shovel testing on Spread 6.

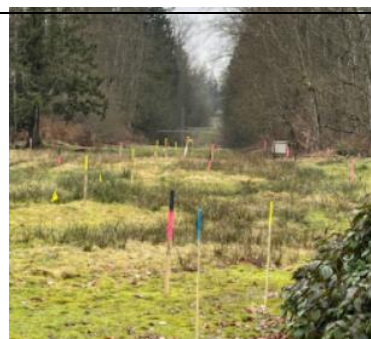
Staking observed during a walk-through of KP 1140.000 to KP 1146.600.

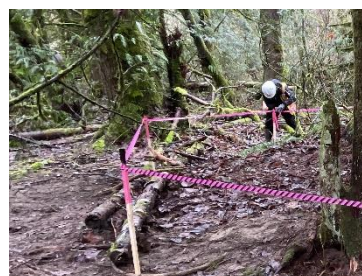
In February, the Indigenous Monitors inspected Culturally Modified Tree (CMT) flagging at Bridal Falls near KP 1076 and KP 1077, as well as participated in a pre-construction CMT locating walk-throughs with the Environmental Inspector and the contractor at KP 1143.91 to 1144.22. All pre-identified CMTs were located and flagged off effectively. The Indigenous Monitors also inspected TLU staking and signage at various locations including KP 1139.66 and KP 1117.52.

CMT flagging and buffer near KP 1143.91.

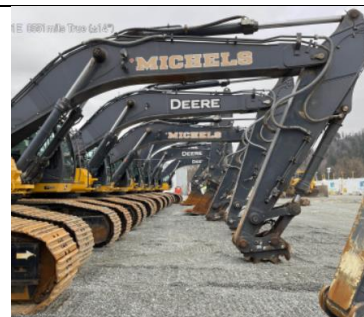
In February, monitoring included an inspection at Lackaway Yard, which also included observation of erosion and sediment control (ESC) measures like check dams and spill response. During the inspection at Lackaway Yard, a fuel spill was identified and the Environmental Inspector addressed the deficiency with the contractor.

Inactive heavy machinery at Lackaway Yard.

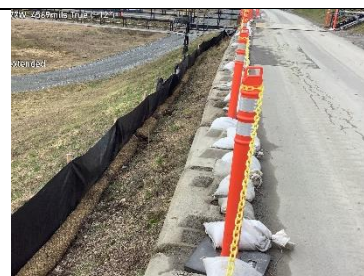
In February at Sumas Terminal, the Indigenous Monitor observed environmental mitigation measures relating to ESC, including placement of sediment fencing and straw waddles along the Tank Bay 104 access road. These measures were installed in anticipation of increased vehicle and equipment traffic along this arterial terminal access. The Indigenous Monitor observed a piece of sediment fencing along a wetland area in need of repair. The Environmental Inspector logged the deficiency and addressed the necessary fix with the contractor.

Extended length of sediment fence and straw waddle along the terminal main access road.

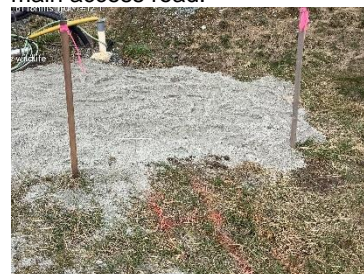
The Indigenous Monitor observed a utility line located near the fire-water pond above Tank Bay 104 at Sumas Terminal. To locate buried utility lines, hydrovacacs are used to identify underground utilities using water at high pressure. The Indigenous Monitor observed that these areas were backfilled with native soil and in a timely manner.

Hydrovac holes above Tank 104 backfilled to prevent wildlife from entering.

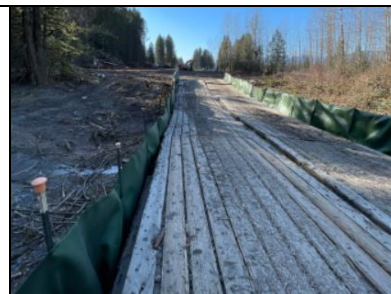
At KP 1077.550 to 1077.900, the Indigenous Monitors observed ESC measures such as sediment fencing installed under wooden access matting.

Wing wall sediment fencing installed under access matting at KP 1077.900.

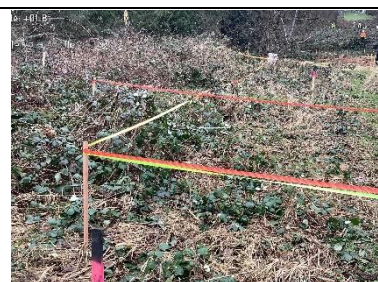
In February, the Indigenous Monitors participated in pre-clearing walk-throughs at KP 1132 and KP 1140 with the Environmental Inspector and contractor to ensure appropriate staking, flagging and signage of environmental features were in place prior to tree falling activities.

Pre-clearing walk-through near KP 1132.300.

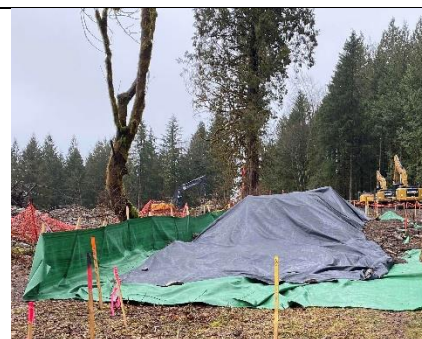
Course woody debris and topsoil material covered at KP 1077.700.

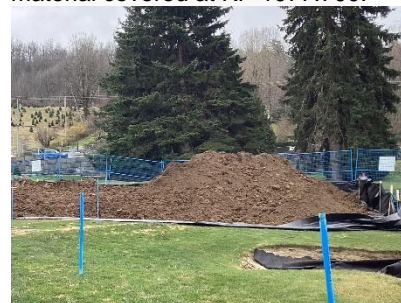
Stripped sub-surface soil stored on top of geofabric at KP 1117.6.
