INDIGENOUS MONITOR OVERVIEW REPORT

Month: February 2023

Project Region: Fraser Valley

Indigenous Monitors on the Trans Mountain Expansion Project – Overview

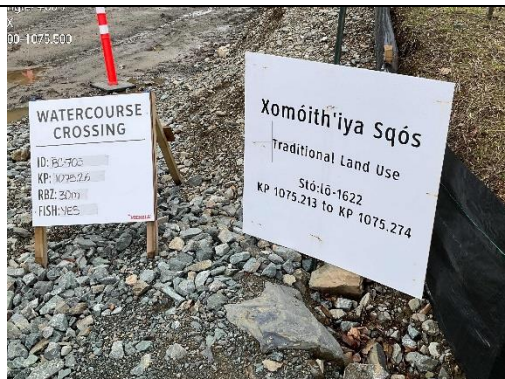
Indigenous Monitors inspected multiple site locations, including KP 1075 (Sto:lo-1622), KP 1129 (TLU-49), KP 1135 (Sto:lo-AQ32) as well as archaeological areas near KP 1097, KP 1102, KP 1135, KP 1145 and KP 1152. Signage was in place and the area was staked and flagged. No concerns were identified.

TLU signage inspected near KP 1075.

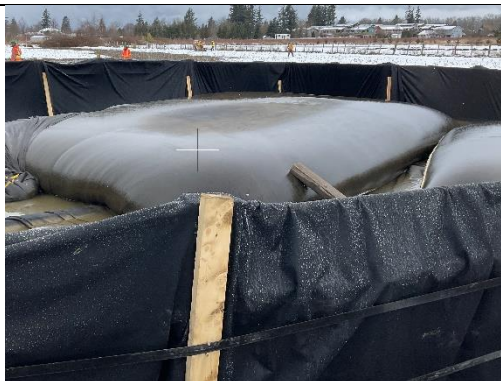
Near KP 1102 and KP 1135, the Indigenous Monitor observed that water accumulating on-site was pumped off to a settling containment system and filter bags. Water flowing out of the filtration system is discharged upland to a well-vegetated area. The settling containment systems were inspected and functioning as intended and no sediment loading was identified at the discharge points.

Near KP 1102, the dewatering system was observed to be functioning as intended.

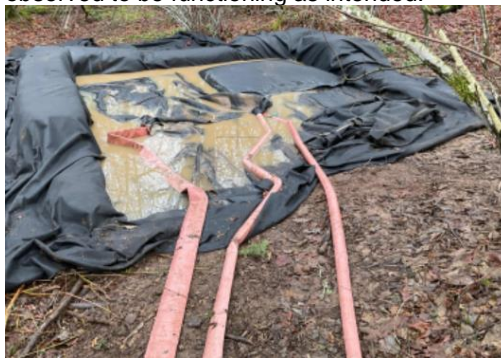
Near KP 1135, the dewatering system was observed to be functioning as intended.

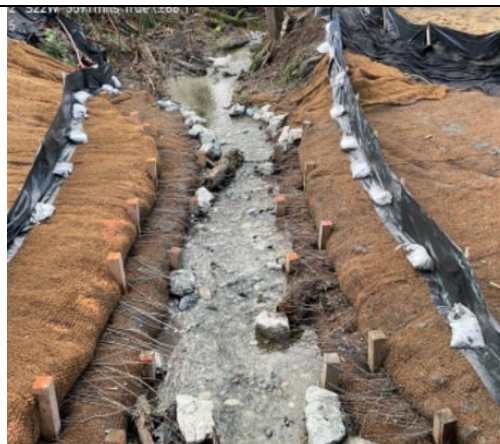
KP 1138, the Indigenous Monitor inspected the restoration efforts at watercourse BC748. Restoration of the creek was observed as complete and ESC measures were installed. No sediment was identified in the watercourse.

Restoration of watercourse BC748 inspected near KP 1138.

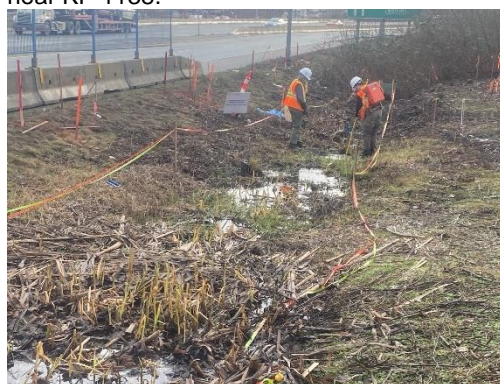
Near KP 1160, the Indigenous Monitor observed the Resource Specialist conduct a fish salvage using visual, manual and electro-fishing techniques. No fish were identified.

Fish salvage observed near KP 1160.

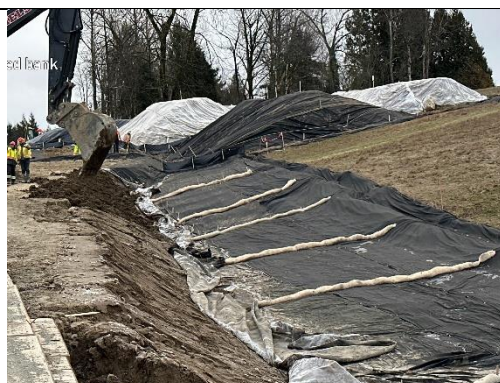
At KP 1132, the Indigenous Monitor inspected straw wattles, swales and straw blankets installed to mitigate erosion and potential sediment transfer into watercourses BC739a, BC740 and BC741. The Indigenous Monitor also observed the contractor re-

Regrading of a bank near KP 1132 to mitigate erosion underneath wooden access matting.

grade a bank to mitigate erosion from occurring underneath the protective wooden access matting. No turbid water was seen entering the inspected watercourses.

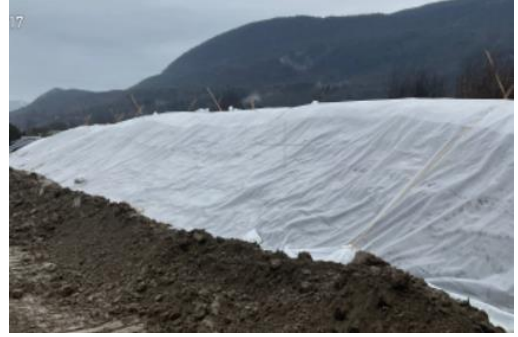
At KP 1105, KP 1129 and KP 1136, the Indigenous Monitor confirmed ESC measures for stored topsoil and subsoil were intact and in good condition.

Polyethylene sheeting inspected near KP 1129 functioning as intended.

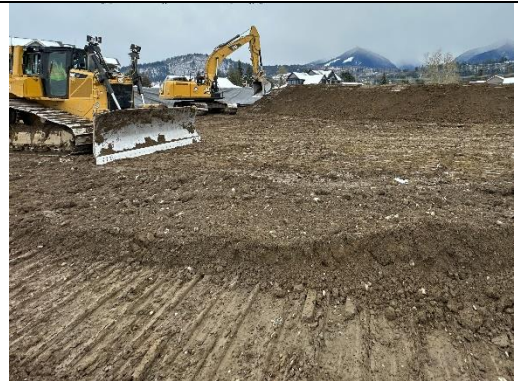
Near KP 1135, the Indigenous Monitor observed the Resource Specialist (archaeologist) conduct archaeology monitoring of topsoil stripping near archaeologically sensitive areas. Near KP 1094, the Indigenous Monitor observed topsoil stripping and grading. The Indigenous Monitors also inspected the construction areas before and after soil stripping to identify any potential chance finds. No potential chance finds were identified.

Topsoil shaped by excavator inspected near KP 1094.5.

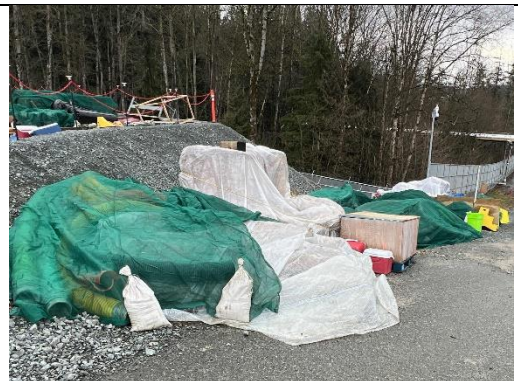
At Sumas Terminal, the Indigenous Monitor completed site inspections that included observing and documenting general housekeeping, waste management, ESC measures, soil stripping and storage, concrete management, groundwater management and wildlife management. The Indigenous Monitor observed and inspected the

Netting and polyethylene sheeting placed as a bird deterrent was inspected at Sumas Terminal.

contractor begin to install mitigations for nesting birds. No environmental concerns were identified.
