# INDIGENOUS MONITOR OVERVIEW REPORT

**Month: June 2022**

**Project Region: Fraser Valley**

## **Indigenous Monitors on the Trans Mountain Expansion Project – Overview**

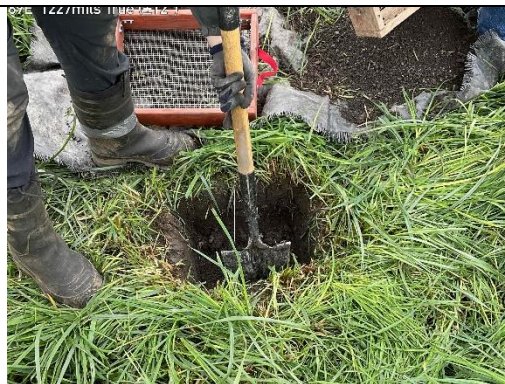
Test hole conducted near KP 1125 during AIA activity.

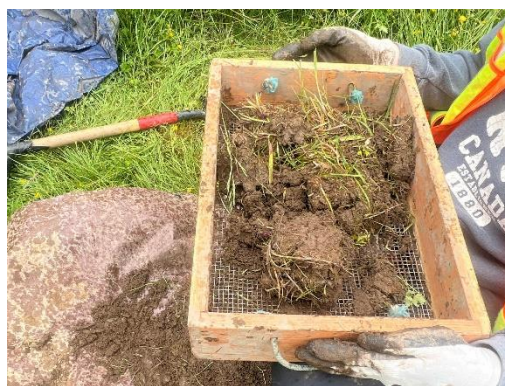
Soil from an AIA test hole near near KP 1153 being sifted by the Trans Mountain Archaeological Resource Specialist.

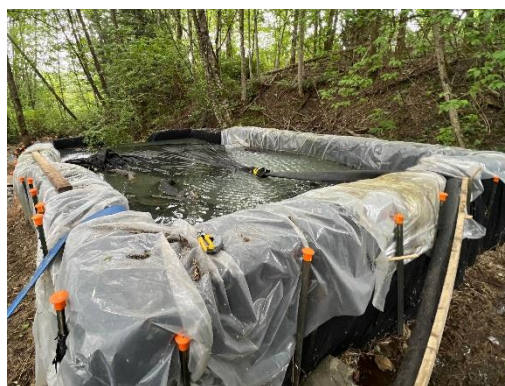
The Indigenous Monitors inspected to ensure the settling containment system was functioning as intended and that no sediment was loading at the discharge point. No deficiencies were observed.

Settling containment system at KP 1160 observed to be functioning as intended.

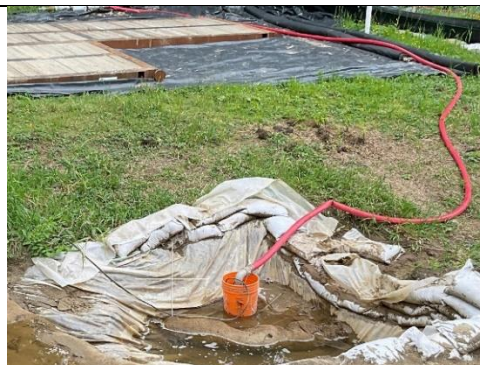
At KP 1116, the Indigenous Monitor observed water that had accumulated in a drainage ditch was

contained with sandbag berms, sediment cloth and polyethylene sheeting, then pumped –off-site to an approved location. No deficiencies were found.

Drainage ditch pump-off at KP 1116.

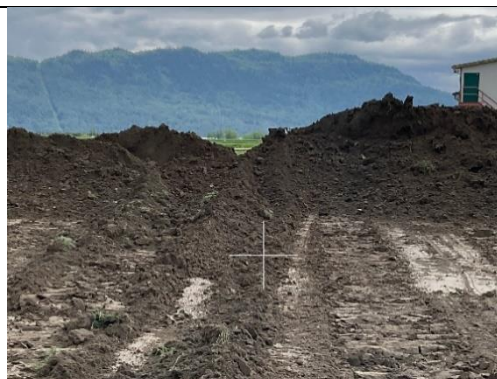
Topsoil stripping at KP 1110.

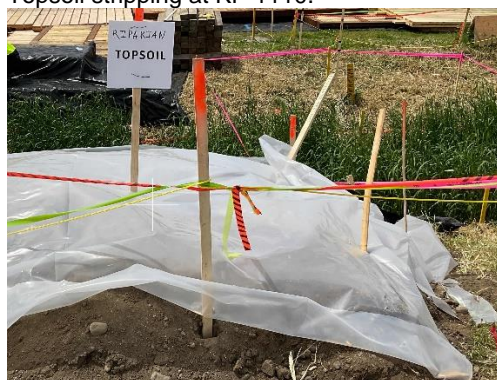
Topsoil salvaged from a riparian area near KP 1110 stored and covered with polyethylene sheeting with effective signage.

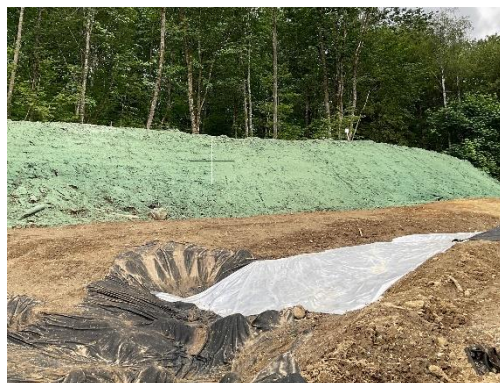
Tackifier installed on topsoil as well as geocloth and polyethylene sheeting installed as ESC measures at KP 1116.

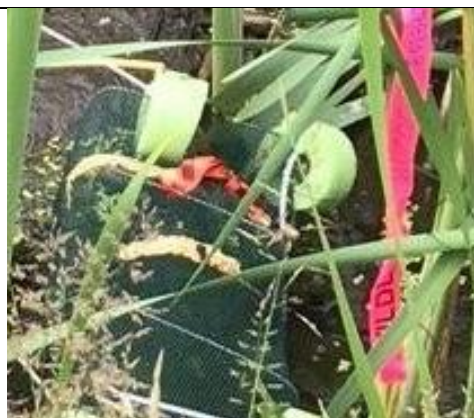
Amphibian trap inspected at 1158.

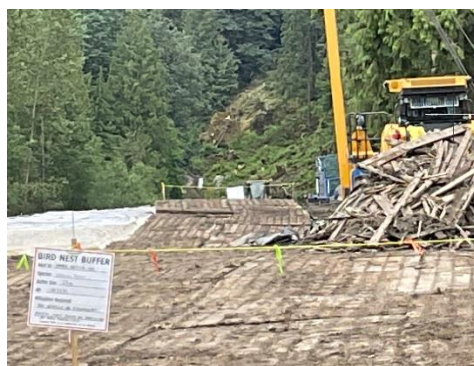
Bird nest buffer zone at KP 1078.

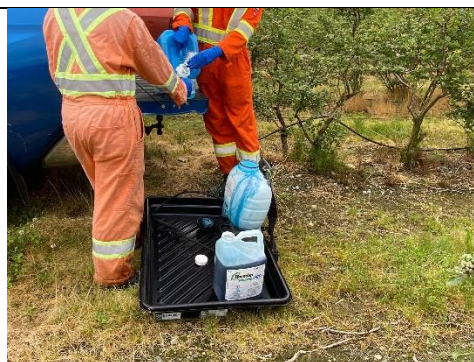
At KP1108, secondary containment is used when mixing herbicide to be sprayed on Japanese Knotweed, an invasive weed species.

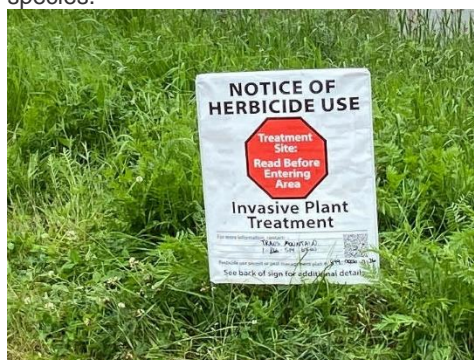
Signage placed after area at KP 1108 was sprayed with herbicide.

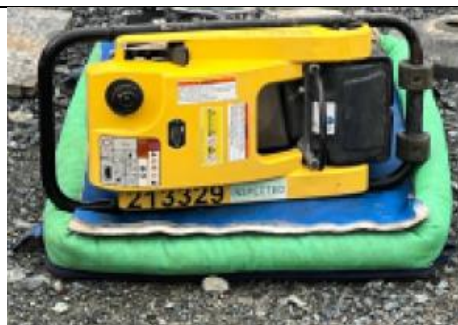
Secondary containment placed under equipment at Sumas Terminal.
