INDIGENOUS MONITOR OVERVIEW REPORT

Month: June 2023

Project Region: Fraser Valley

Indigenous Monitors on the Trans Mountain Expansion Project – Overview

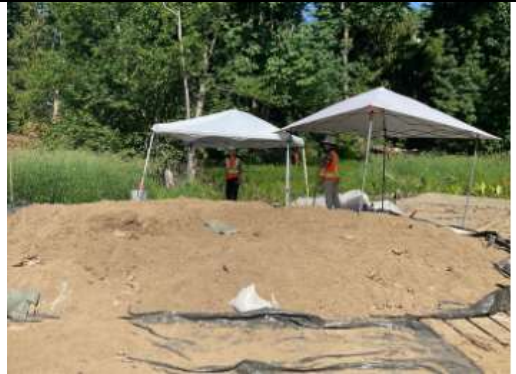
Soil being raked by the resource specialist observed near KP 1127.

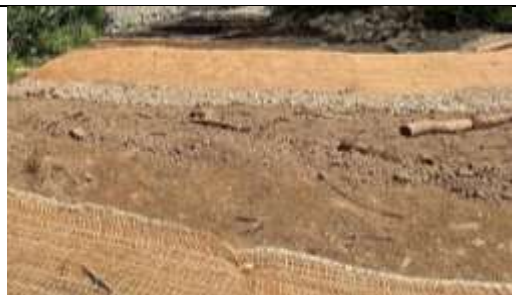
Reclamation measures observed near KP 1118, including backfilling, application of a tackifier and installation of wood debris, as well as coco matting installed for ESC measures.

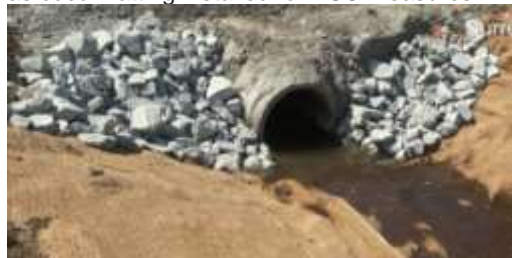
Reinstallation of drainage with rock armouring and coco matting for ESC measures observed near KP 1158.

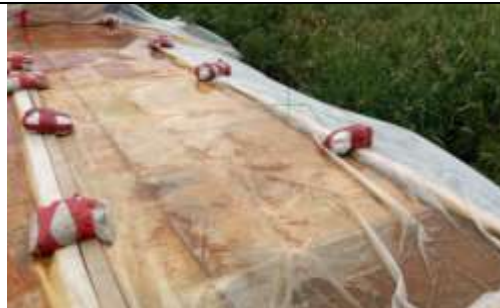
The dewatering system near KP 1092 observed to be functioning as intended.

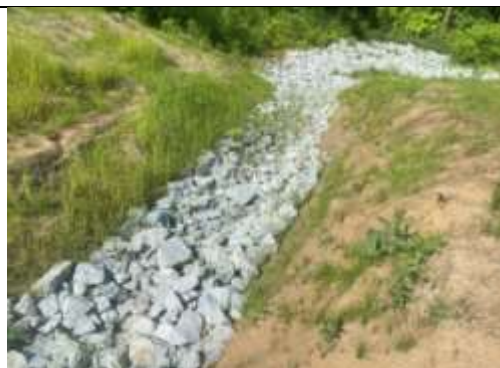
Re-installation of drainage observed during a substantial completion inspection with the Environmental Inspector and the contractor near KP 1158. No concerns were identified.

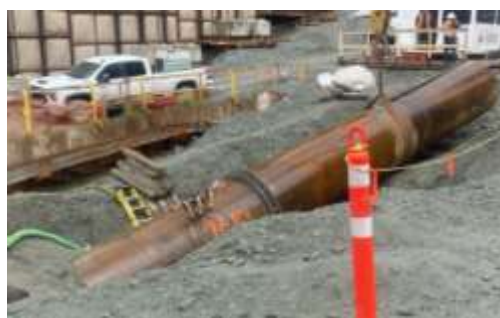
Preparation for HDD observed near KP 1145. No concerns were identified.

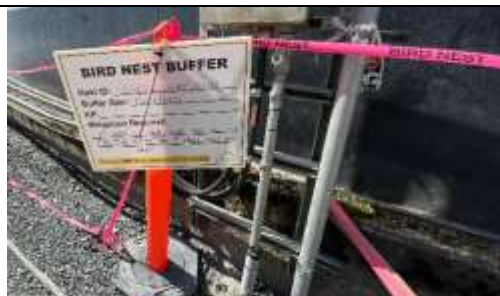
Bird nest signage and buffer observed near Tank 103 at Sumas Terminal.

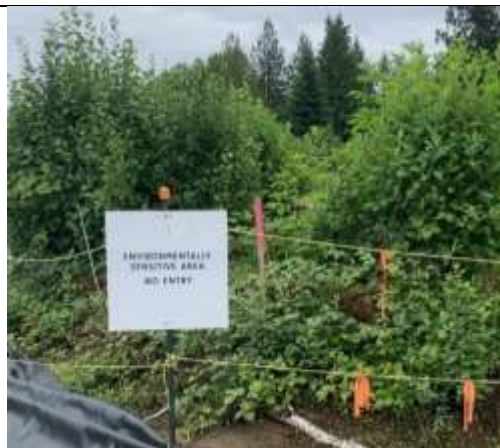
Environmental feature signage delineating an archaeological area inspected near KP 1153.
