# INDIGENOUS MONITOR OVERVIEW REPORT

**Month: May 2023**

**Project Region: Fraser Valley**

**Kilometre Posts (KPs) monitored:  
KP 1075–1165**

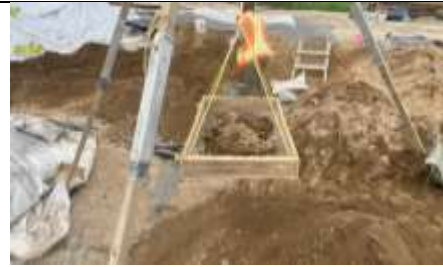
The Indigenous Monitors observed the implementation of an AIA conducted near KP 1127. The assessment, completed by a qualified archaeologist and Indigenous participants, may include visual inspection to identify features with predictable archaeological potential, surface inspection of areas with exposed sediments for cultural materials and shovel testing of terrain features exhibiting archaeological potential. No concerns were identified.

Soil from an evaluation unit sifted by the resource specialist observed near KP 1127.

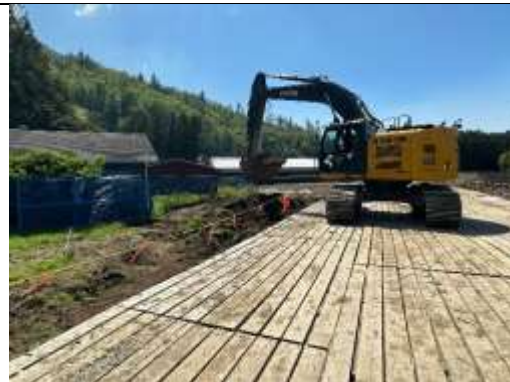
The Indigenous Monitor observed topsoil stripping and grading and observed measures during topsoil stockpiling in various areas including but not limited to KP 1088, KP 1089, KP 1091 and KP 1101. Near KP 1101, the Indigenous Monitor observed the resource specialist conduct topsoil depth checks. The Indigenous Monitors also inspected the construction areas before and after soil stripping to identify any potential chance finds. No potential chance finds were identified.

Topsoil being stripped near KP 1101 observed.

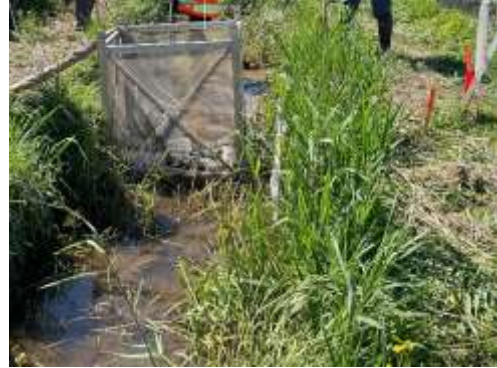
Near KP 1103, the Indigenous Monitor observed the resource specialist conduct a fish and amphibian salvage. Stickleback and coho fish, larvae and a Northwestern salamander were salvaged during inspection.

Fish and amphibian salvage observed near KP 1103.

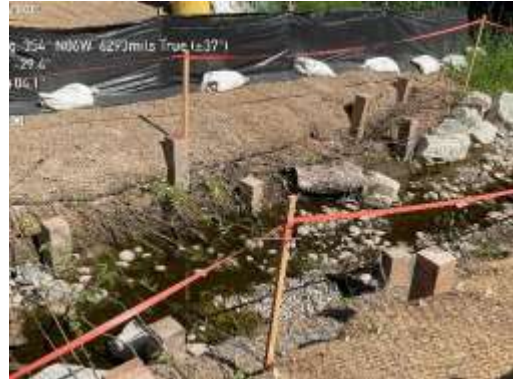
Near KP 1138, the Indigenous Monitor observed the reclamation of watercourse BC-748, including erosion and sediment measures such as silt fencing. No environmental concerns were identified.

Reclamation of BC-748 observed near KP 1138.

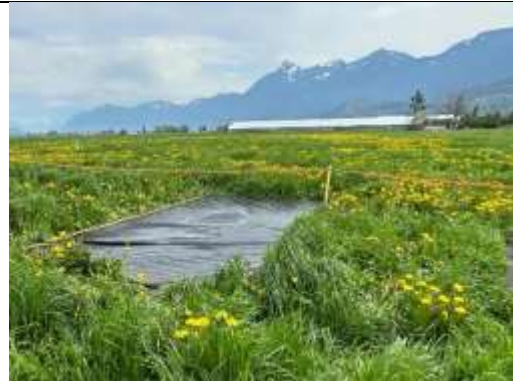
In various areas on Spread 6 and 7A, the Indigenous Monitor observed that water accumulating on-site was pumped off to a settling containment system and filter bags. Water flowing out of the filtration system was discharged upland to a well-vegetated area. The settling containment systems were inspected and functioning as intended and no sediment loading was identified at the discharge points.

The dewatering system near KP 1087 observed functioning as intended.

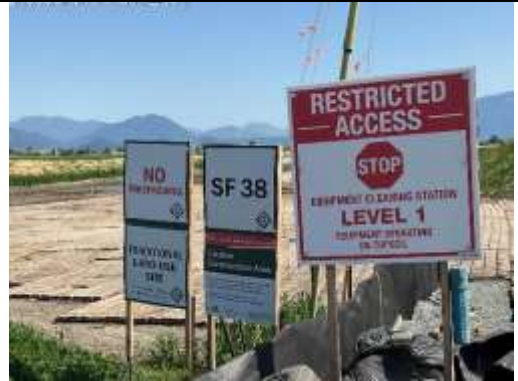
Environmental signage inspected near KP 1091.

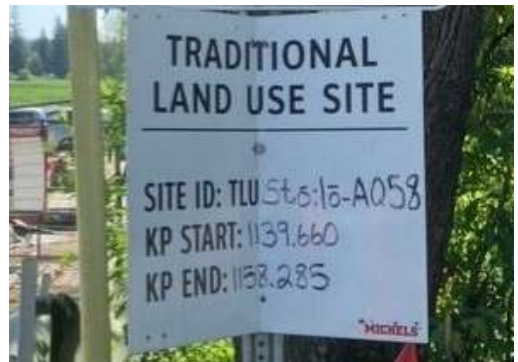
TLU signage inspected near KP 1139.

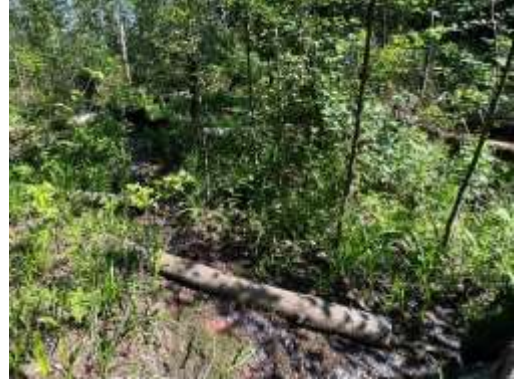
IFR walking pathway cleanup inspected near KP 1164.

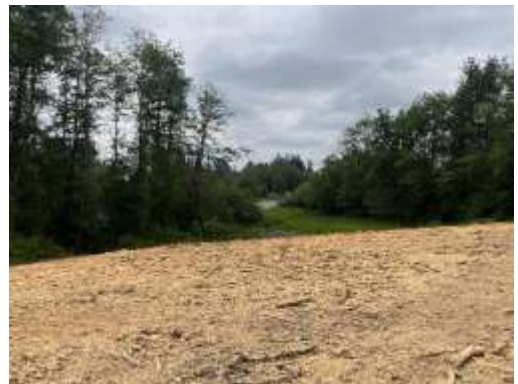
The Indigenous Monitors participated in inspections of environmental mitigations at the HDD crossings. Inspections included observing that signage and buffers were in place for environmental features, including archaeological sensitive areas, and that these areas were undisturbed during construction activities. Other environmental mitigations observed included inspection of Inadvertent Fluid Release (IFR) cleanup materials, ESC measures and participation in wildlife sweeps. The Indigenous Monitor worked alongside the Environmental Inspector near KP 1153 and 1164 to ensure the IFR walking pathway was being cleared of construction materials after work was complete. Near KP 1158, the Indigenous Monitor observed that sediment fencing had been removed and hydroseeding had occurred in the completed area. No concerns were identified.

Completed hydroseeding observed near KP 1158.
