# INDIGENOUS MONITOR OVERVIEW REPORT

**Month: November 2022**

**Project Region: Fraser Valley**

**Kilometre Posts (KPs) monitored:  
KP 1075–1165**

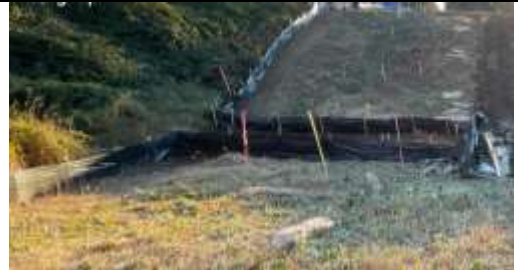
Near KP 1142, wildlife exclusion fencing was observed along BC-748a.

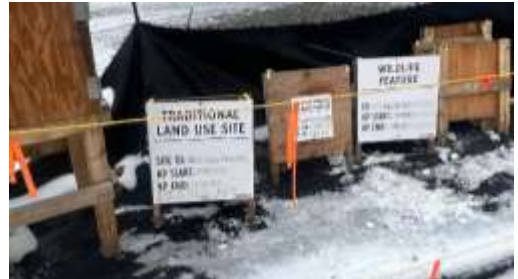
Indigenous Monitors inspect TLU sites with a focus on sites near active construction to ensure mitigation measures are in place to protect Traditional Land Use. Site locations inspected included KP 1112 (Sto:loAQ21, Sto:lo2013b, Sto:lo-2339, Sto:lo780), KP 1132 (Sto:lo1614X) and KP 1135 (Sto:loAQ32). Signage was in place and the area was staked and flagged. No concerns were identified during the inspection.

Environmental feature signage inspected near KP 1135.

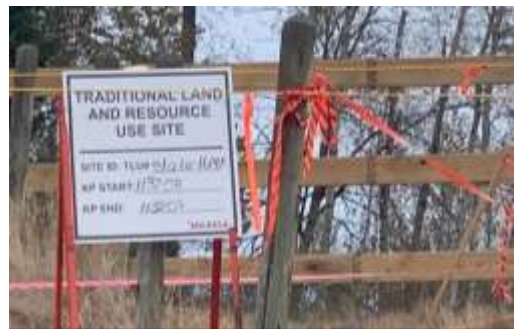
Environmental feature signed inspected near KP 1132.

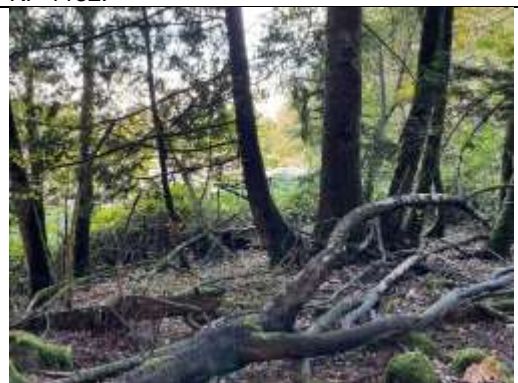
The Indigenous Monitor conducted CMT walk-throughs from KP 1080 to KP 1079 and near KP 1097. No potential CMTs were identified.

Area swept for CMTs between KP 1080.300 and KP 1079.00.

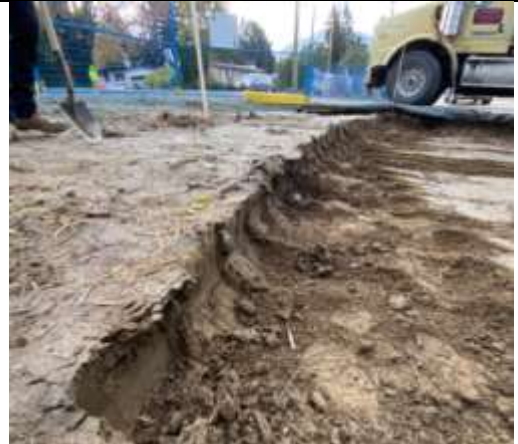
At locations near KP 1076, KP 1077, KP 1084 and KP 1096, Indigenous Monitors were involved in monitoring and inspecting such soil salvage mitigations. They confirmed topsoil was separated and labelled and piles remained inside the construction footprint.

Topsoil stripped near KP 1096 to 30 cm as prescribed by the Resource Specialist.

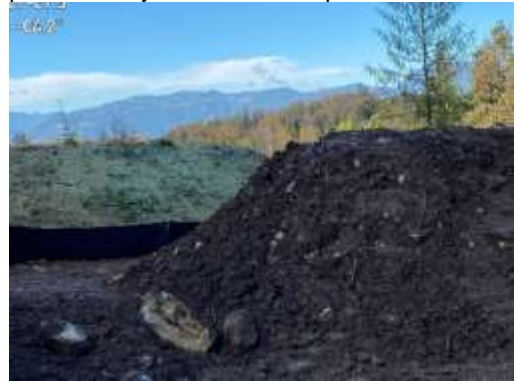
Topsoil pile and surrounding sediment fence observed near KP 1176.

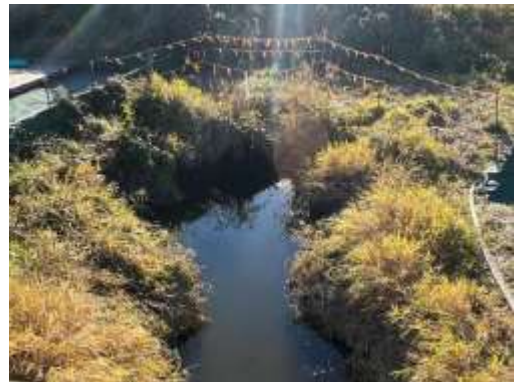
Near KP 1142 (watercourse BC750) and KP 1152 (watercourse BC766), the Indigenous Monitors observed the Resource Specialist conduct water quality sampling for turbidity upstream and downstream of construction activity. At watercourse BC766, no environmental concerns regarding water quality were observed during the time of inspection.

Watercourse BC-766 near KP 1152 flowing clear and clean.

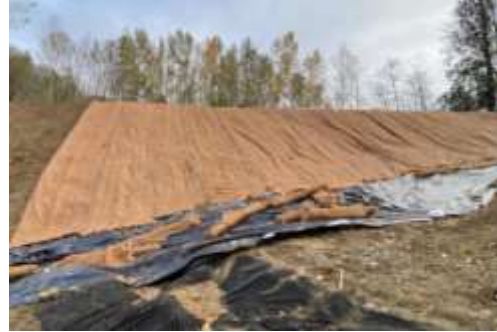
Near KP 1116, the Indigenous Monitor observed and inspected the installation of coco matting on top of topsoil windrows to reduce erosion. After installation, the Indigenous Monitor observed that any excess ESC material was cleaned up and the site was left tidy, as per the Environmental Protection Plan.

Coco matting being installed on top of a topsoil windrow to prevent sluffing and erosion at KP 1116.

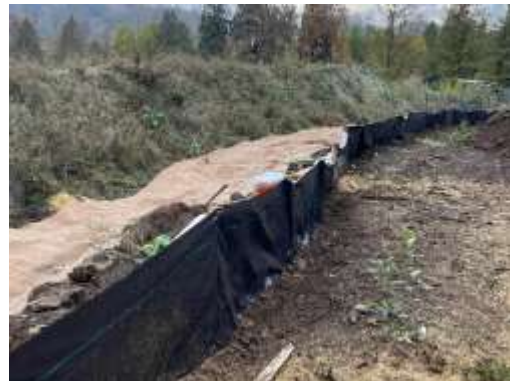
Near KP 1076, the Indigenous Monitor participated in a site walk-through and observed the installation of ESC measures around the area where a borehole will be installed. No deficiencies were identified during the inspection.

Near KP 1076 sediment fencing, straw wattles, and coco matting installed for ESC measures.

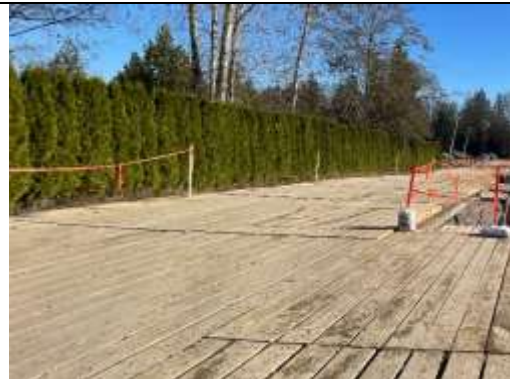
Indigenous Monitors conducted housekeeping inspections at KP 1109 and KP 1142. Garbage and recycling receptacles were observed in good standing order and secondary containment measures were in place.

KP 1142 site inspected and housekeeping in good order.

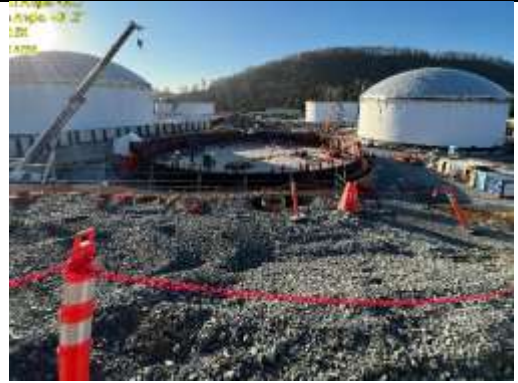
Building of new tank at Sumas Terminal.
