INDIGENOUS MONITOR OVERVIEW REPORT

Month: October 2022

Project Region: Fraser Valley

**Kilometre Posts (KPs) monitored:
KP 1075–1165**

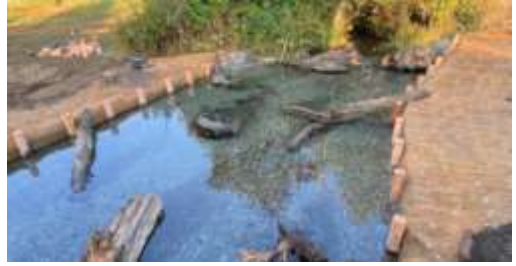
Indigenous Monitors observed watercourse BC 720 at KP 1101 to inspect the completed stream bank restoration, observed site housekeeping efforts, transplant areas, erosion and sediment control (ESC) and stream bed material replacement. Replacement of topsoil in the riparian buffer zone was also observed. No deficiencies were identified during inspections.

Positive inspection of the stream bed restoration of watercourse BC720.

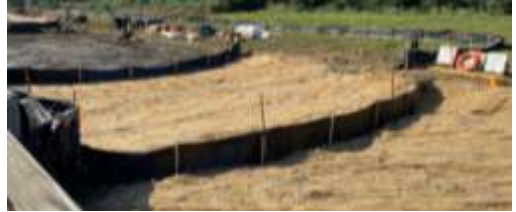
ESC measures observed for the restoration of BC720, including sediment and exclusion fencing with seed placed underneath coconut matting.

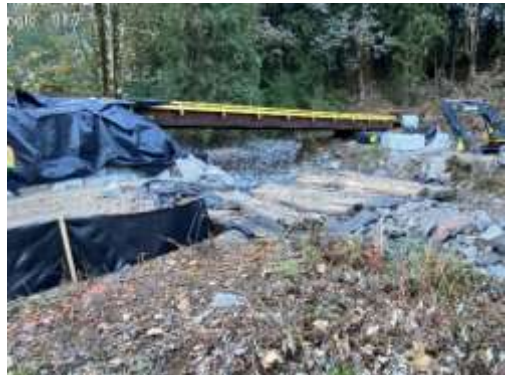
At Anderson Creek (watercourse BC705) near KP 1075, the Indigenous Monitor observed the contractor install a clear span bridge and cover it with geotextile fabric to keep construction debris from entering the watercourse.

Geotextile fabric is placed on top of the bridge as an ESC mitigation measure near KP 1075.

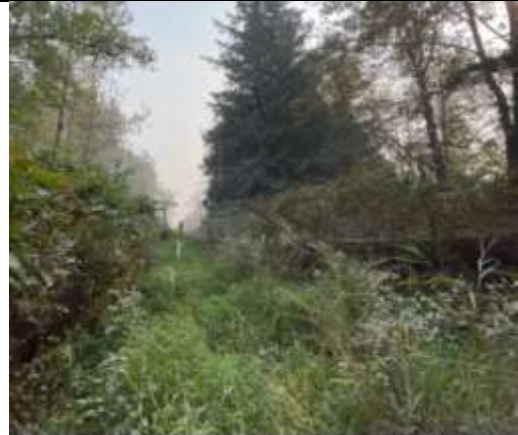
Area swept for CMTs near KP 1113. No CMT were identified during walk-through.

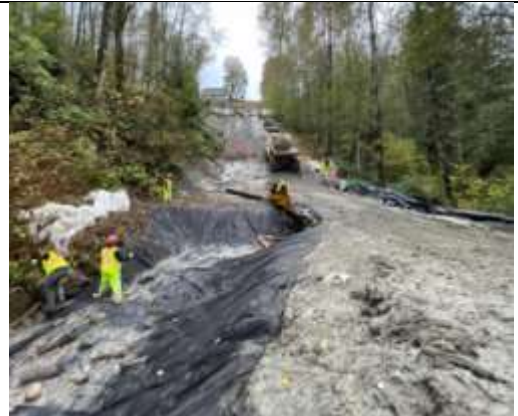
Indigenous Monitors observed the contractor prepare for in-stream work at watercourse BC730 near KP 1118, which included installation of sediment cloth and placement of dewatering hoses and pumps. In-stream work is planned for November and restoration is anticipated to be completed shortly afterwards. No issues were identified during inspection.

Sediment cloth being placed near KP 1118.

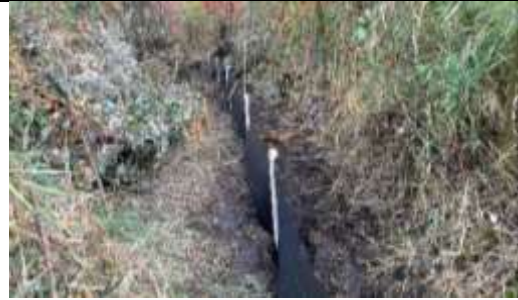
Amphibian exclusion fencing installed by the Resource Specialist near KP 1075.

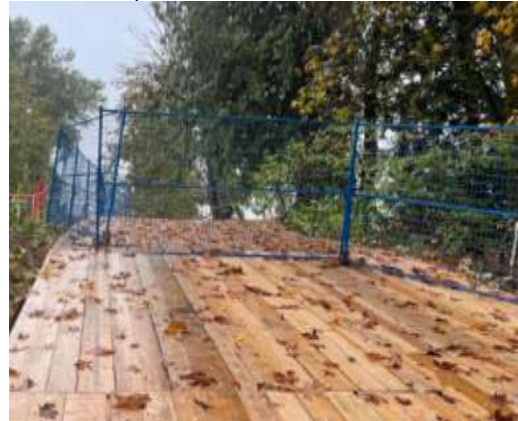
Near KP 1142, the Indigenous Monitor inspected wildlife mitigations including fencing installed to delineate an owl sanctuary and observed amphibian exclusion fencing near KP 1075. No issues were identified during inspection.

Fencing installed to delineate an owl sanctuary and prevent trespass inspected near KP 1142.

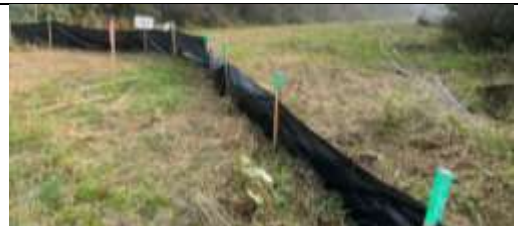
Sediment fence observed during a pre-construction walk-through near KP 1115.

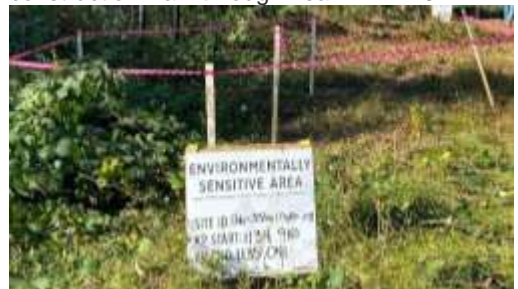
Near KP 1135 environmental feature buffer and signage was inspected.

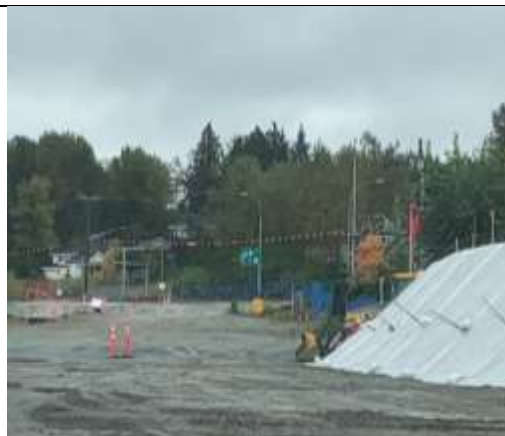
KP 1161 site inspected and housekeeping in good order.

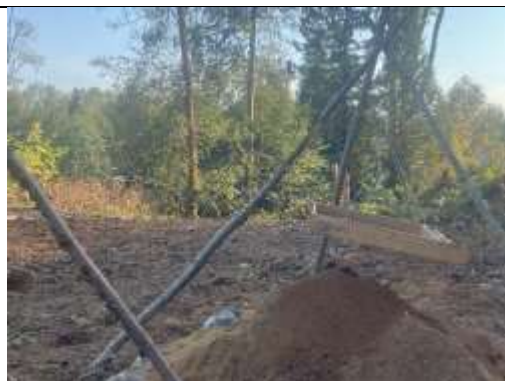
Soil being sifted by the Archaeological Resource Specialist during subsurface testing near KP 1162.

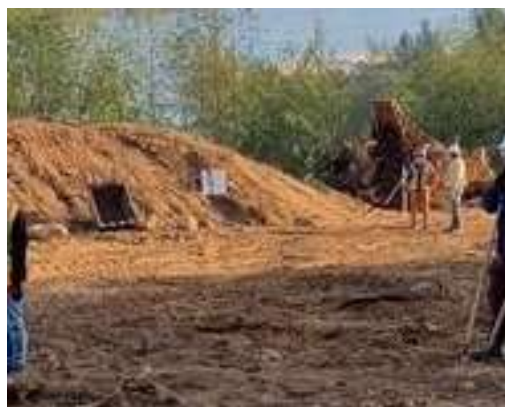
At KP 1164, Indigenous Monitors observed construction activity, including topsoil stripping, alongside the Archaeological Resource Specialist

Archaeological Resource Specialist raking area stripped of topsoil near KP 1164.
