INDIGENOUS MONITOR OVERVIEW REPORT

Month: January 2022

**Project Region: Jasper to Mount
Robson Reactivation**

**Kilometre Posts (KPs) monitored:
KP 322–461**

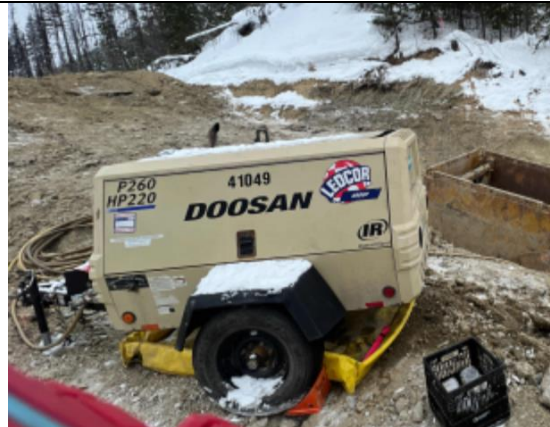
Spill containment in place at Dig 51 KP 440.

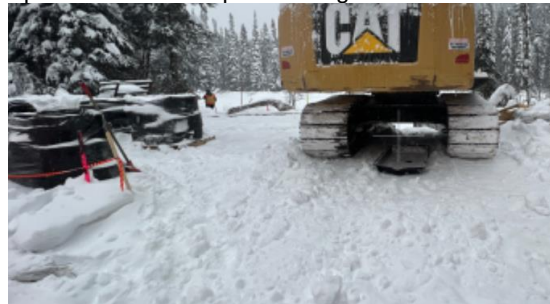
Spill containment in use, material delineated Fraser2 KP 423.

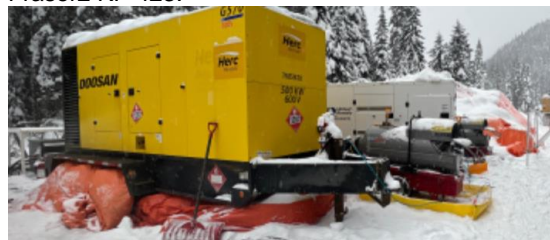
Spill containment in use at KP 423.

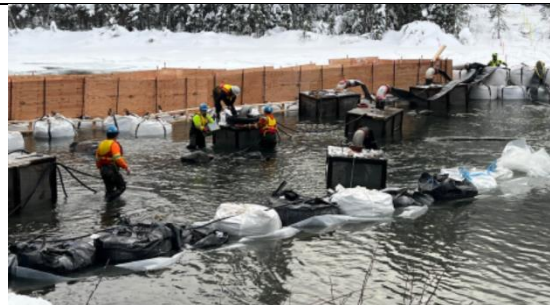
Pumps in stream at Fraser 2 KP 423.

Indigenous monitors communicated regularly with the on-site resource specialists, confirming the pumps are maintaining flow and that downstream turbidity levels are acceptable.

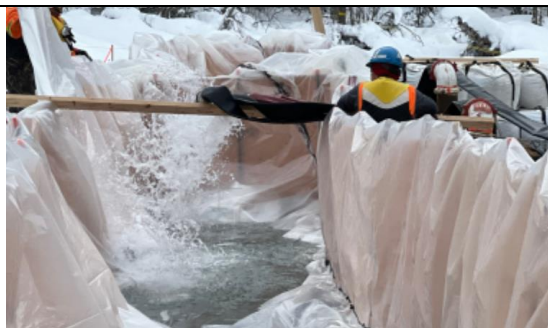
Indigenous Monitors inspected to confirm that mitigation measures were in place during construction at Fraser 2. The watercourse crossing plans were executed as intended and no unplanned events occurred during construction on Fraser 2.

Coffer dams controlling water turbidity Fraser 2 KP 423.

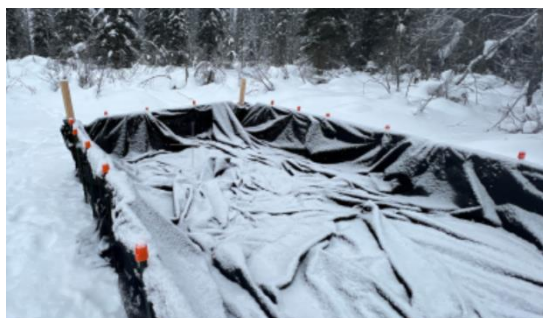
At dig 46 (KP 432), an Indigenous Monitor reviewed the Site-Specific Wetland Crossing Execution Plan. In saturated soil, pump-off is a regular requirement to keep excavations open and safe. The prepared pump-off location was inspected prior to and during pump-off activity. The Indigenous Monitor inspected to ensure no sediment loading occurred, replacement materials were available and the pump-off location was at least 50 m from the nearest watercourse in a location approved by an Environmental Inspector. The Indigenous Monitor will continue to inspect the site and monitor dewatering activities throughout the duration of the crossing. No environmental concerns were identified.

Sediment trap constructed for pump-off at Dig 46 KP 432.

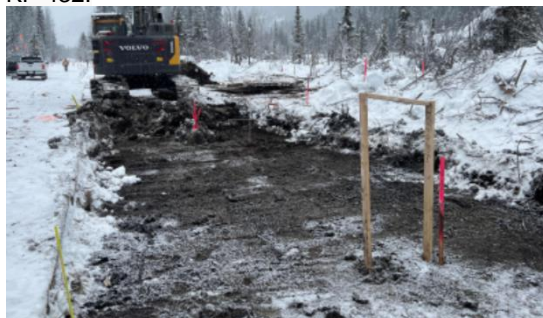
Topsoil stripping underway at Dig 46 KP 432

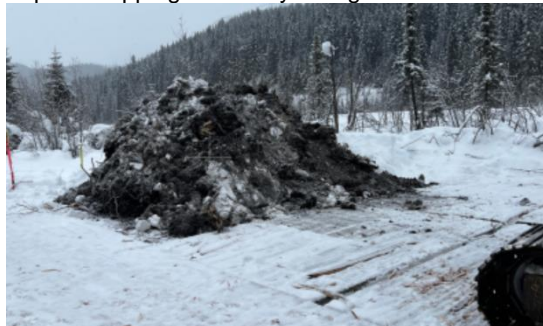
Topsoil separated and within the limits of the right-of-way at Dig 46 KP 432
