## INDIGENOUS MONITOR OVERVIEW REPORT

**Month: December 2022**  
**Project Region: North Thompson**  
**(Spread 3/4A and Spread 4B)**

**Indigenous Monitor days on-site: 26**  
**Kilometre Posts (KPs) monitored:**  
**Spread 3/4A: KP 470–696**  
**Spread 4B: KP 697–764**

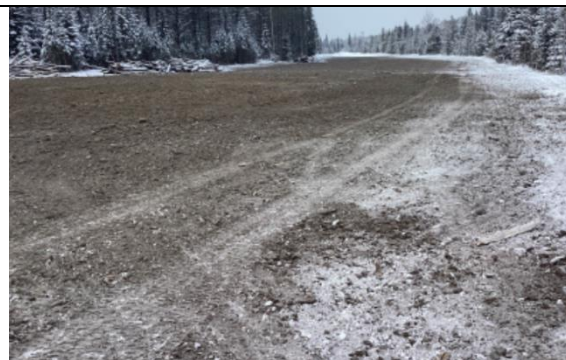
Indigenous Monitors were on-site inspecting various reclamation activities, including discing for soil decompaction, topsoil replacement, confirming topsoil depth and seeding. Indigenous Monitors were engaged in conversations with crews and EIs in all stages of reclamation. No deficiencies were found.

Reclamation KP 521.

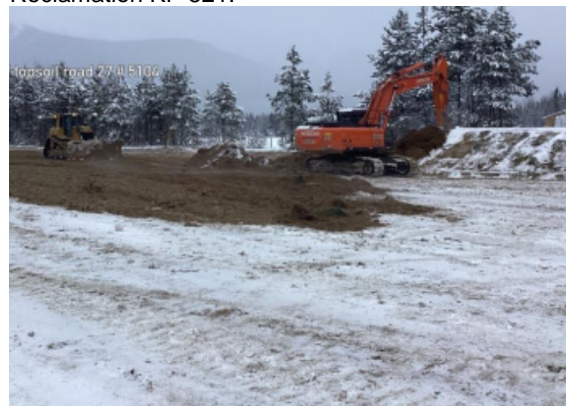
Topsoil replacement KP 525.

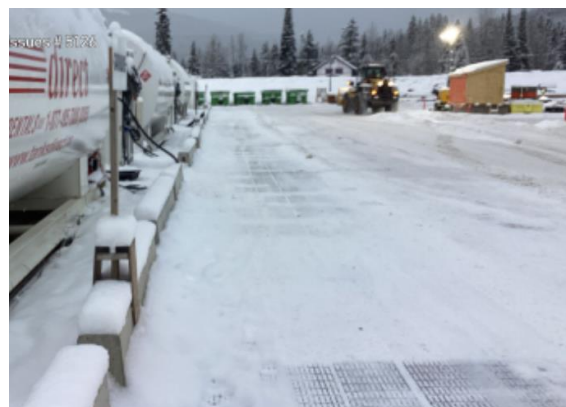
The inspection included housekeeping and waste management with corrective actions noted, including proper waste disposal and using drip trays. In addition, spill kits and spill response procedures were reviewed and implemented at the site. Loose miscellaneous debris was identified and disposed of during the inspection.

Blue River yard inspection KP 611.

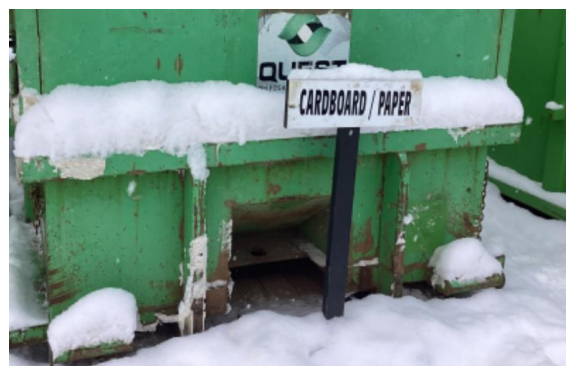
Blue River Camp inspection KP 611.

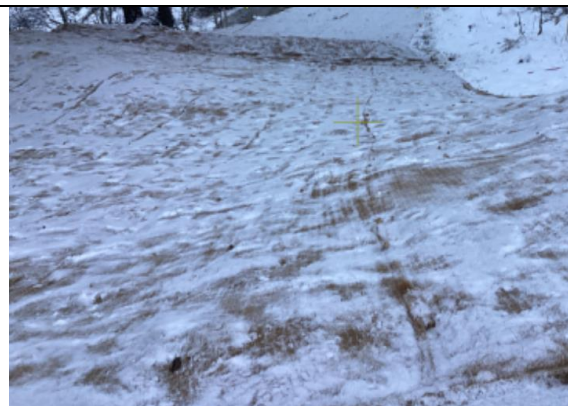
An Indigenous Monitor performed an inspection of ESC measures near KP 750. Coco matting was installed on the hill to help protect and retain sediment. This area was hydroseeded. When vegetation is re-established, it will act as primary ESC. No issues or environmental concerns were identified during the inspection.

Coco matting installed at KP 704.

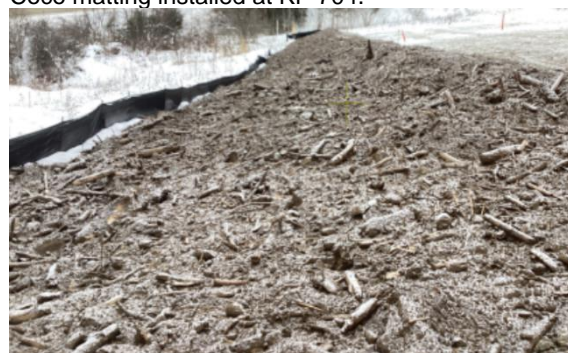
CWD installed at KP 747.

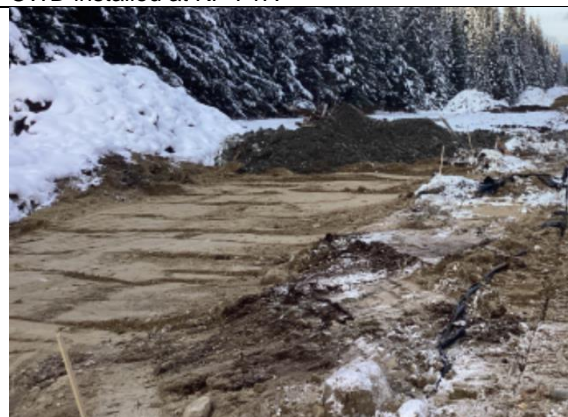
Backfill complete at KP 615.

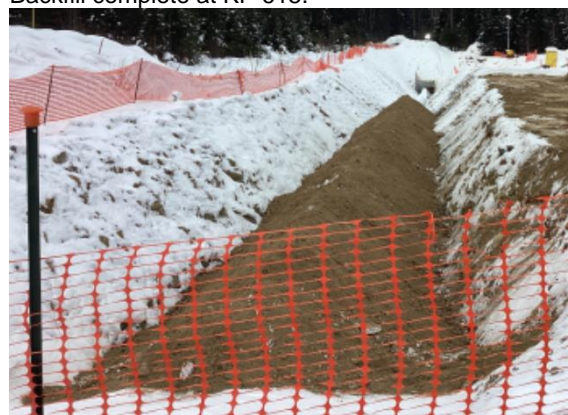
Backfill in progress at KP 554.

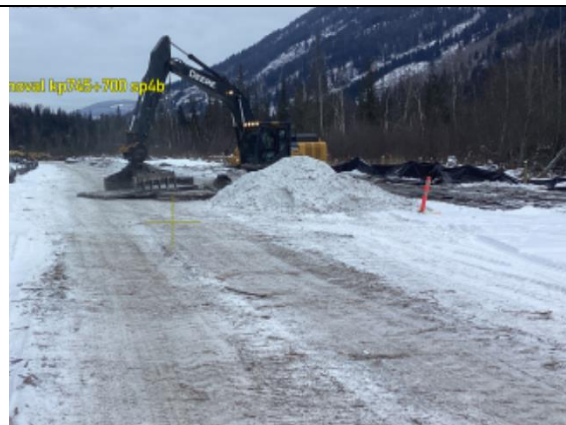
Indigenous Monitor observations during matting removal at KP 745 included good housekeeping practices, debris removal, proper signage and work remained within boundaries of the right-of-way. Mats removed from the area are stockpiled until required in another Project area. No concerns were identified.

Mat removal KP 745.
