## INDIGENOUS MONITOR OVERVIEW REPORT

**Month: January 2023**

**Project Region: North Thompson  
(Spread 3/4A and Spread 4B)**

**Kilometre Posts (KPs) monitored:  
Spread 3/4A: KP 470–696  
Spread 4B: KP 697–764**

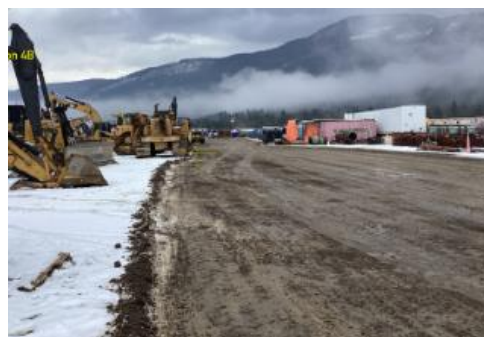
The inspections included housekeeping and waste management, including proper waste disposal and using drip trays. In addition, spill kits and spill response procedures were reviewed at site. Loose miscellaneous debris was identified and disposed of during the inspection.

Vavenby yard inspection KP 697.

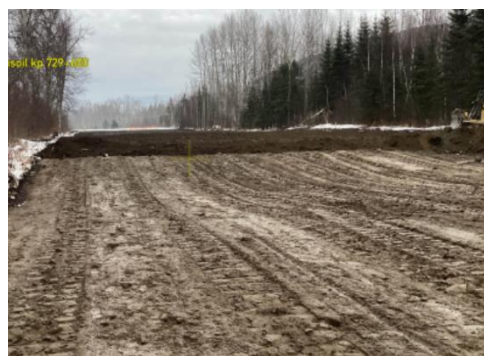
Indigenous Monitors were on-site inspecting various reclamation activities, including discing for soil decompaction, topsoil replacement, confirming topsoil depth and confirmation that proper seed mixes are applied. Indigenous Monitors were engaged in conversations with crews and EIs in all stages of reclamation. No deficiencies were found.

Topsoil replacement and reclamation at KP 729.

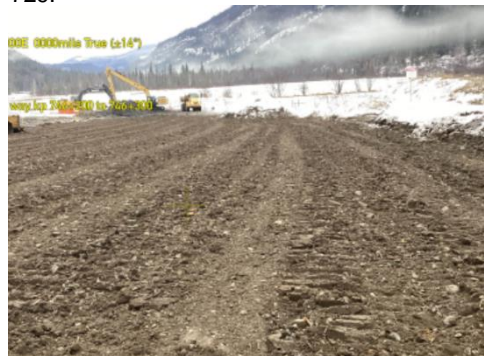
Reclamation ongoing at KP 746.

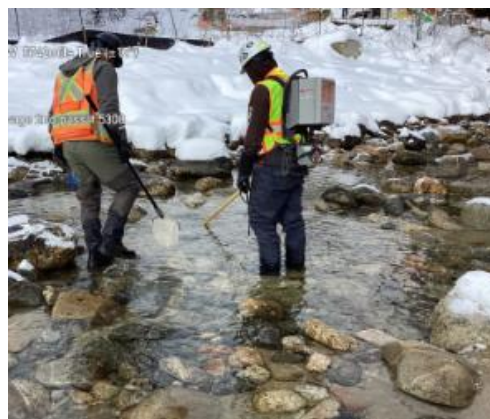
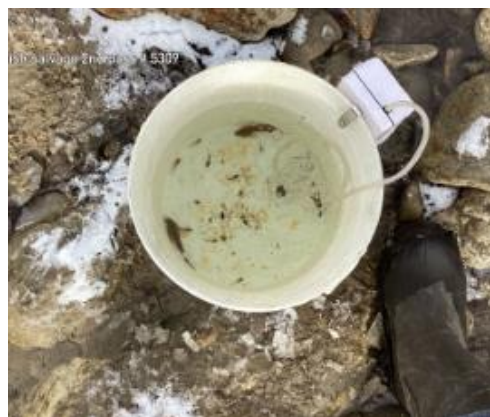
Indigenous Monitors also observed and assisted with the fish salvage conducted by Environmental Resource Specialists. Several fish were salvaged and released downstream of the crossing. No environmental concerns were identified.

Fish salvage Finn Creek BC 201 KP 633.

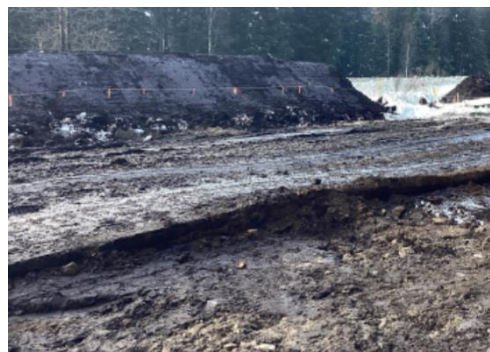
The Indigenous Monitors noted mitigations for topsoil piles to reduce erosion potential, including grading, separation of wetland soils from upland soils and shaping of piles to prevent erosion. Inspections were conducted for the excavated soil placed in the trench over the installed pipe. The Indigenous Monitors observed sand and subsoil being backfilled over the pipe prior to topsoil being replaced and noted backfill activities were confined to the construction right-of-way. No issues or potential chance finds were identified.

Topsoil stripping, prep for trenching at KP 634 BC-202a.

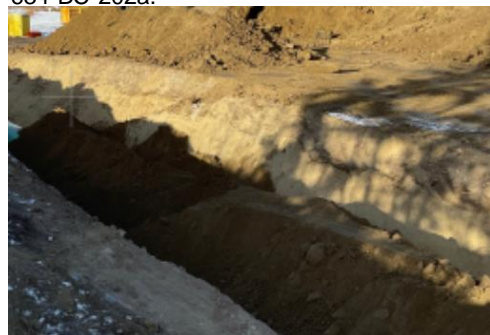
Backfill in progress at KP 554.
