INDIGENOUS MONITOR OVERVIEW REPORT

Month: January 2022

**Project Region: North Thompson
(Spread 3/4A and Spread 4B)**

Indigenous Monitors on the Trans Mountain Expansion Project – Overview

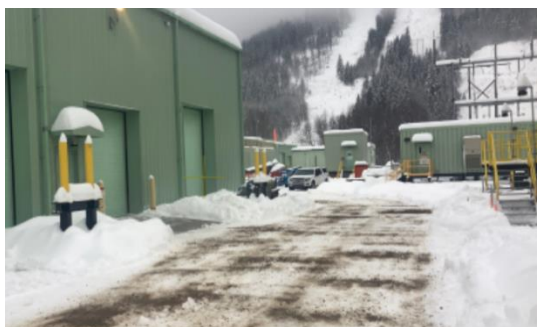
Indigenous Monitors followed up on preparation for shipping of historically contaminated soil from Blackpool Pump Station, which was reported on in December. A change in the plan was noted, that the contaminated soil will be hauled out in spring and has been appropriately isolated. Snow clearing and electrical work, sandblasting and coating were the primary construction activities. No environmental concerns were identified at the time of inspection.

Blackpool Pump Station KP 732.

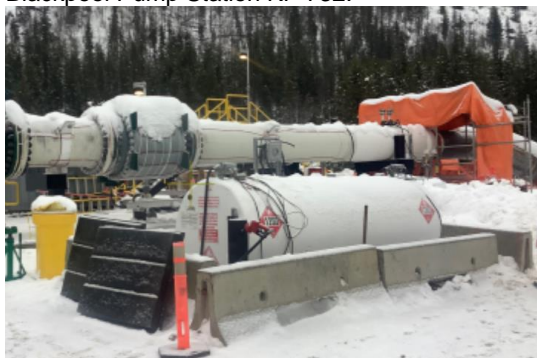
The inspection at the McMurphy Pump Station highlighted trailers being moved west of the pump station onto an area of the right-of-way to make room for ongoing construction. A Corrective Action was submitted to the General Construction Contractor (GCC) for proper waste separation. The Indigenous Monitor followed up to ensure that this corrective action was completed. Backfill was underway on the east side of the pump station site.

McMurphy Pump Station KP 667.

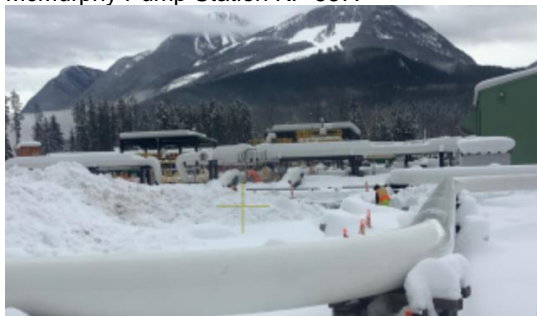
The Blue River Pump Station inspection noted electrical and sandblasting/coating crews working on-site. Waste separation was inspected with no deficiencies. A large snow pile had accumulated from clearing snow that had gravel in it. The GCC had been tasked with installing erosion and sediment control measures around the pile before it melts to prevent sediment from leaving the right-of-way. The Indigenous Monitor returned to confirm completion of the corrective action.

Blue River Pump Station KP 610.7

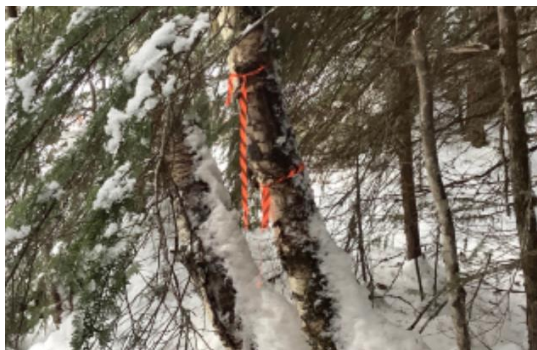
Near KP 634, the Indigenous Monitor participated in the implementation of the TLU Site Discovery Contingency Plan in areas where trees were identified as potentially culturally modified trees (CMT). Indigenous Monitors continue conducting CMT sweeps ahead of construction activity. Trees found during a CMT sweep were examined by the Indigenous Monitors and Environmental Inspectors on-site to collect initial information. The area was flagged off for additional evaluation. Resource specialists were contacted for evaluation of the tree and potential mitigation. The engagement process with applicable Indigenous groups was initiated to share information about the resource and seek feedback. The assessment of this resource is in progress.

Chance find CMT flagged and buffered KP634.

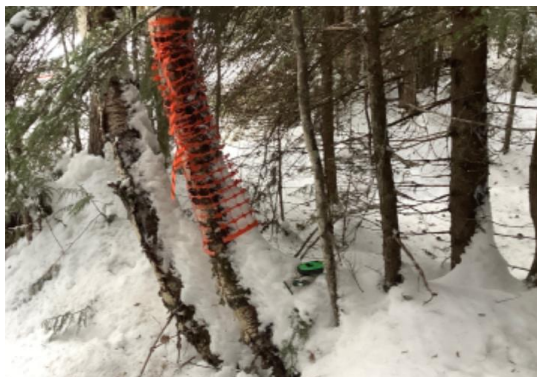
Chance find CMT after chance find procedure was completed and marked with snow fence KP 634.

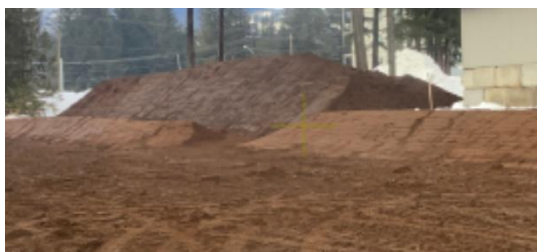
At KP 718, Indigenous Monitors were involved in monitoring the salvage and placement of topsoil and subsoil and were available if any potential heritage resources or items of traditional land use interest are unearthed during soil stripping operations. During the inspection, the Indigenous Monitor confirmed the soil piles were within the surveyed limits and no potential chance finds were identified.

Soil separated and labelled at SF45 KP 718.

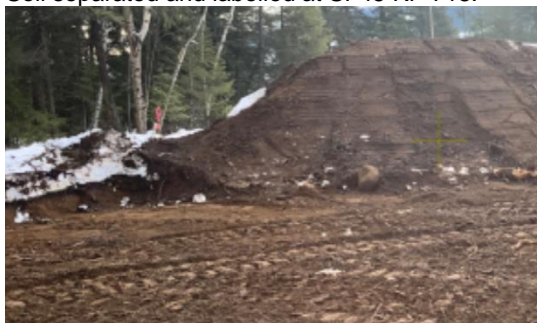
Soil pile inside limits of right-of-way SF45 KP 718.

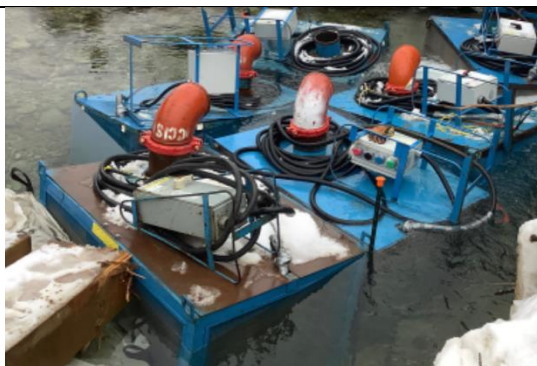
Pumps with fish screens in stream at Froth Creek BC 189 KP 622.

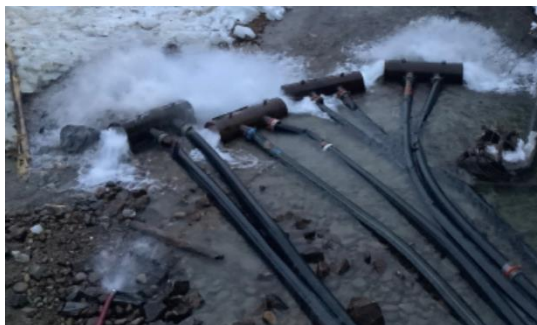
Downstream at Swift Creek BC 32 KP 518.

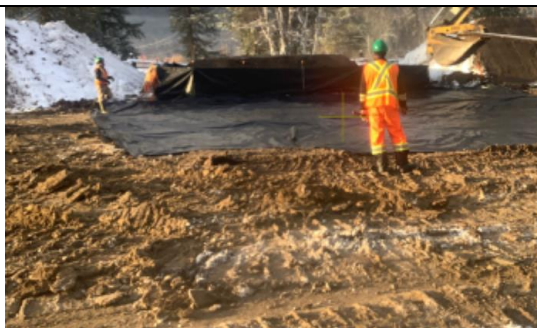
Near KP 713, an Indigenous Monitor inspected TLU areas and archaeological sites to verify the staking and boundaries. The process to ensure delineation and understanding of archaeological sites and mitigation measures were reviewed by the Environmental Inspector, Indigenous Monitor, construction contractor and surveyors. The inspected sites were matted over and excavation near these sites has taken place. Ongoing monitoring by the Indigenous Monitor continues at these sites.

Preparing to mat over heritage site to mitigate impact.

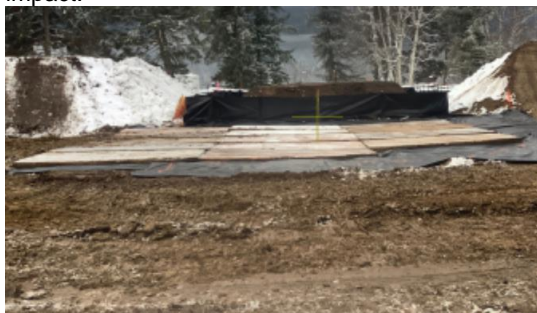
Ongoing matting efforts at heritage site.
