## INDIGENOUS MONITOR OVERVIEW REPORT

**Month: July 2022**

**Project Region: North Thompson  
(Spread 3/4A and Spread 4B)**

**Kilometre Posts (KPs) monitored:  
Spread 3/4A: KP 470–696  
Spread 4B: KP 697–764**

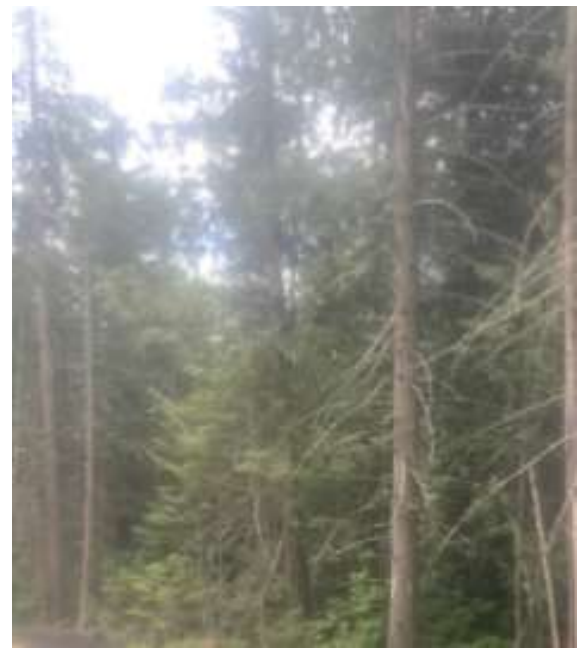
An Indigenous Monitor inspected the site of a previously identified CMT near KP 640. The site-specific mitigations were followed as described in the Resource Specific Mitigation Table. No concerns were identified during the inspection. If a potential CMT were identified, the TLU Site Discovery Contingency Plan would be implemented. Indigenous Monitors continue conducting CMT sweeps ahead of construction activity.

General area of CMT monitoring.

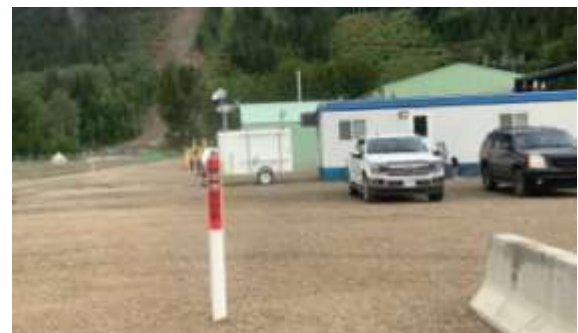
Blackpool Pump Station KP 732.

At the Blackpool Pump Station (KP 732), soil was being hauled in for final grade work and fence installation was underway. The indigenous monitor confirmed that proper housekeeping and waste separation were in use and that the mitigations for active bird nests were in place, including buffer zones and signage. No concerns were identified.

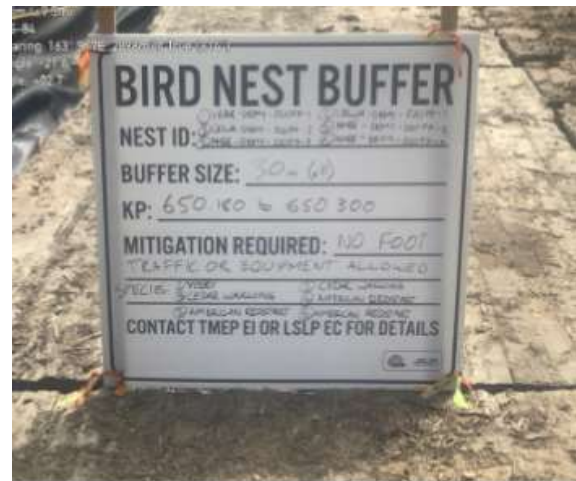
Bird buffer signage in place KP 650.

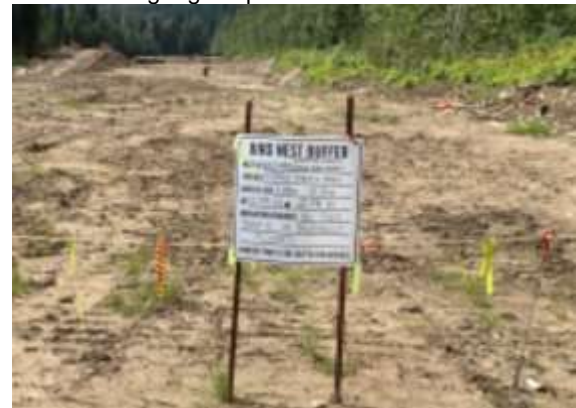
Bird nest chance find near KP 578.

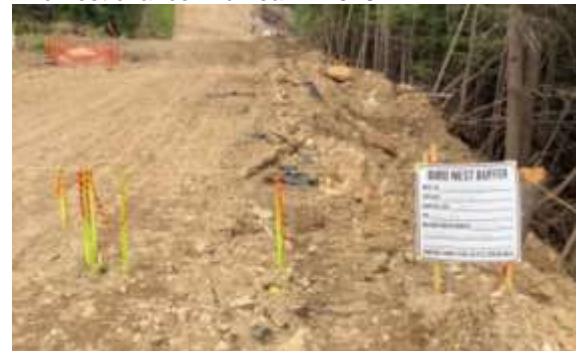
Bird nest buffer KP 602.

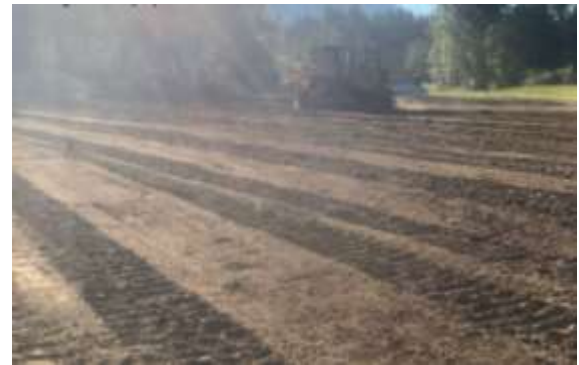
Topsoil replacement KP 715.

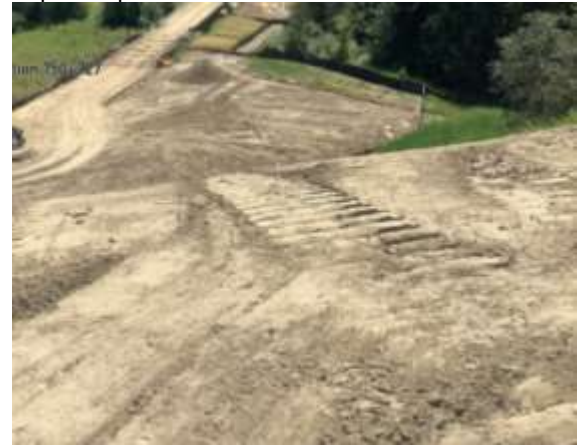
Reclamation ongoing KP 750.

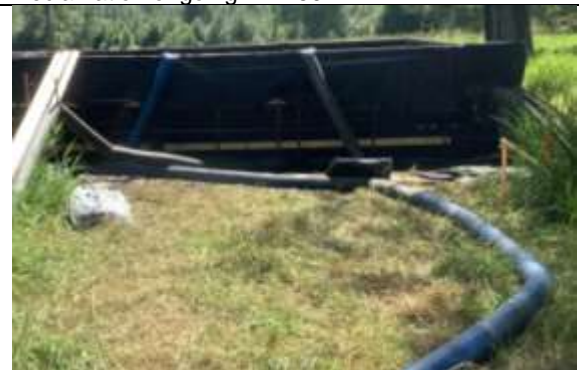
An Indigenous Monitor inspected to ensure the settling containment system was functioning as intended and that no sediment loading was identified at the discharge point. It was observed that pump-off water was released a minimum of 50 m from the nearest watercourse, replacement materials were readily available, including sediment control devices, pumps, spills kits and secondary containment, and housekeeping of off-construction footprint locations. No deficiencies were identified.

Pump-off sediment containment working as intended at Lemieux Creek KP 744.

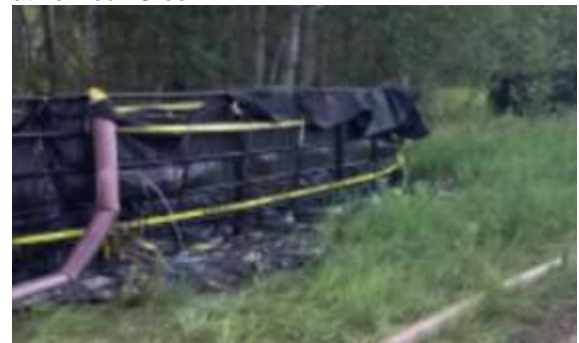
Pump-off location KP 739.

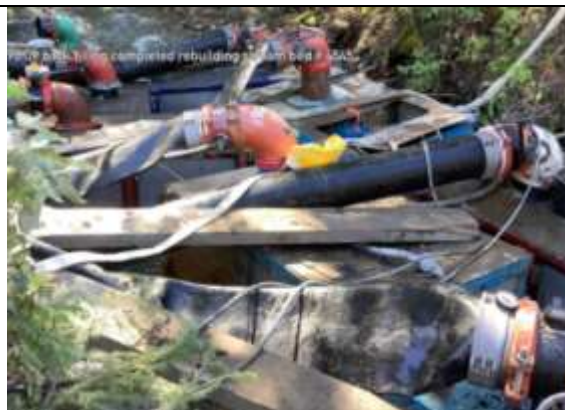
An Indigenous Monitor observed the contractor prepare and execute in-stream work at BC-3 KP 490. The upstream water was diverted downstream of the crossing area to maintain natural flow conditions and water quality. The Indigenous Monitor talked with the Resource Specialist about water quality monitoring during in-stream work, and observed and assisted with fish salvage and restoration. During stream bank and bed restoration, Indigenous Monitors discussed with the Resource Specialist the efforts made to recreate fish habitat using various-sized rock. No environmental concerns or deficiencies were found during these inspections.

Pumps instream BC-3 KP 490.

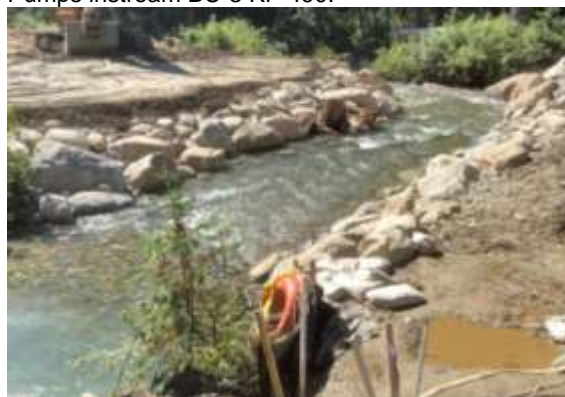
Restoration work BC-3 KP 490.
