## INDIGENOUS MONITOR OVERVIEW REPORT

**Month: June 2022**

**Project Region: North Thompson  
(Spread 3/4A and Spread 4B)**

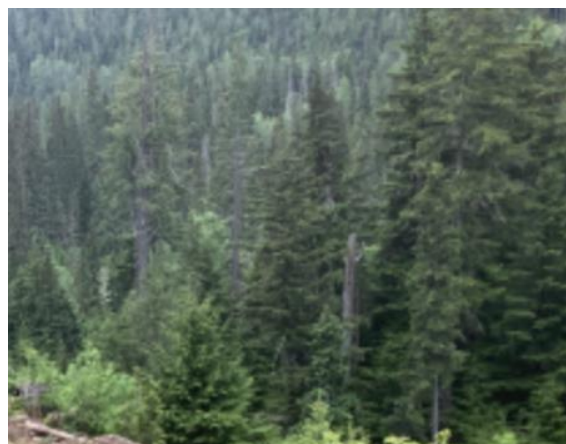
General area of CMT sweeps.

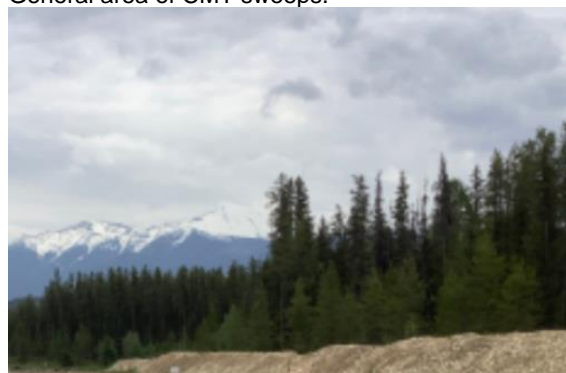
General area of CMT sweeps.

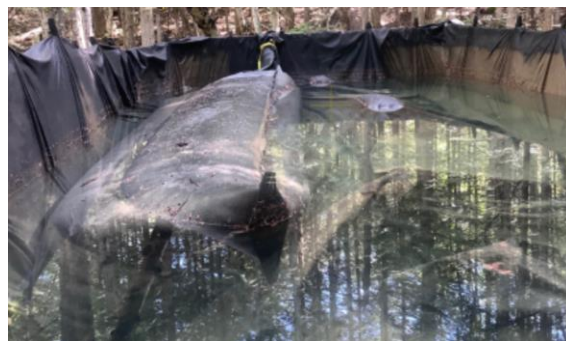
An Indigenous Monitor inspected to verify the settling containment system was functioning as intended and that no sediment loading was identified at the discharge point. It was observed that pump-off water was released a minimum of 50 m from the nearest watercourse, replacement materials were readily available, including sediment control devices, pumps, spills kits and secondary containment, and housekeeping of off-construction footprint locations. No deficiencies were identified.

Pump-off sediment containment working as intended at KP 742.

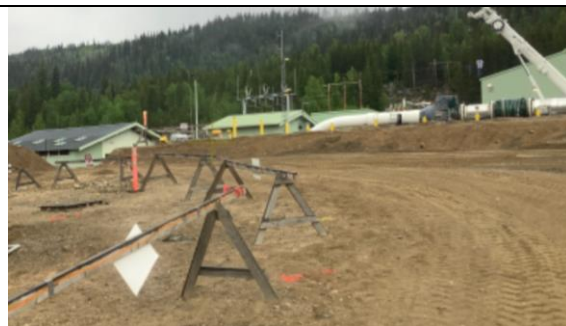
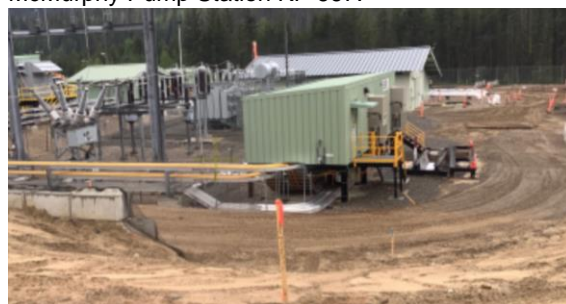
McMurphy Pump Station KP 667.

During the inspection at the McMurphy Pump Station (KP 667.2), bear safety was a focus after a black bear and cubs were sighted in the area. IMs inspected waste segregation, with a focus on food waste, and was confirmed to be compliant with waste handling procedures. Open excavations were properly delineated with signage, snow fencing and larger physical barriers when needed. Erosion and sediment control measures were inspected and observed to be in good repair. No concerns were identified.

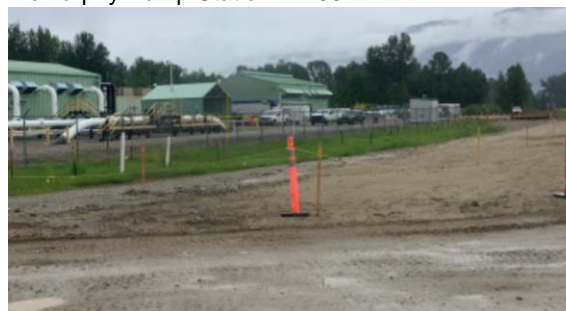
Blackpool Pump Station KP 732.

At the Blackpool Pump Station (KP 732), soil was being hauled in for final grade work and fence installation was under way. The Indigenous Monitor confirmed that proper housekeeping and waste separation were in use and that mitigations for active bird nests were in place, including buffer zones and signage. No concerns were identified at the time of inspection.

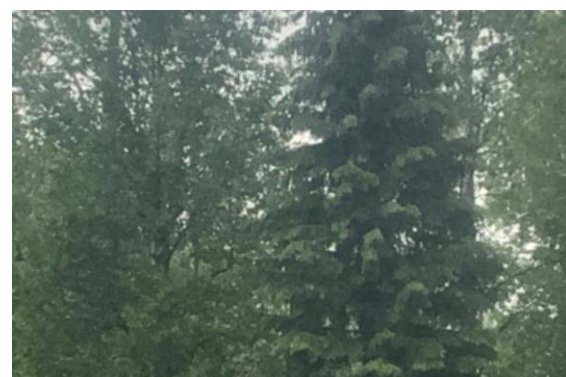
Bird sweeps KP 652.

Resource Specialists performed sweeps in all areas where active construction is or will soon be underway. An Indigenous Monitor joined bird sweeps between KP 478 and KP 652. After bird sweeps were completed, the Indigenous Monitor and Environmental Inspectors confirmed that proper buffers and signage were in place and continue to communicate daily about active bird nest locations and mitigations. During one inspection, the signage for a buffer zone was down and the Indigenous Monitor replaced it at that time. No other issues were identified.

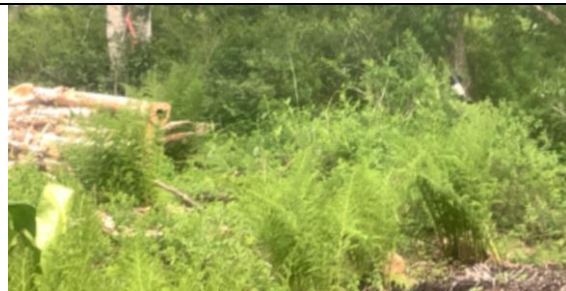
Bird nest chance find near KP 561.

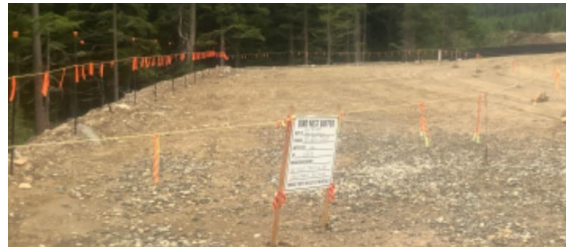
Bird nest buffer KP 635.

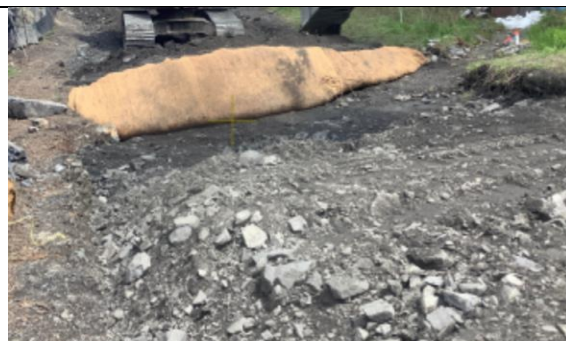
An Indigenous Monitor observed and inspected cleanup and restoration activities at Unnamed Channel BC-328. Activities observed included site housekeeping efforts, recontour of the bank, transplant areas including erosion control blanket, willow stakes in riparian zones, re-seeding in previously excavated and backfilled areas and rock armouring and stream bed

Stream bed restoration BC-328 KP 641.

material replacement. These mitigations were installed and working as planned. No deficiencies were identified.

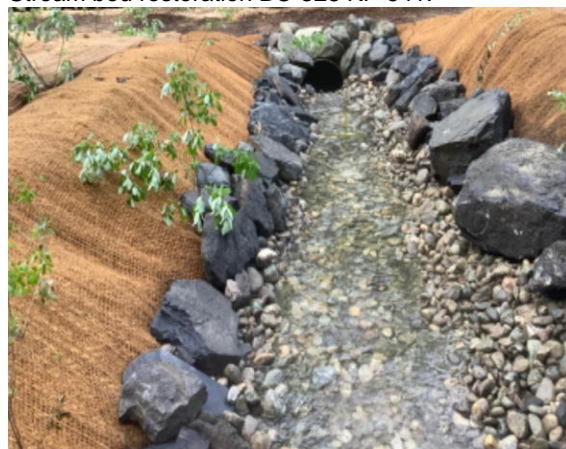
Restoration complete BC-328 KP 641.
