INDIGENOUS MONITOR OVERVIEW REPORT

Month: November 2022
Project Region: North Thompson
(Spread 3/4A and Spread 4B)

Indigenous Monitors on the Trans Mountain Expansion Project – Overview

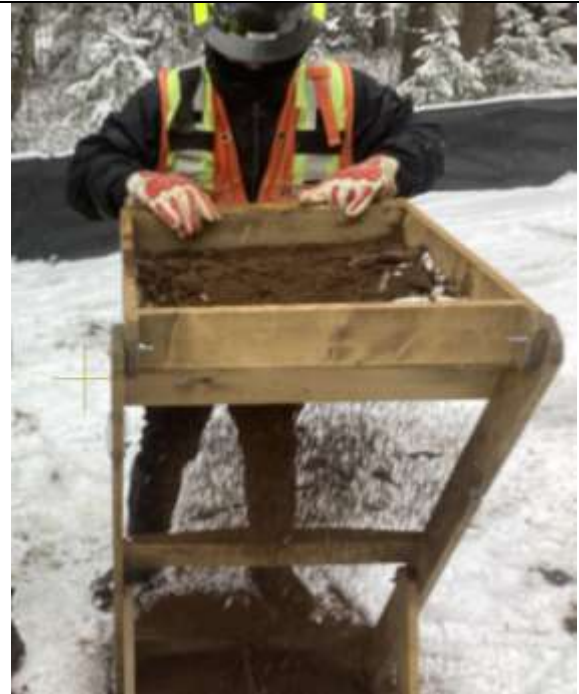
Soil piles at KP 721 were marked for location and identification by the Archaeological Resource Specialist.

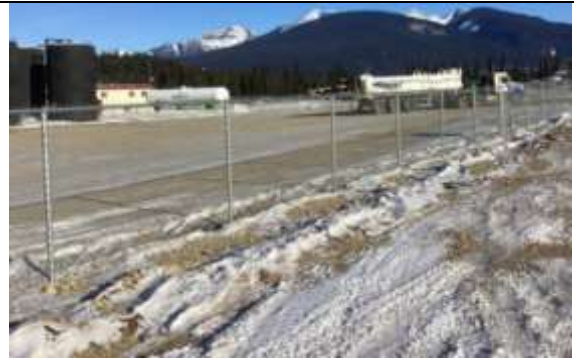
Blue River Yard inspection KP 611.

Key aspects of the inspections included housekeeping and waste management with corrective actions noted, including proper waste disposal and using drip trays. In addition, spill kits and spill response procedures were reviewed and implemented at site. Loose miscellaneous debris was identified and disposed of during the inspection.

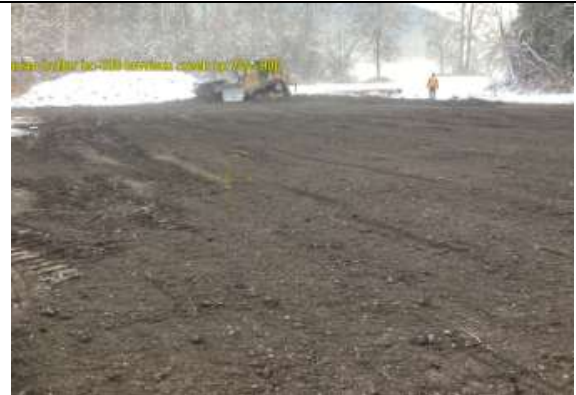
Reclamation KP 744.

Indigenous Monitors were on-site inspecting various reclamation activities, including discing for soil decompaction, topsoil replacement, confirming topsoil depth and seeding. Indigenous Monitors were engaged in conversations with crews and EIs in all stages of reclamation. They discussed the need to postpone topsoil replacement in wet or windy conditions to prevent damage to soil structure or erosion of topsoil. No deficiencies were found.

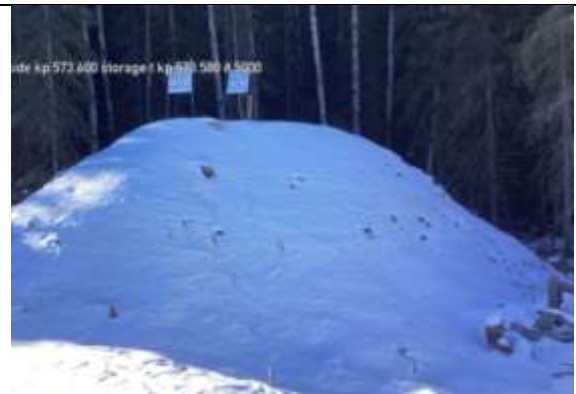
Mitigations in place TLU 30/31.

Indigenous Monitors inspect TLU sites with a focus on sites near active construction to ensure mitigation measures are in place to protect Heritage Resources. Sites inspected include TLU-30 and TLU-31. Signage was in place and the area was staked and flagged. No concerns were identified during the inspection.

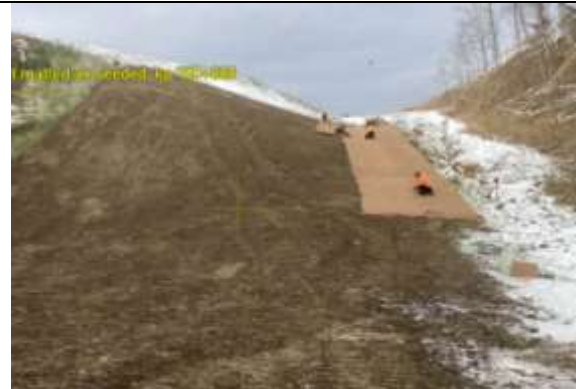
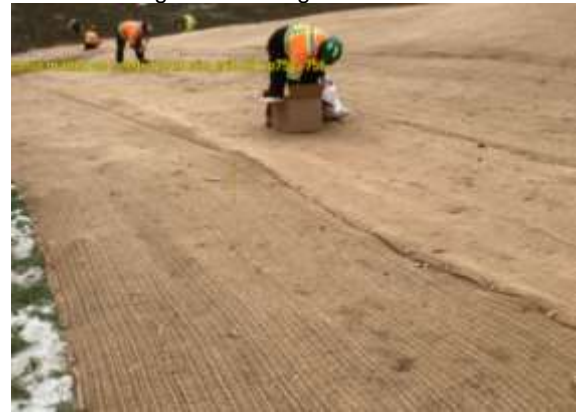
An Indigenous Monitor performed an inspection of ESC measures in place near KP 750. Coco matting was installed on the hill to help protect and retain sediment. This area was hydroseeded. When vegetation is re-established, it will act as primary ESC. No issues or environmental concerns were identified.

Crew installing coco matting at KP 750.

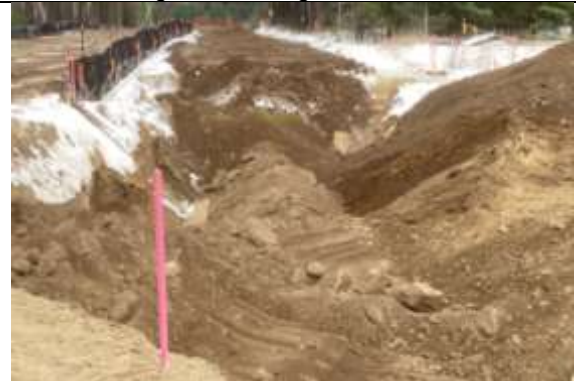
Backfill KP 720.

The Indigenous Monitors noted mitigations for topsoil piles to reduce erosion potential, including grading, separation of wetland soils from upland soils and tarps to prevent erosion. Inspections were conducted for the excavated soil placed in the trench over the installed pipe. The Indigenous Monitors observed sand and subsoil being backfilled over the pipe prior to topsoil being replaced and ensured backfill activities were confined to the construction right-of-way. No issues or potential chance finds were identified.
