INDIGENOUS MONITOR OVERVIEW REPORT

Month: October 2023
Project Region: North Thompson
(Spread 3/4A and Spread 4B)

Indigenous Monitors on the Trans Mountain Expansion Project – Overview

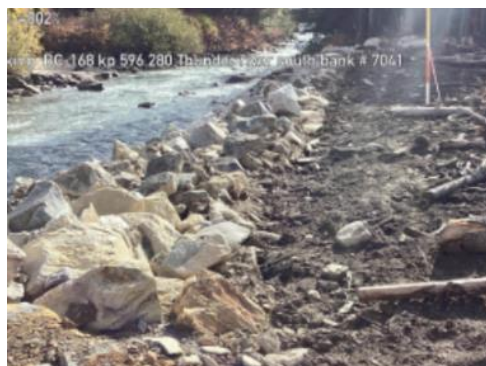
Creek restoration complete BC-168 KP 596.

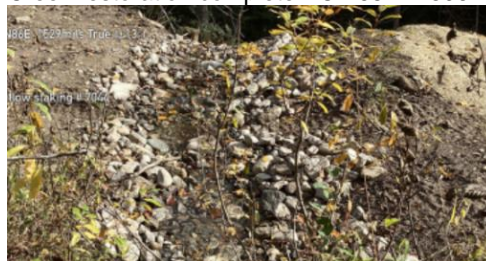
Creek restoration at BC-172 KP 600.

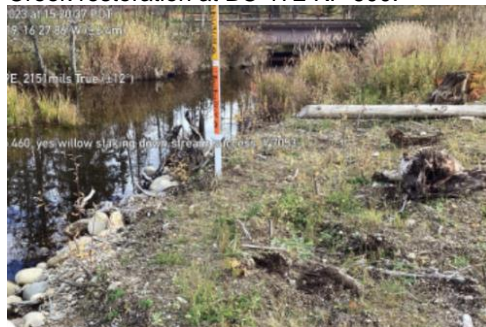
Restoration complete BC-176 KP 605.

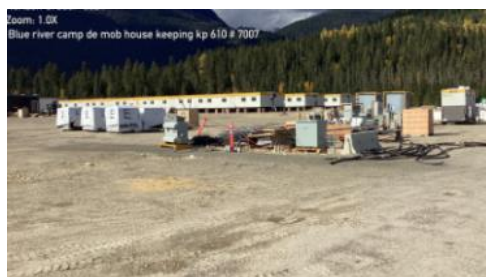
The Blue River Camp Community closed at the end of August 2023. An Indigenous Monitor inspected the Blue River Camp during demobilization activities in October. The inspection focused on ongoing housekeeping during the work. No issues were identified. The Indigenous Monitor is expected to inspect the site again as demobilization is complete.

Blue River Camp early October.

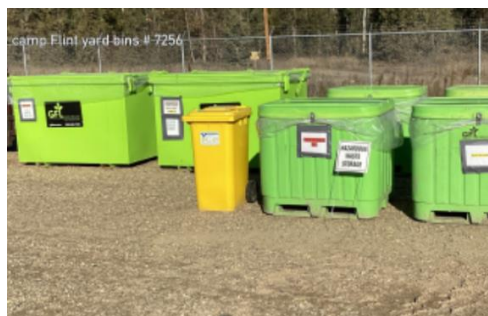
The Indigenous Monitor worked with an Environmental Inspector to ensure mitigation measures were in place during demobilization activities. An inspection of the Clearwater Camp yard was completed, with a focus on housekeeping, waste segregation and spill preparedness. The Indigenous Monitor reviewed daily communications about activities on the spread and monitoring of ESC measures ongoing. No environmental concerns were identified.

Clearwater Camp yard inspection.

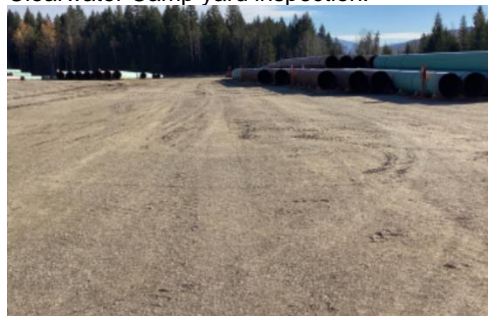
Good housekeeping Clearwater yard.

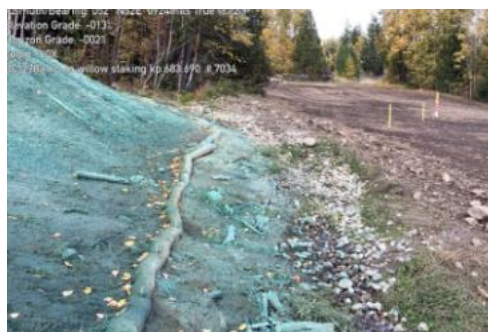
ESC measures are a major focus as crews prepare for spring runoff. The Indigenous Monitor inspected ESC mitigations on spread 3,4A between KP 490 and KP 683, including wing walls and silt fencing through several wetlands, erosion control blankets secured with willow stakes, rock armouring, swales and placement of CWD in and around the several watercourse crossings and steep slopes. Locations monitored included BC-166 KP 596, BC-167 KP 596, BC-168 KP 596, BC-172 KP 600, BC-172a KP 600 BC-173 KP 601, BC-175a KP 604 and BC-176 KP 605. No deficiencies were identified.

Seeding and ESC in place KP 683.

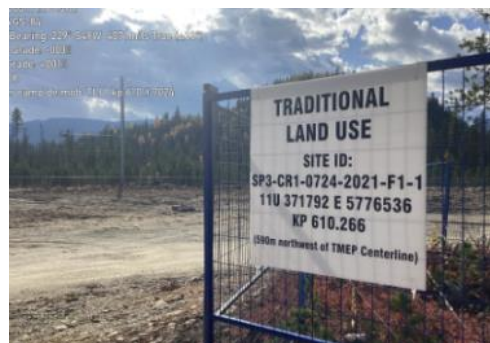
Indigenous Monitors inspected TLU areas and archaeological sites to verify staking and signage remains in good standing condition. Ongoing monitoring by the Indigenous Monitors continues at such sites.

Mitigations in place at TLU site.

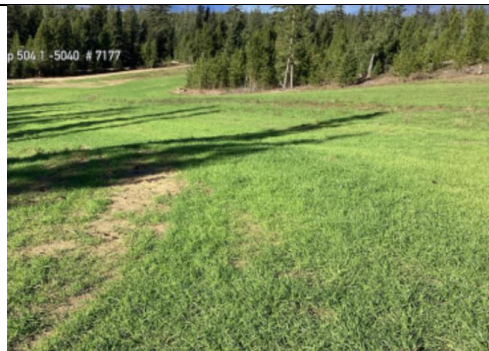
Reclamation complete and regrowth KP 504.

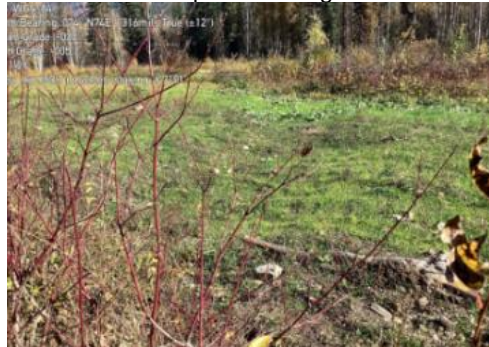
Reclamation and regrowth KP 659.
