## INDIGENOUS MONITOR OVERVIEW REPORT

**Month: January 2022**

**Project Region: West Barriere  
Reactivation 2**

**Kilometre Posts (KPs) monitored:  
KP 741.00–784.00**

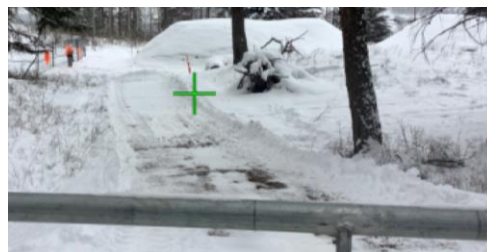
Snow removal required at a access road near KP 759.

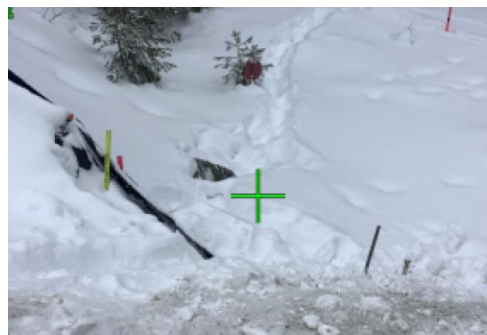
Installed geocloth near KP 759.

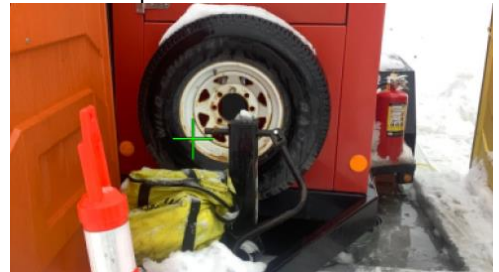
Spill kits appropriately positioned and stocked.

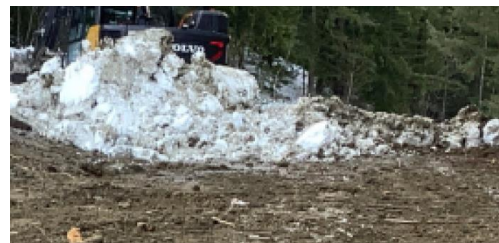
Backfill and topsoil replaced at KP 759.

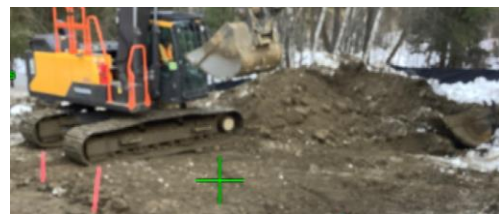
Backfill of excavated area near KP 757.

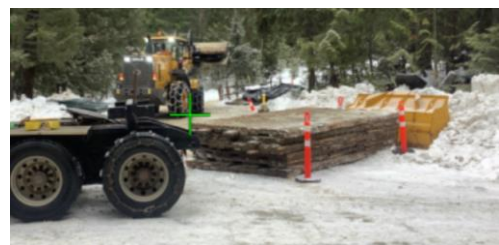
Rig matting removal at KP 759.

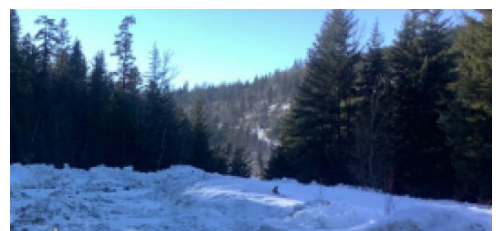
Site cleanup near KP 759.
