INDIGENOUS MONITOR OVERVIEW REPORT

Month: July 2021 Indigenous Monitor days on-site: 25

Project Region: Jasper to Mount

Robson Reactivation (Hinton to Hargreaves)

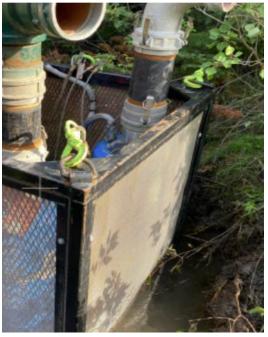
The Indigenous Monitors observed the contractor install diversion pumps and hoses used to divert the water for in-stream work to occur at watercourse Unnamed Creek 348 and Devona Creek. The upstream water is being diverted downstream of the crossing area to maintain natural flow conditions and water quality. Hoses were placed on plywood to reduce the potential impacts of topsoil scouring, soil erosion, and water quality turbidity increases. The Indigenous Monitors observed that the hoses were working as intended and water was flowing onto the plywood; no adverse environmental impacts were identified during the time of inspection. The Indigenous Monitors also observed the fish salvage at Devona Creek; 18 Brook Trout were salvaged, inspected and released downstream of the crossing. This observation was in compliance with TMEP's restricted access permit issued by Jasper National Park.

Dewatering equipment at Devona Creek.
