INDIGENOUS MONITOR OVERVIEW REPORT

Month: April 2021

Project Region: Yellowhead (Spread 2)

**Kilometre Posts (KPs) monitored:
134–337**

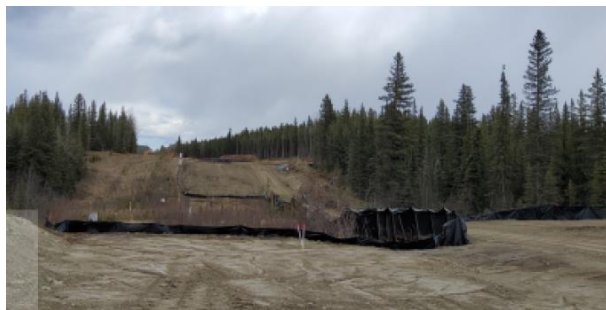
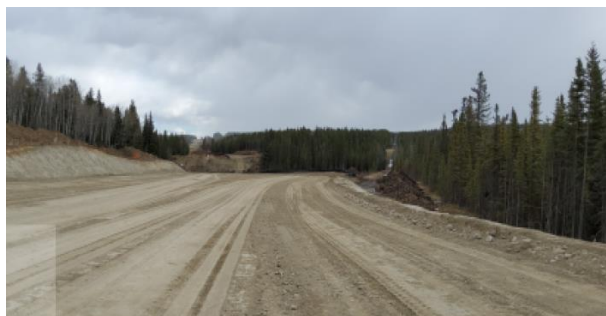
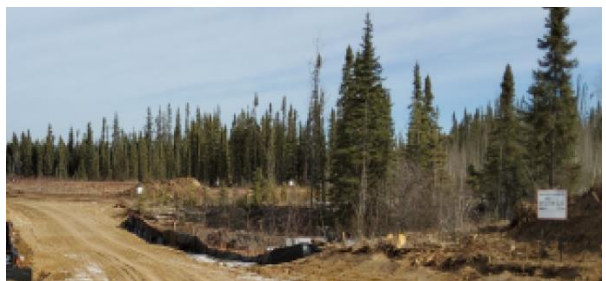
Construction progress west of Hinton.

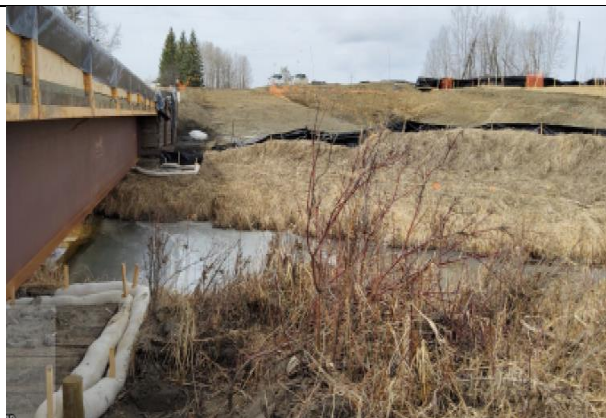
At KP 191, the Indigenous Monitors inspected signage and boundaries and confirmed use of straw wattles and geo-tech fencing. There were no deficiencies identified in this area.

Erosion and sediment control measures in place at Carrot Creek.

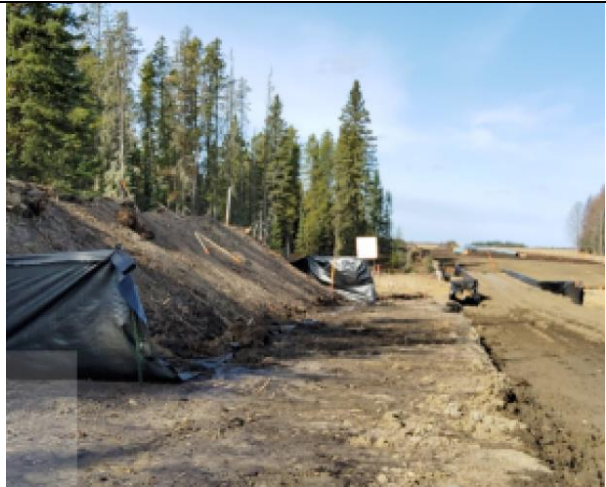
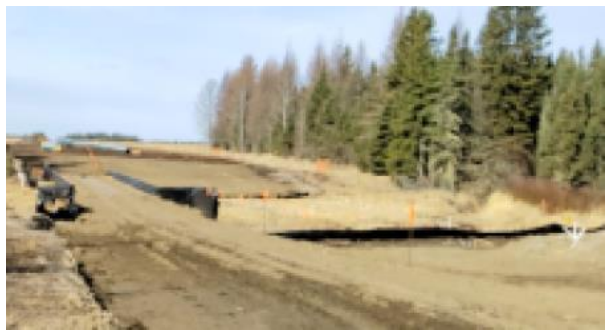
Soil piles steaked and labeled with geotech matting near KP 177.

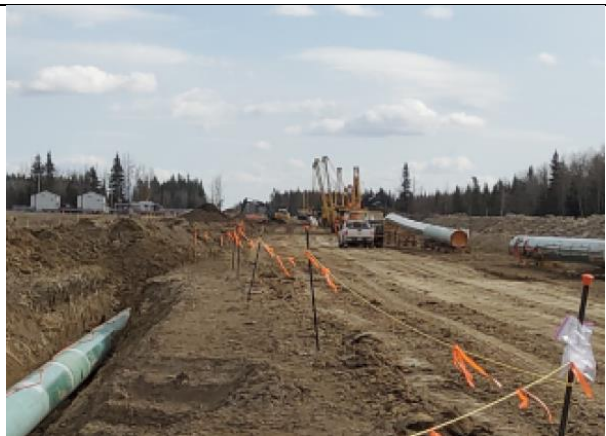
The Indigenous Monitors inspected excavated soil placed in the trench over the installed pipe. Soil is placed in a mound over the pipe to compensate for soil settlement. The Indigenous Monitors observed the subsoil being backfilled over the pipe prior to topsoil being replaced and ensure backfill activities are confined to the construction right-of-way. No concerns were identified.

Installed pipe with fibre optic leak detection system near KP 191.

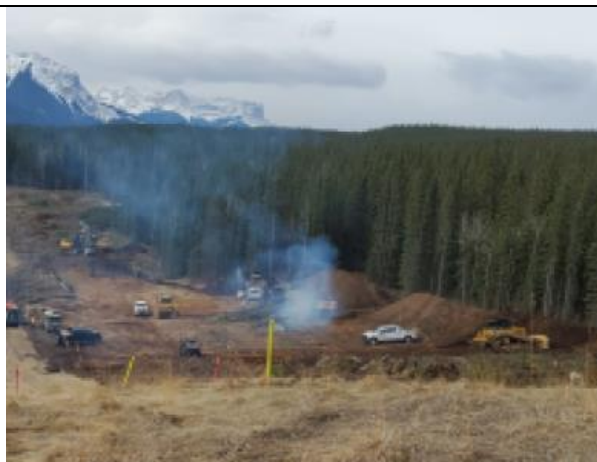
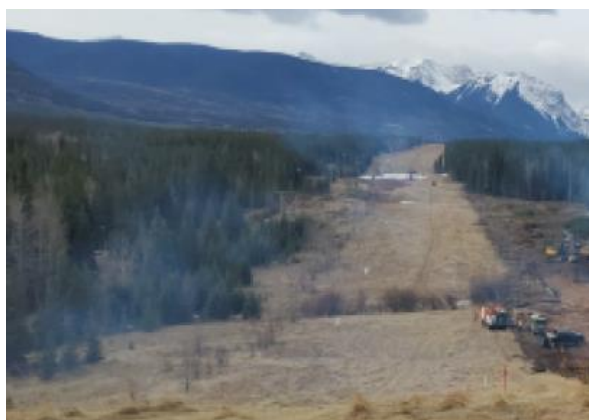
The Indigenous Monitors were on-site performing monitoring and inspection duties during the debris removal. Flagging, signage and good housekeeping were observed. No concerns were identified.

Burning activities monitored near KP 333.
