INDIGENOUS MONITOR OVERVIEW REPORT

Month: November 2020 Indigenous Monitor days on-site: 25

Project Region: Yellowhead (Spread 2) Kilometre Posts (KPs) monitored:

Indigenous Monitors on the Trans Mountain Expansion Project - Overview

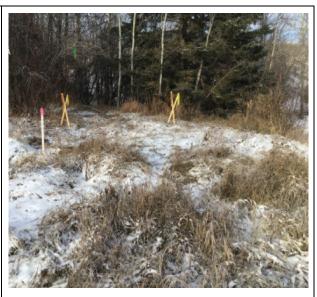
Plant gathering site, plants identified.
