INDIGENOUS MONITOR OVERVIEW REPORT

Month: November 2021

Project Region: Yellowhead, Spread 2

**Kilometre Posts (KPs) monitored:
KP 47–377**

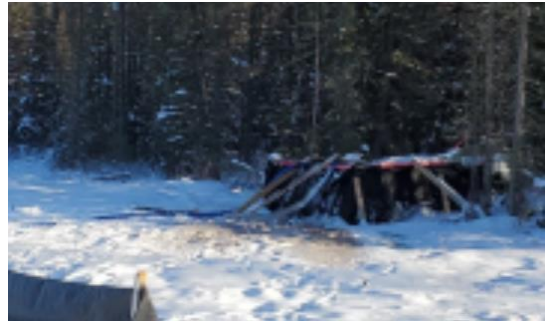
At watercourse (WT) 849/851 KP 303-304, an Indigenous Monitor reviewed the Site-Specific Wetland Crossing Execution Plan. Indigenous Monitors inspected and ensured equipment and vehicles arrived at the worksite clean and free of soil and vegetative debris. Indigenous Monitors observed the execution of mitigations, such as matting, geotech/wing walls and clay ramps being installed, and wetland topsoil being stored separately from upland soil. In saturated soil, pump-off is a regular requirement to keep excavations open and safe. The Indigenous Monitor performed a Focus Inspection on the pump-off activity and noted ice buildup that could later cause problems. The contractor was notified and ice was promptly removed. No outstanding environmental concerns were found when the inspection was complete.

Sediment trap at pump-off location WT849/851

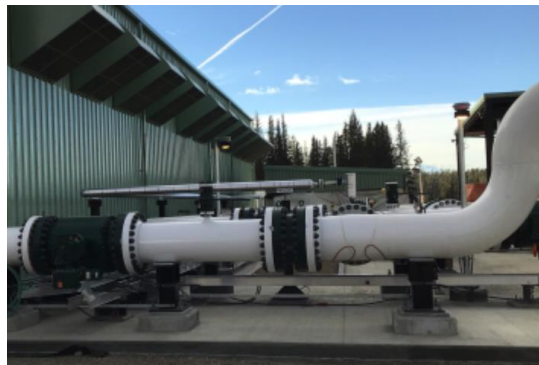
In November, joint inspections were conducted by an Environmental Inspector and an Indigenous Monitor at Edson and Gainford Pump Stations. The Facilities Environmental Protection Plan was reviewed and referenced during the inspection to ensure correct mitigations were identified. The inspection included observing the sites' waste management procedures and disposal bins, use of secondary containment and the installation of the liner surrounding the pump station that leads to the hydrocarbon retention pond at the Gainford Pump Station. Edson Pump Station construction was nearly complete during the inspection and no construction activity is anticipated there until spring 2022, when reclamation activities will resume. No cultural or environmental concerns were recorded at the time of the inspection.

Edson pumphouse south view KP 245.

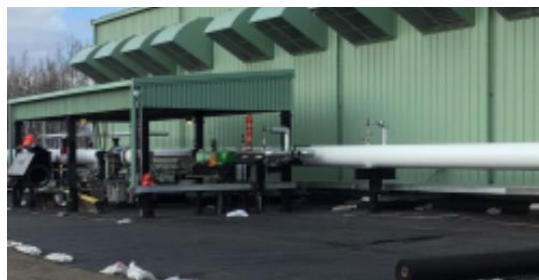
Gainford Pump Station KP116.

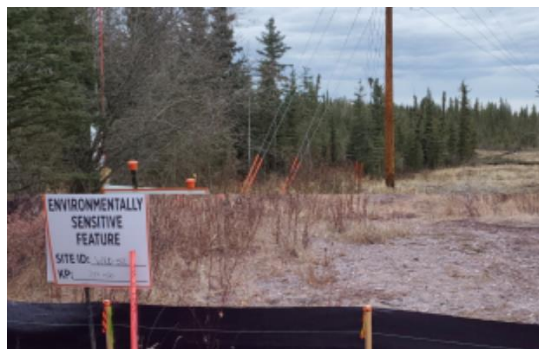
Signage in place to advise workers of the feature at KP 337.

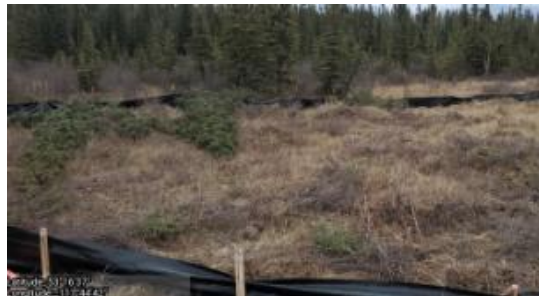
Salvaged amphibians were released outside of isolation points. An Indigenous Monitor inspected a wetland that was isolated to keep salvaged Three Toed Salamanders in a suitable overwintering habitat. The fence was intact and there was no disturbance. No concerns were identified at the time of inspection.

Salamander habitat isolated KP337.

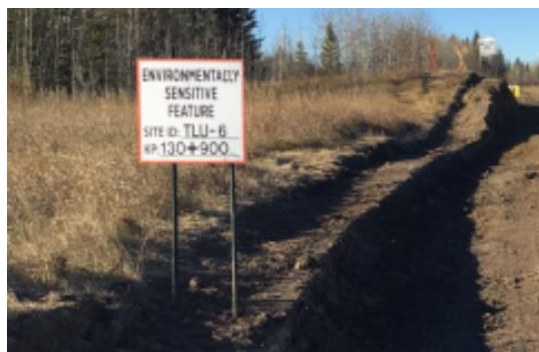
Proper signage in place at the approach of a TLU site.

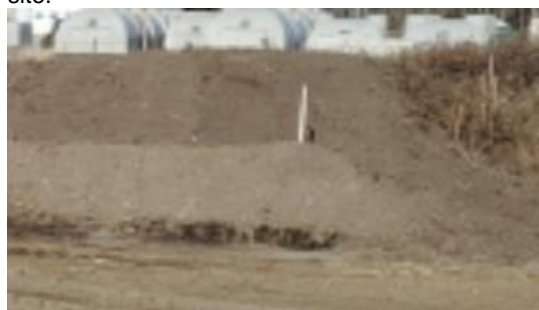
Indigenous Monitors assist, where possible, with corrective actions and confirm completion. An Indigenous Monitor inspected the pictured TLU site to confirm the root zone soil remained labelled and separated. This soil contains the seed bed for traditionally used plants. The seed bed will be replaced during reclamation. No outstanding deficiencies were found at the above-mentioned sites.

Soils separated, staked and labelled at KP130.
