**Re: Response to June 6 Written Warning Letter for Failure to Comply with *Fisheries Act* Authorization (17-HPAC-00071)
Trans Mountain Expansion Project, Westridge Marine Terminal Expansion.**

Fisheries and Oceans Canada – Monthly Report

01-13283-TW-WT00-RG-RPT-0022– DFO Authorization #17-HPAC-00071 Monthly Report

Fisheries and Oceans Canada
Non-Conformance Assessment And Action Plan Report
DFO Authorization #17-HPAC-00071 (Section 6.3)

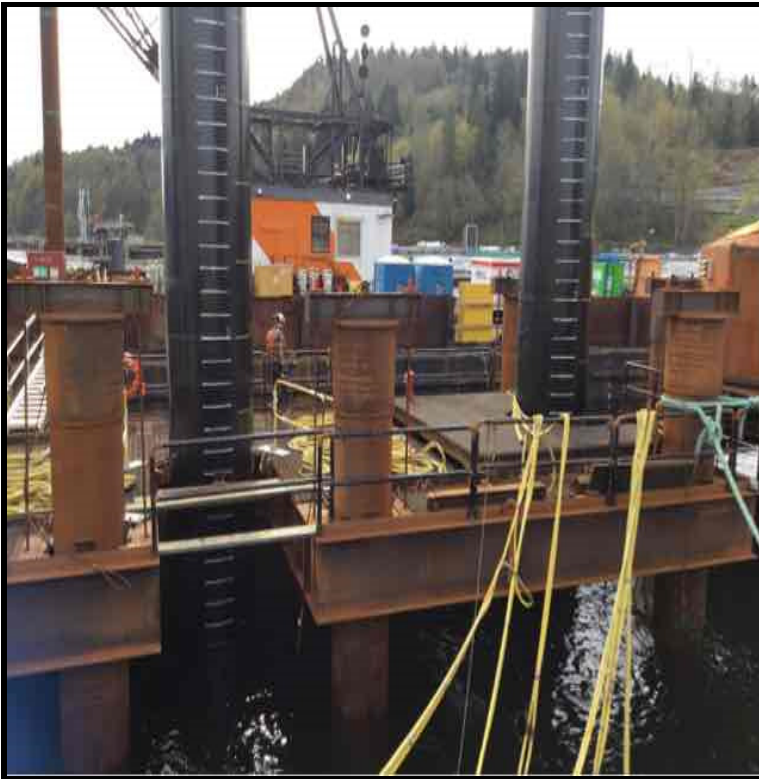
Photo 004_20180418: Crew installing bubble curtains around Piles J and K.

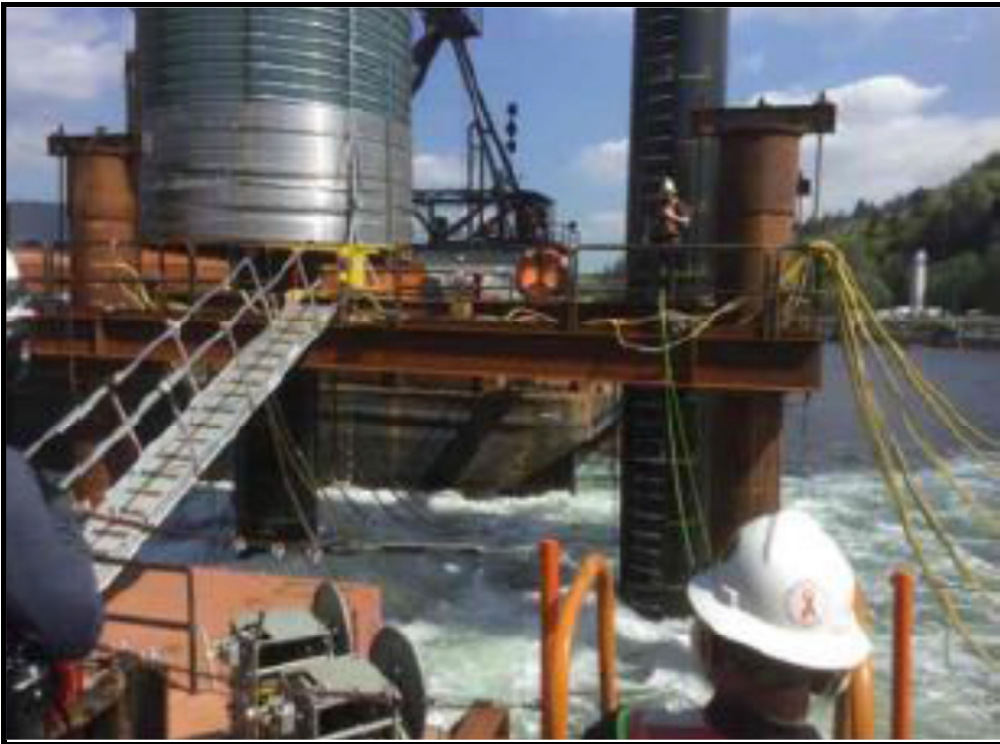
Photo 001_20180502: Active bubble curtain during impact pile installation of Pile I.

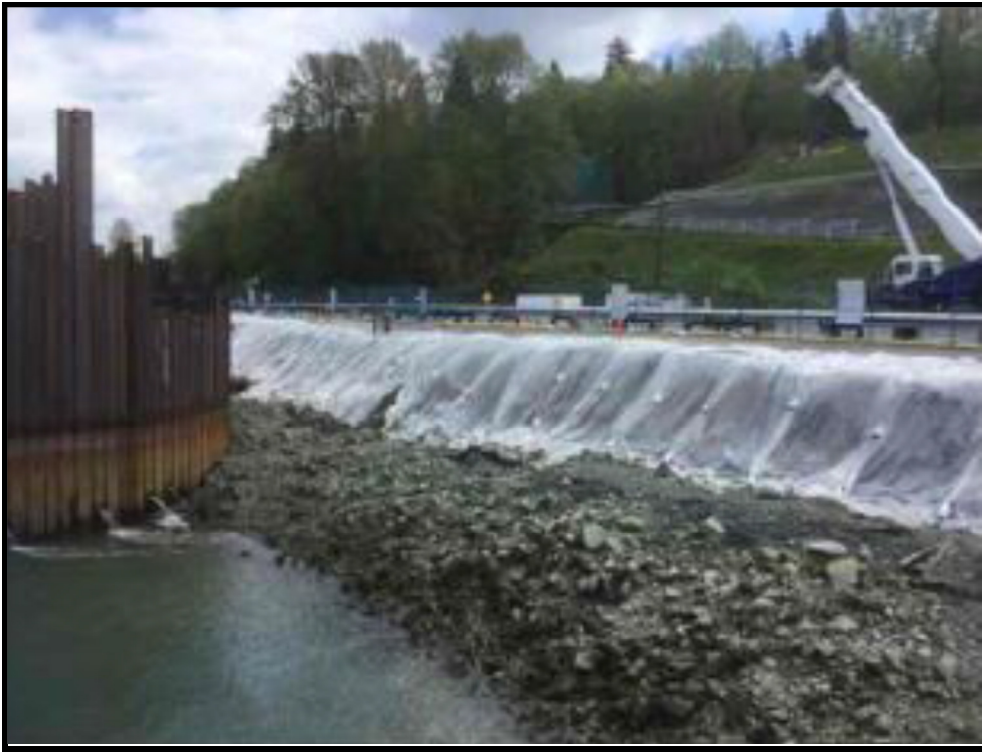
Photo 002_20180501: Poly sheeting installed along shoreline to protect backshore sediment.

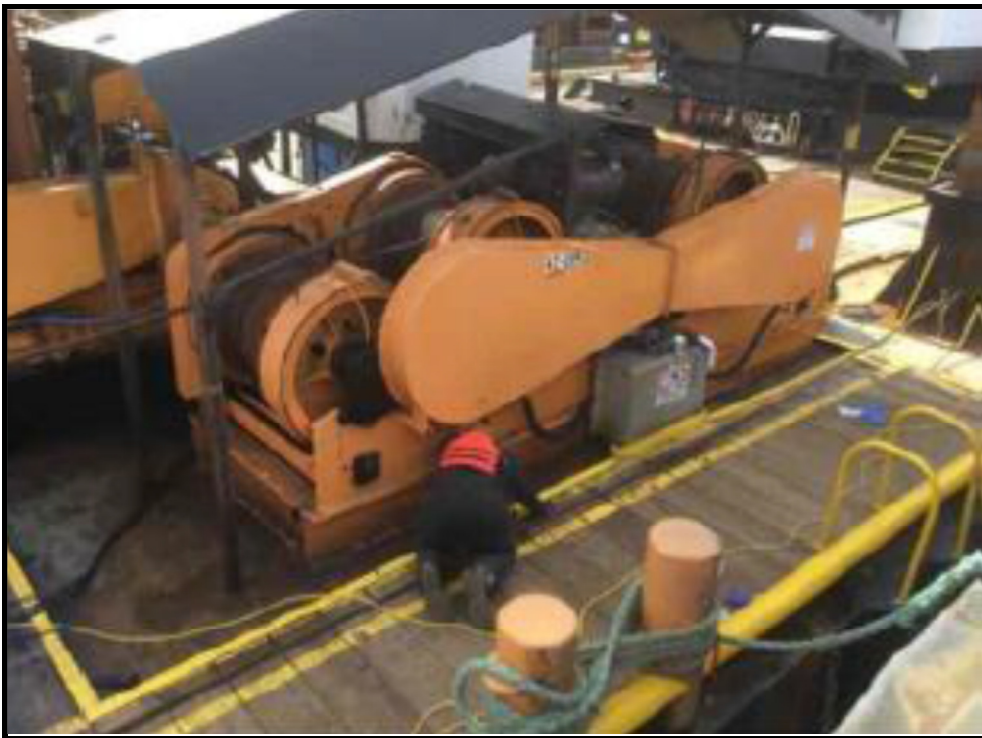
Photo 002_20180503: Crew installing secondary containment around deck winch on DB Olympia.
