# INDIGENOUS MONITOR OVERVIEW REPORT

**Month: November 2022**

**Project Region: Lower Mainland**

**Kilometre Posts (KPs) monitored:  
Spread 7 KP 1165–1176**

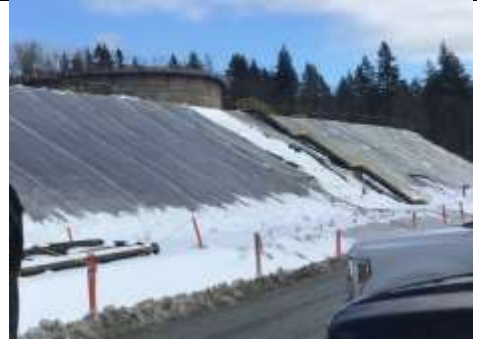
Polyethylene sheeting effectively placed a berm near Lower Road at Burnaby Terminal.

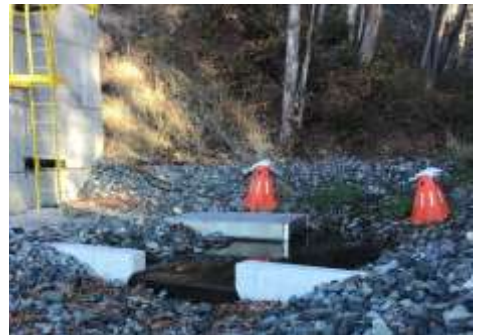
At Burnaby Terminal, the Indigenous Monitor observed the Eagle Creek and Silver Creek tributary realignment diversions were functioning as intended. No concerns were observed as the water being realigned was flowing well and as intended to mitigate any potential sediment transfer.

Eagle Creek diversion entry point at Burnaby Terminal observed to be flowing well.

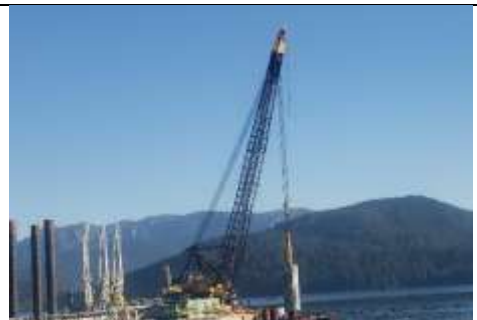
During impact pile driving, noise shrouds and underwater bubble curtains are installed around the pile to reduce underwater noise levels. Analysis of underwater noise data indicates the use of two bubble curtains (primary and secondary) results in greater noise reduction than the primary bubble curtain alone.

The DB General lowering the noise shroud for pile driving at WMT.

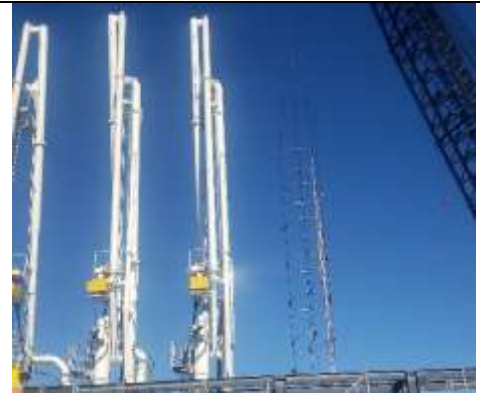
Lowering the bubble curtain for pile driving at WMT.

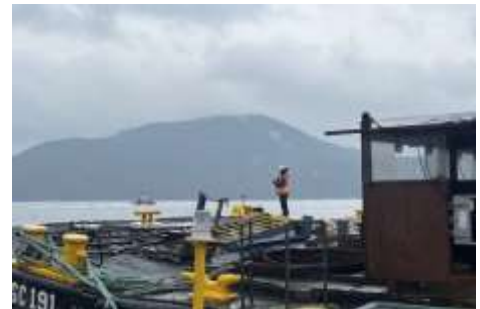
During impact pile driving, four marine mammal monitors are deployed and if a marine mammal is observed, pile driving activities are suspended for 30 minutes.

A marine mammal monitor observing during impact piling activities at WMT.

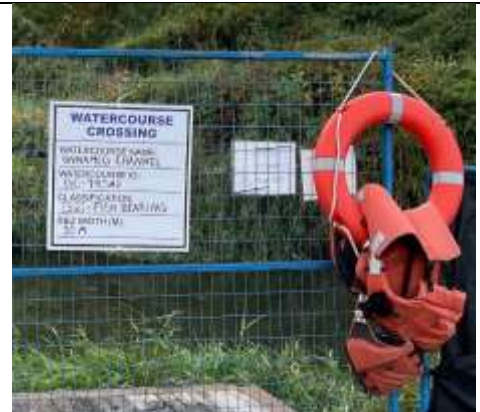
The Indigenous Monitor observed and inspected various environmental mitigations at the temporary workspace, including environmental feature signage, erosion and sediment control measures, site housekeeping and secondary containment for equipment and machinery. Inspections included ensuring signage posted at watercourses near the entry and exit pits, including the Fraser River (BC780), Port Mann Slough (BC780.1) and Unnamed Channel (BC780A1), were sturdy and visible.

Watercourse BC780A1 signage inspected at CWP 62.

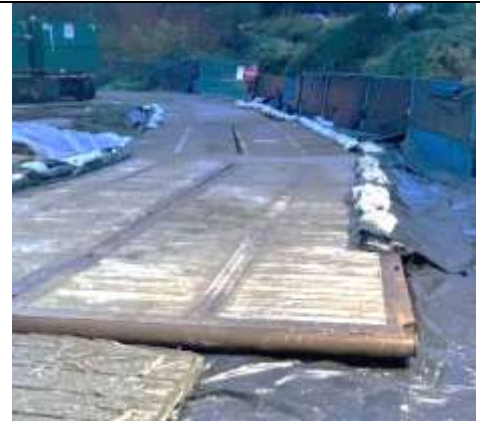
Roadway installed around the HDD drill bore-pit hole. ESC measures along the roadway were intact and functioning to avoid sediment from entering watercourse BC780A1.
