# INDIGENOUS MONITOR OVERVIEW REPORT

**Month: October 2022**

**Project Region: Lower Mainland**

## **Indigenous Monitors on the Trans Mountain Expansion Project – Overview**

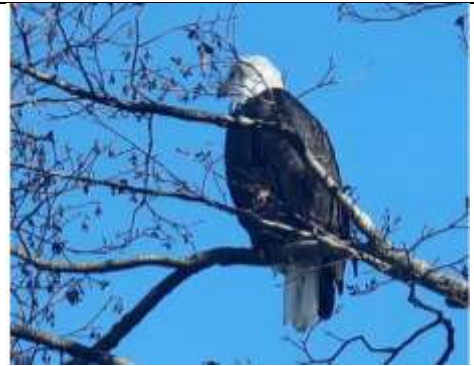
The Indigenous Monitor at WMT observed a Bald Eagle nest built on an artificial nesting platform near the Kask Bros. Temporary Infrastructure Site at WMT. The nesting platform was placed in a Western Hemlock tree in September 2017 as prescribed in the Westridge Trans Mountain Bald Eagle Mitigation Project–Nest Construction & Capping Summary Report. This nest site will be monitored in the upcoming months.

Bald Eagle observed at WMT.

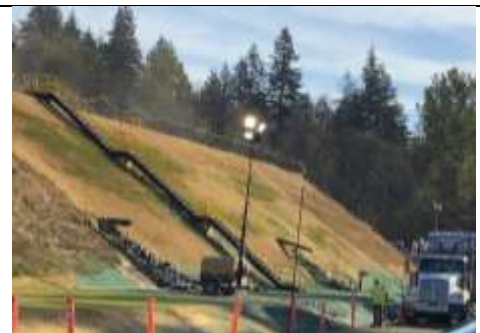
At Burnaby Terminal and WMT, the Indigenous Monitors conducted inspections to verify ESC measures throughout the terminals were installed effectively as prescribed in the Environmental Protection Plan. This included inspecting berms and exposed slopes were securely covered with polyethene sheeting or hydroseed was correctly applied. Ditches and other water conveyance measures throughout the terminal and along the perimeter of the Project footprint were also inspected to ensure they were free of construction materials and debris.

Hydroseed being applied on a slope along Lower Road at Burnaby Terminal.

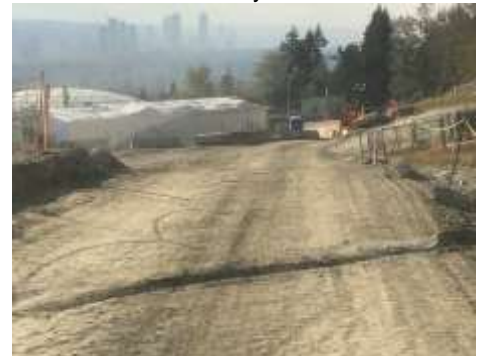
At Burnaby Terminal, the Indigenous Monitor observed and inspected road bars that were installed intermittently along all active gravel roadways throughout the site. The function of the road bars is to divert rainwater from the roads to into drainage ditches that flow into the Burnaby Terminal water treatment plant.

Road bars created on Reservoir Road at Burnaby Terminal.

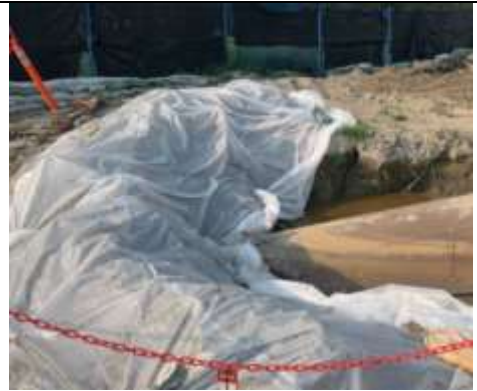
The Indigenous Monitor observed and inspected various environmental mitigations at the temporary workspace, including erosion and sediment control measures, site housekeeping, dust control and secondary containment for equipment and machinery. During inspections, the Indigenous Monitor observed spill containment measures had been installed underneath operating stationary equipment and that secondary containment around the HDD borehole pit area, including polyethylene sheeting covering the berm surrounding the HDD pit, to be working effectively and mitigating potential sediment transfer into a nearby fish-bearing watercourse.

Polyethylene sheeting placed along the berm surrounding the HDD bore pit.

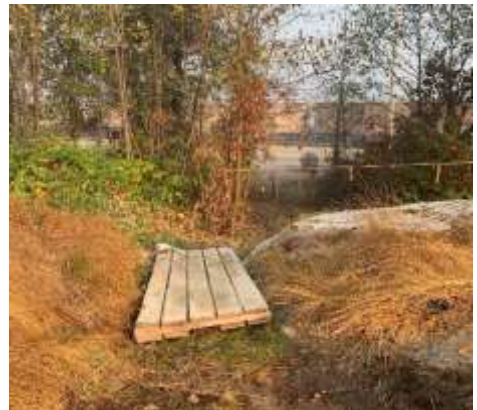
The Indigenous Monitor accompanied the Environmental Inspector on walk-throughs along the path being created to follow the route of the HDD drill. On the south side of the Fraser River HDD worksite, they observed grading of the path and installation of protective wooden matting being paced on top of the sheeting. This pathway will be used to monitor for inadvertent fluid release (IFR) during future drilling operations.

Protective wooden matting being placed on top of the IFR pathway on the south side of the Fraser River HDD worksite.

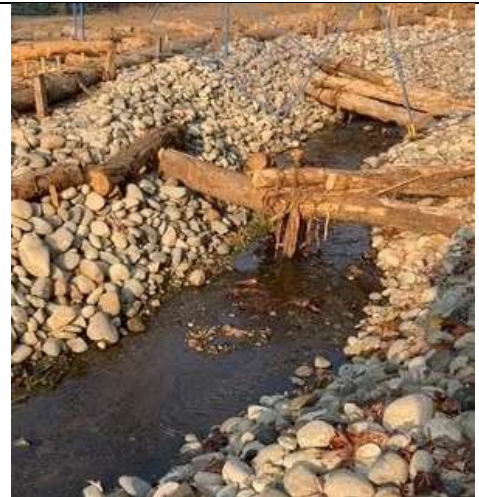
At Holmes Creek (watercourse BC-783b) and Austin Creek (watercourse BC-783a) near KP 1175, the Indigenous Monitor observed watercourse restoration measures. These measures include placement of river rock to reinforce the creek bank and replacement of coarse woody debris to assist with erosion control and regrowth of vegetation. Environmental feature signage was also inspected in the vicinity. No concerns were reported.

River rock and coarse woody debris observed at Holmes Creek (watercourse BC-783b).
