# INDIGENOUS MONITOR OVERVIEW REPORT

**Month: June 2022**

**Project Region: Fraser Valley**

## **Indigenous Monitors on the Trans Mountain Expansion Project – Overview**

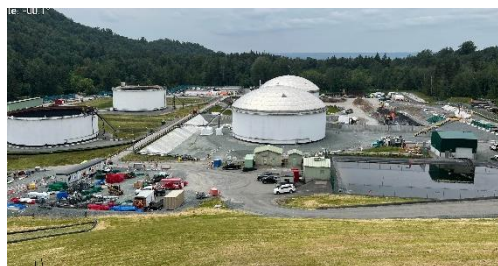
At Sumas Terminal, the Indigenous Monitor completed site inspections. The inspections included observing and documenting general housekeeping, waste management, erosion and sediment control measures, soil stripping and storage, concrete management, groundwater management and wildlife management. No deficiencies were observed.

Photo of Sumas Terminal taken by the Indigenous Monitor on June 15.
